Re: Forest Lakes Homeowners Association

Forest Lakes Circle - West Palm Beach, Florida

Mansard Roofs' Inspection

Inspection Date: April 14, 2022 to May 5, 2022

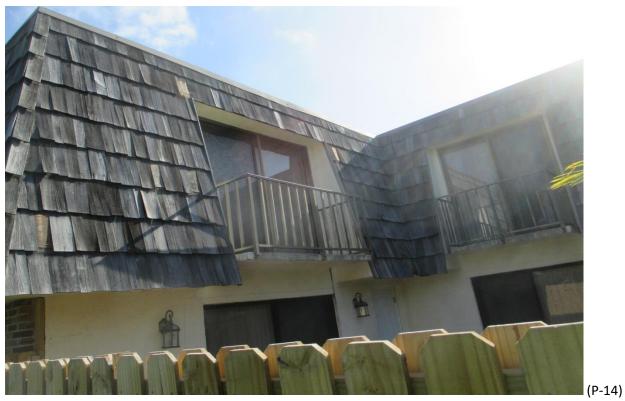
Mansard Roof Inspection Performed on Building #1524 at Forest Lakes - Unit: D – West Palm Beach, Fl.

- A. Fair Condition, (Photograph #9)
- B. Fair Condition; some curling shingles. (Photographs #10 & #11)
- C. Fair Condition; there are missing and curling shingles. (Photographs #12 & #13)
- D. Fair Condition; there are some missing and curling shingles. (Photographs #14 & #15)

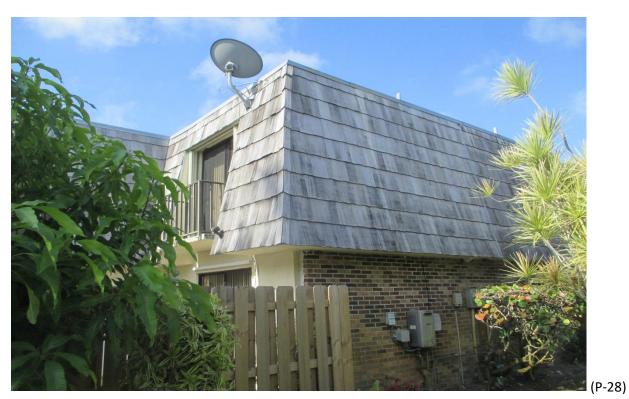
Mansard Roof Inspection Performed on Building #1534 at Forest Lakes - Unit: C – West Palm Beach, Fl.

- A. Poor Condition; some missing, curling and improper shim repairs. (Photographs #23 & #24)
- B. Fair Condition; some curling shingles and improper shim repairs. (Photographs #25 & #26)
- C. Fair Condition, (Photographs #27 & #28)
- D. Poor Condition; some missing, curled and improper shim repaired shingles. (Photographs #29 & #30)
