4-Point Inspection Form						
	4-r onit insp					
Insured/Applicant Name:	Canterbury at Aberdeen Condo Assoc.	Application / Policy #:				
Address Inspected: 8050	Aberdeen Dr, Boynton Beach, FL 33472					
Actual Year Built: 1997		Date Inspected: 03/06/2023				
Minimum Photo Require	ments					
Dwelling: Each side	🗹 Dwelling: Each side 🗹 Roof: Each slope 🗹 Plumbing: Water heater, under cabinet plumbing/drains, exposed valves					
	e panel with interior door label					
Electrical box with pa						
All hazards or defici	iencies noted in this report					
	A Florida-licensed inspector must	complete, sign and date this form.				
Be advised that Underwriting will rely on the information in this sample form, or a similar form, that is obtained from the Florida licensed professional of your choice. This information only is used to determine insurability and is not a warranty or assurance of the suitability, fitness or longevity of any of the systems inspected.  Electrical System Separate documentation of any aluminum wiring remediation must be provided and certified by a licensed electrician.

South Florida Inspectors 03/06/2023

# **4-Point Inspection Form**

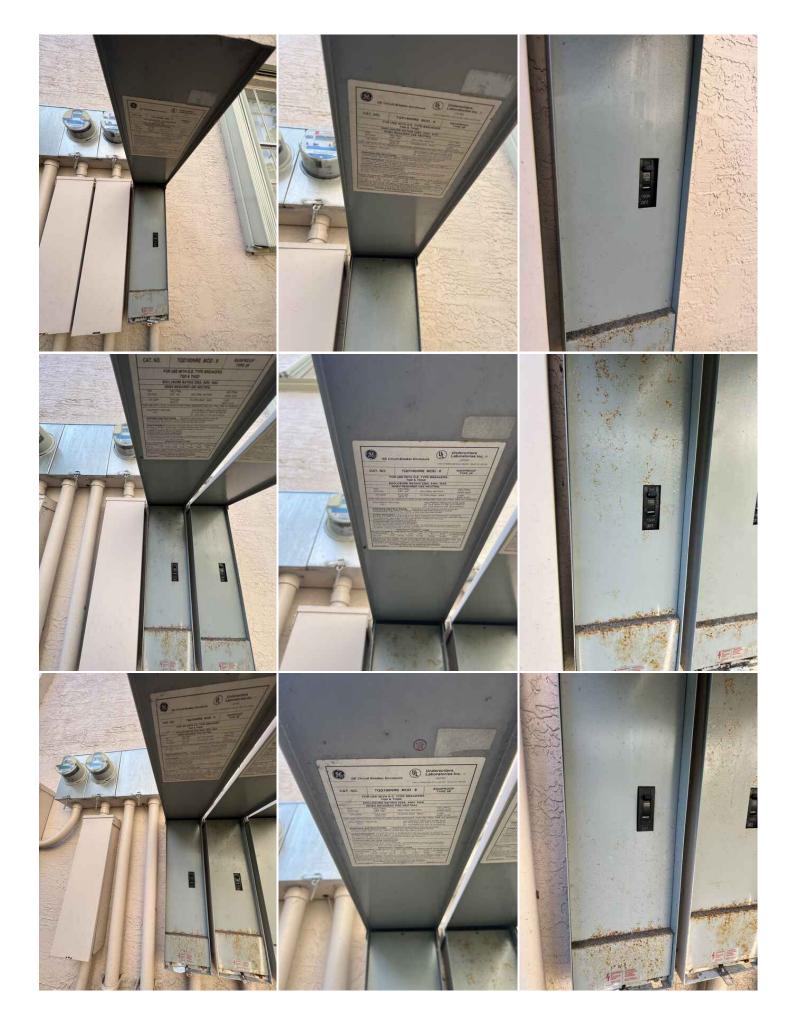
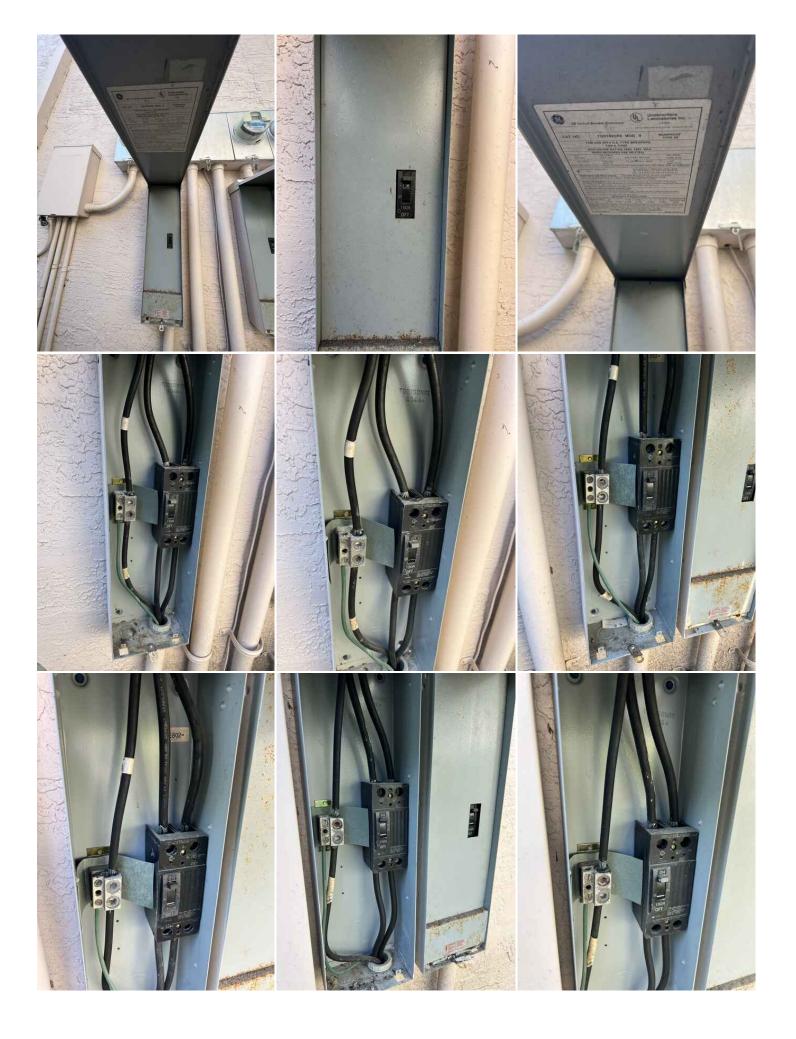
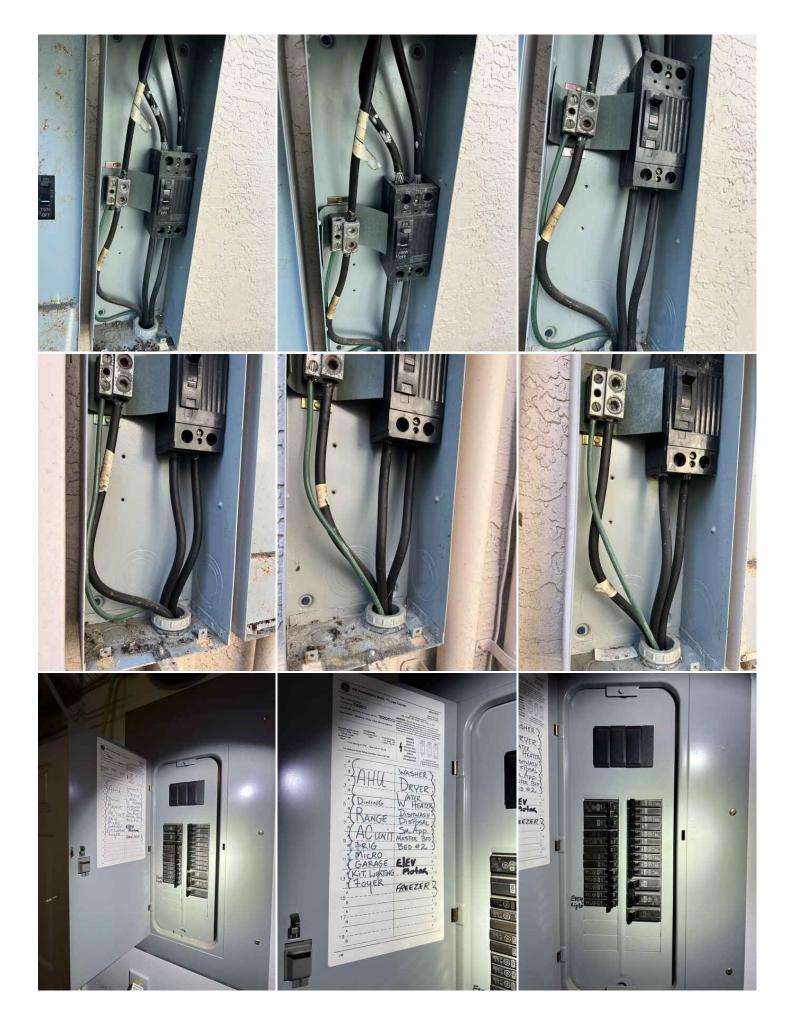
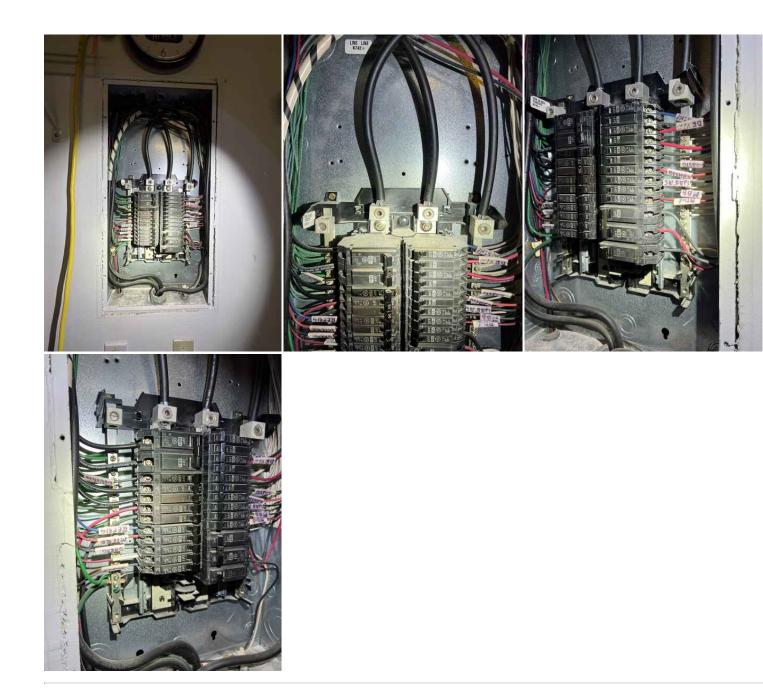
Panel Photos

Hazards Present					
		Double taps			
Blowing fuses		Exposed wiring			
□ Tripping breakers		Unsafe wiring			
Empty sockets		Improper breaker size			
Loose Wiring		□ Scoring			
Improper grounding		□ Other (explain)			
□ Over fusing					
General condition of the electrical system: 🗹 Satisfactory 🗆 Unsatisfactory (explain)					
Supplemental information					
Main Panel	in Panel Second Panel		Wiring Type		
Panel age: <u>1997</u> Panel age: <u>2010</u>			Copper		
Year last updated: <u>1997</u>	Year last updated: 2010		MM, BX or Conduit		
Brand/Model: General Electric Brand/Model: General Electric		ectric

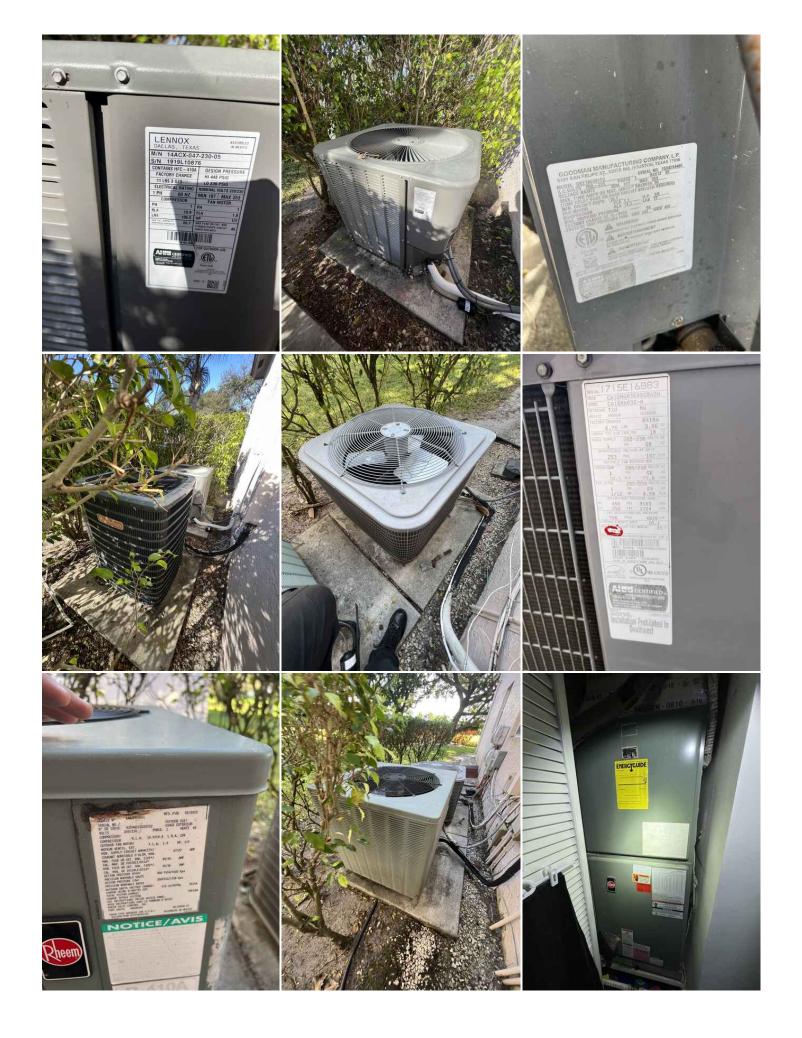
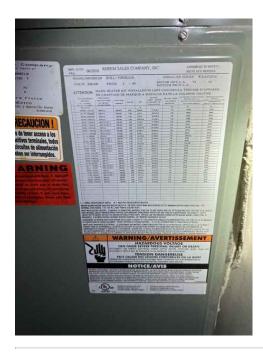
HVAC Equipment

Are the heating, ventilation and air conditioning systems in good working order? 🗹 Yes 🗆 No (explain)

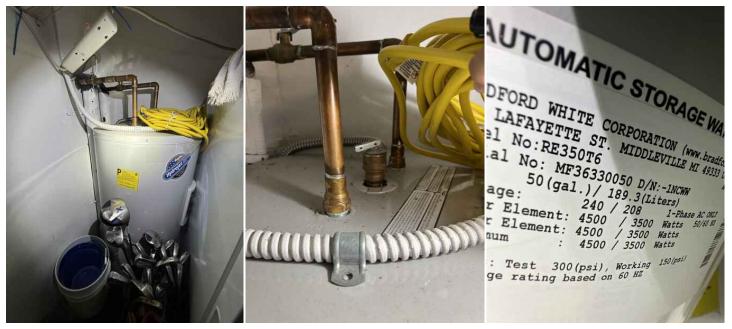
#### Water Heater

Plumbing System								
Is there a temperature pressure relief valve on the water heater? ☑ Yes □ No Is there any indication of an active leak? □ Yes ☑ No Is there any indication of a prior leak? □ Yes ☑ No Water heater location: 								
General condition of the following plumbing fixtures and connections to applicances:								
Satisfactory N/A   Dishwasher Image: Constraint of the second secon	Satisfactory N/A   Toilets I   Sinks I   Sump pump I   Main shut off valve I   All other visible I   ts, mold, corrosion, grout/caulk, etc.).							
Supplemental Information								
Age of Piping System: <u>X</u> Original to home Completely re-piped Partially re-piped (Provide year and extent of renovation in the comments below)	Type of pipes (check all that apply)         ☑ Copper         ☑ PVC/CPVC         □ Galvanized         □ PEX         □ Other (specify)

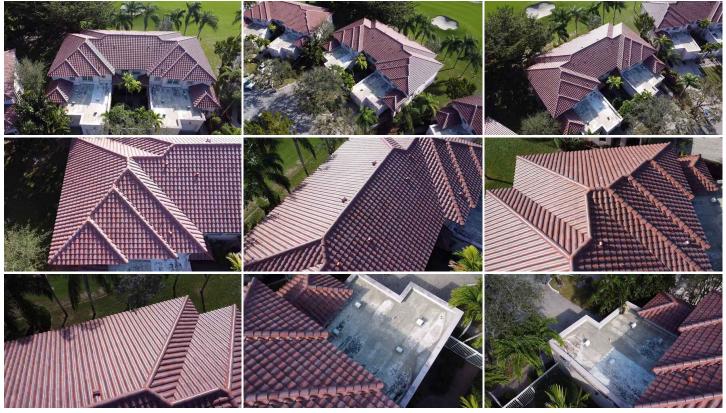
Photos of Each Slope

Roof (With photos of each roof slope, this section can take the place of the <i>Roof Inspection Form.</i> )				
Predominant Roof	Secondary Roof			
Covering material: Clay Tile	Covering material: Modified Bitumen			
Roof age (years): 1	Roof age (years): 25			
Remaining useful life (years): <u>34</u>	Remaining useful life (years): 0			
Date of last roofing permit: 07/01/2022	Date of last roofing permit: 02/19/1999			
Date of last update: 07/01/2022 If updated (check one):	Date of last update: 02/19/1999 If updated (check one):			
li updated (check one).	n updated (check one).			
☑ Full Replacement	✓ Full Replacement			
Partial Replacement	Partial Replacement			
% of replacement	% of replacement			
Overall condition:	Overall condition:			
☑ Satisfactory	Satisfactory			
Unsatisfactory (explain below)	Unsatisfactory (explain below)			
Any visible signs of damage / deterioration?	Any visible signs of damage / deterioration?
