4-Follit ilispection Follii					
Insured/Applicant Name: Canterbury at Abe	rdeen Condo Assoc.	Applicatio	n / Policy #:		
Address Inspected: 8074 Aberdeen Dr, Boynton Beach, FL 33472					
Actual Year Built: 1997	Actual Year Built: 1997 Date Inspected: 03/06/2023				
Minimum Photo Requirements  ☑ Dwelling: Each side ☑ Roof: Each slope ☑ Plumbing: Water heater, under cabinet plumbing/drains, exposed valves ☑ Main electrical service panel with interior door label ☑ Electrical box with panel off ☑ All hazards or deficiencies noted in this report  A Florida-licensed inspector must complete, sign and date this form.					
Be advised that Underwriting will rely on the information in this sample form, or a similar form, that is obtained from the Florida licensed professional of your choice. This information only is used to determine insurability and is not a warranty or assurance of the suitability, fitness or longevity of any of the systems inspected.

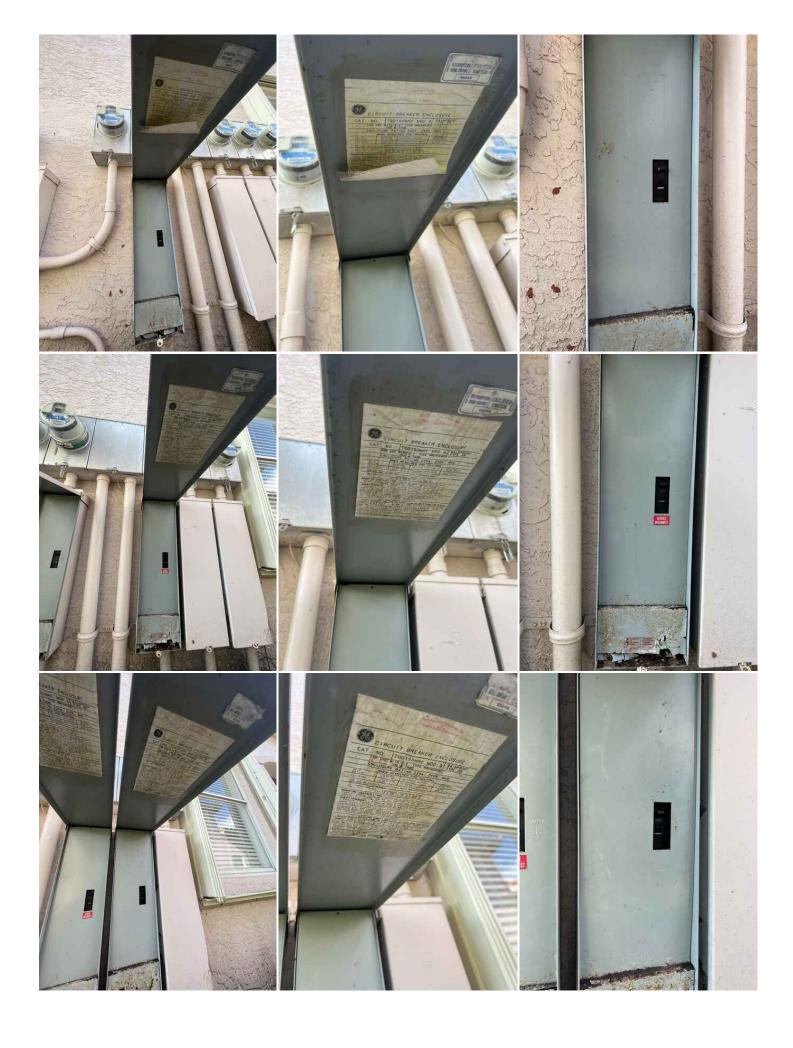
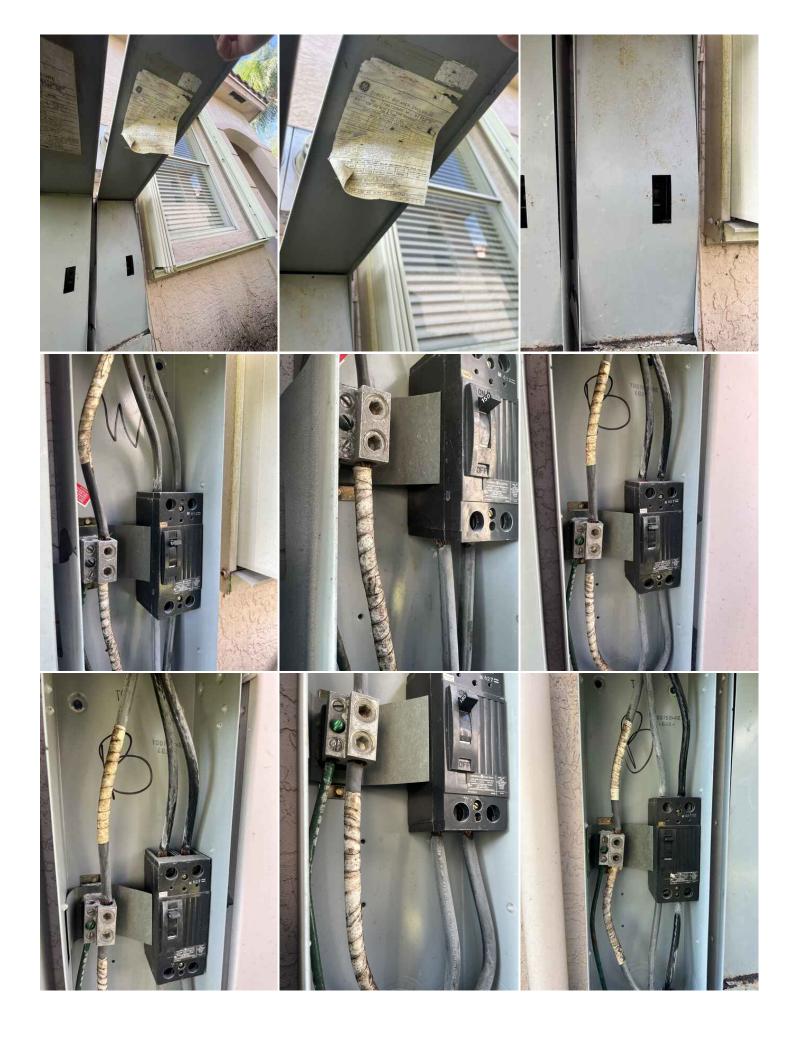
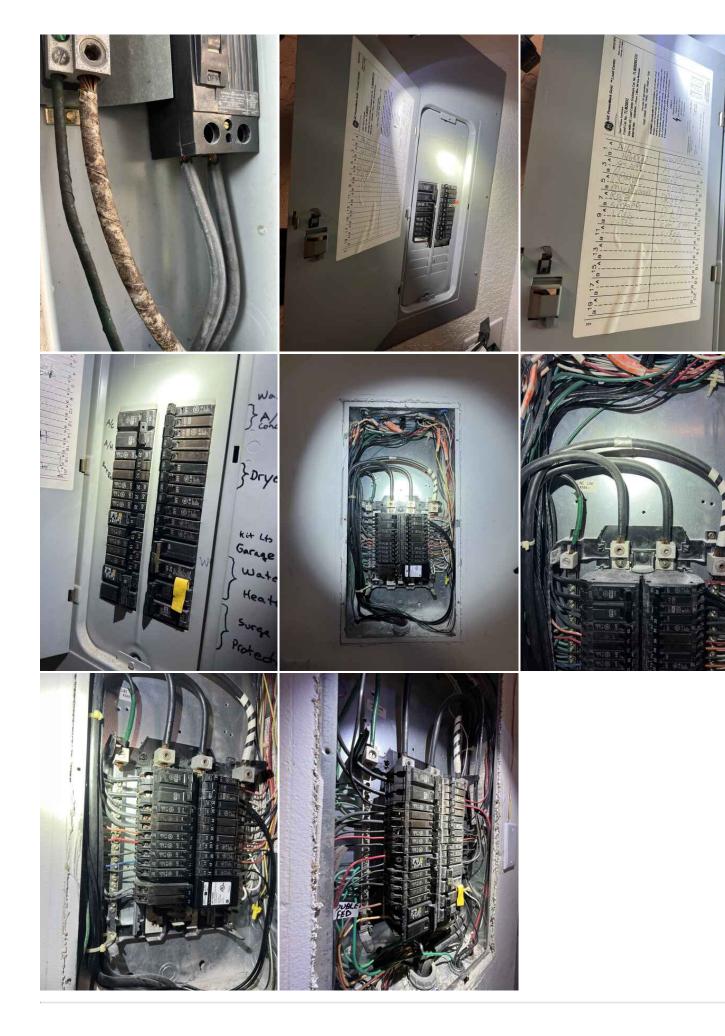
Panel Photos

General condition of the electrical system: ☑ Satisfactory ☐ Unsatisfactory (explain)					
Supplemental information					
Main Panel	Second Panel		Wiring Type		
Panel age: <u>1997</u>	Panel age: <u>2010</u>		☑ Copper		
Year last updated: 1997	Year last updated: 2010		☑ NM, BX or Conduit		
Brand/Model: General Electric	Brand/Model: General Electric
