4-Point Inspection Form					
Insured/Applicant Name:Canterbury at Aberdeen Condo Assoc.	Application / Policy #:				
Address Inspected: 8082 Aberdeen Dr, Boynton Beach, FL 33472					
Actual Year Built: 1997					
Minimum Photo Requirements					
Electrical System Separate documentation of any aluminum wiring remediation must be provided	led and certified by a licensed electrician.				
Main Panel         Type: ☑ Circuit breaker □ Fuse         Total Amps: 150         Is amperage sufficient for current usage? ☑ Yes □ No (explain)	Second Panel Type: ☑ Circuit breaker □ Fuse Total Amps: <u>150</u> Is amperage sufficient for current usage? ☑ Yes □ No (explain)				
Indicate presence of any of the following:   Cloth wiring  Active knob and tube Branch circuit aluminum wiring (If present, describe the usage of all aluminum wiring):  * If single strand (aluminum branch) wiring, provide details of all remediation. <i>Separate documentation of all work must be provided.</i> Connections repair via COPALUM crimp Connections repair via AlumniConn

South Florida Inspectors 03/06/2023

# **4-Point Inspection Form**

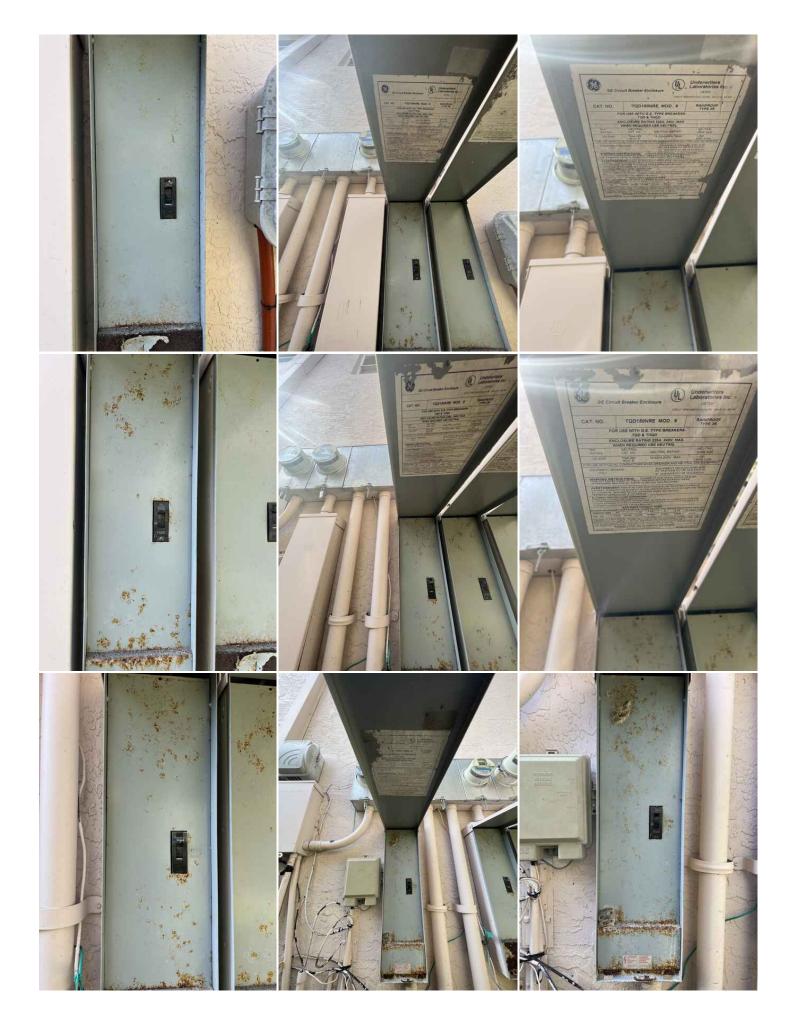
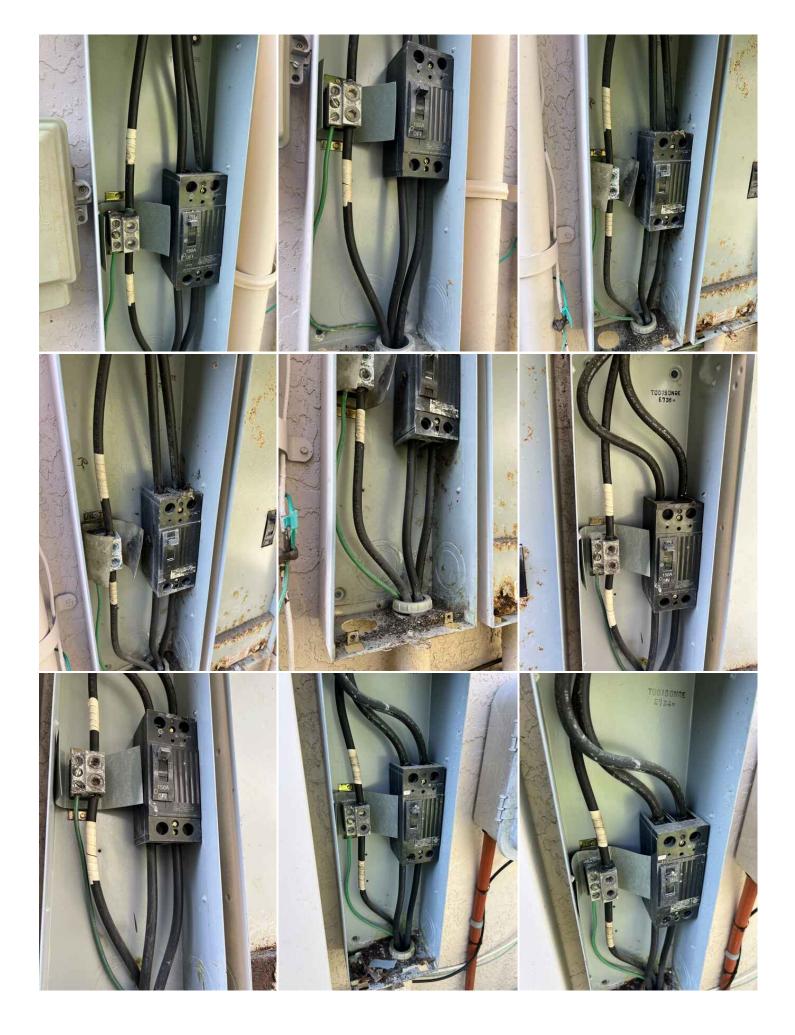
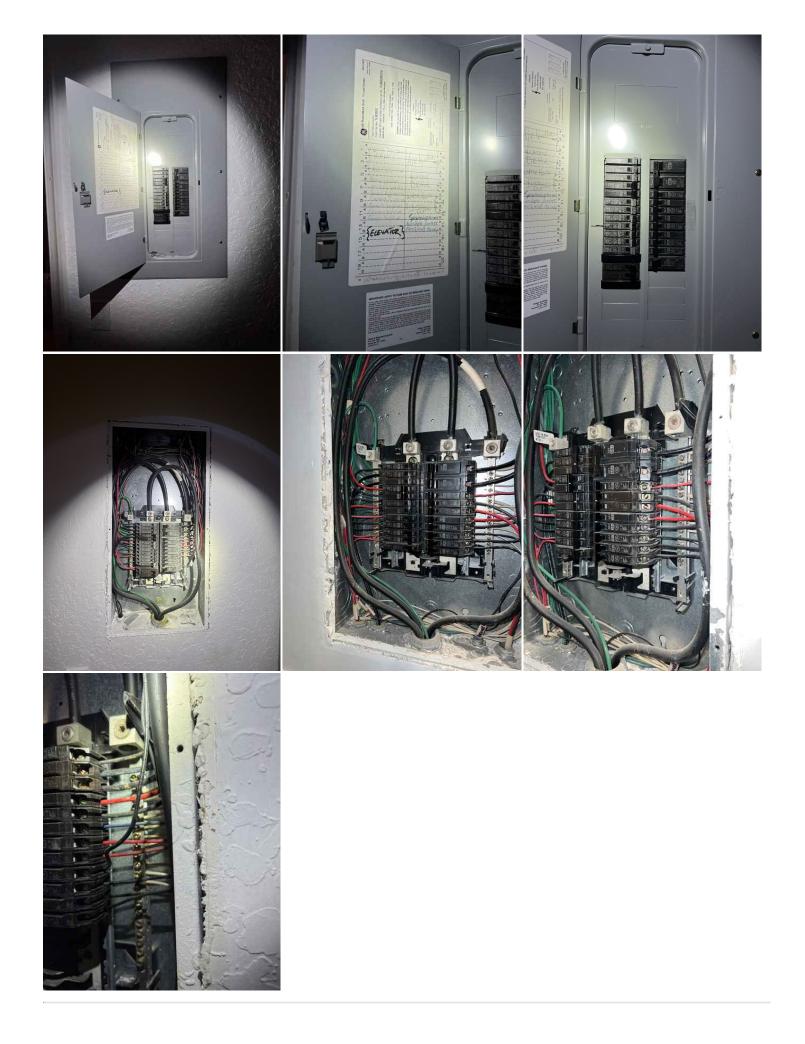
Panel Photos

Panel age: 1997
 Panel age: 2010
 Image: Copper

Brand/Model: General Electric
 Brand/Model: General Electric
 Image: Copper

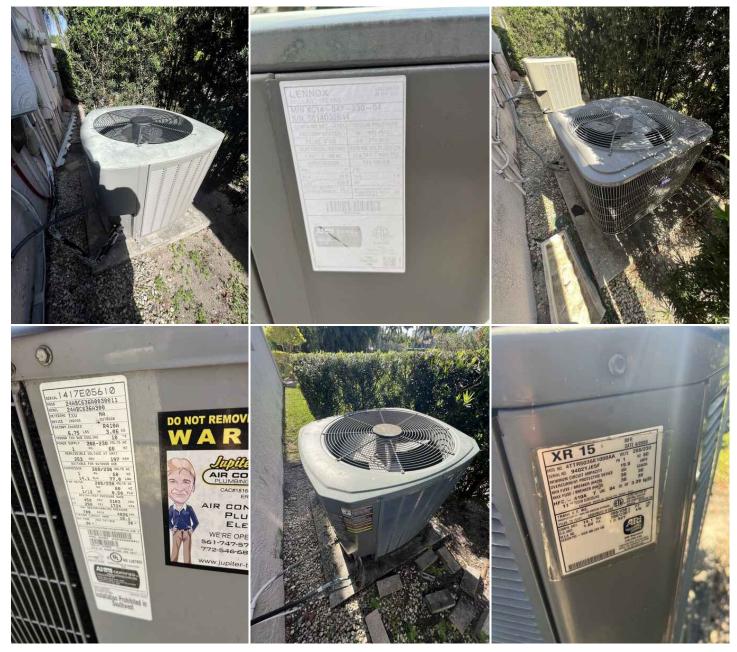
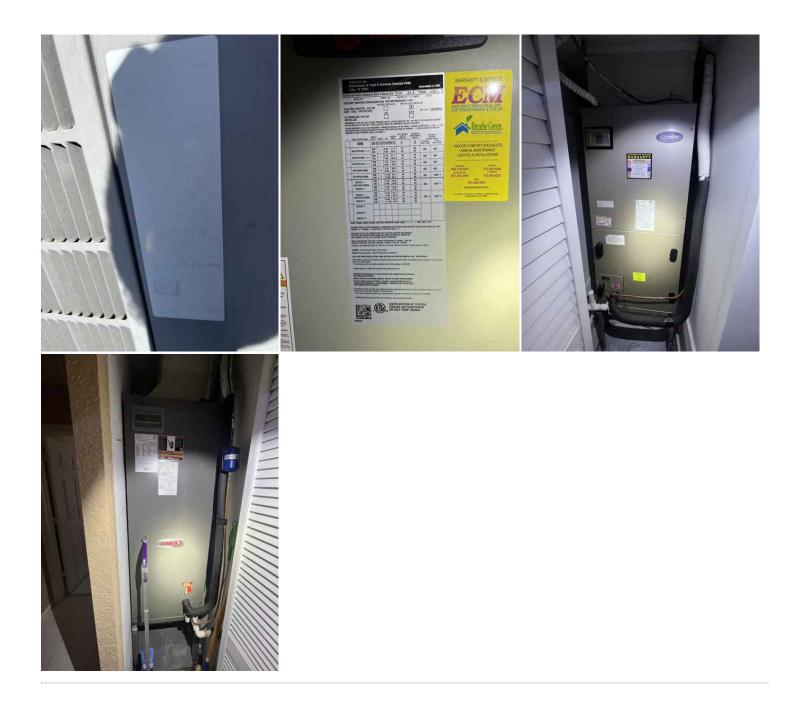
### HVAC Equipment

Are the heating, ventilation and air conditioning systems in good working order? 🗹 Yes 🗌 No (explain)

Age of system: <u>6 years</u>

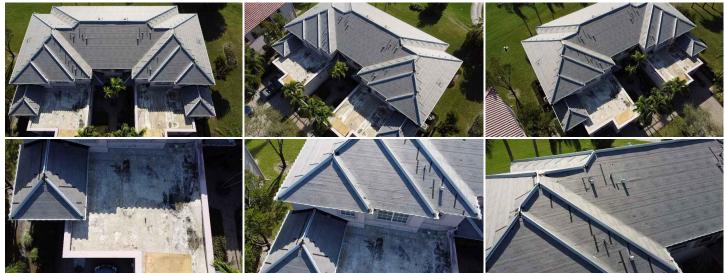
Photos of Each Slope

Roof (With photos of each roof slope, this section can take the place of the Roof Inspection Form.)				
Predominant Roof	Secondary Roof			
Covering material: Clay Tile	Covering material: Modified Bitumen			
Roof age (years): 1	Roof age (years): 25			
Remaining useful life (years): <u>34</u>	Remaining useful life (years): 0			
Date of last roofing permit: 06/30/2022	Date of last roofing permit: 01/06/1999			
Date of last update: 06/30/2022	Date of last update: 01/06/1999			
If updated (check one):	If updated (check one):			
✓ Full Replacement	Full Replacement			
Partial Replacement	Partial Replacement			
% of replacement	% of replacement			
Overall condition:	Overall condition:			
☑ Satisfactory	☑ Satisfactory			
Unsatisfactory (explain below)	Unsatisfactory (explain below)			
Any visible signs of damage / deterioration?	Any visible signs of damage / deterioration?			
(check all that apply and explain below)	(check all that apply and explain below)
