Uniform Mitigation Verification Inspection Form

Inspection Date: 3/11/2021						
Owner Information						
Owner Name: Andover at Wycliffe	Contact Person:					
Address: 10112 Andover Coach Circle		Home Phone: (561) 215-9160				
City: Lake Worth	Zip: 33449	Work Phone:				
County: Palm Beach		Cell Phone:				
Insurance Company: Policy #:						
Year of Home: 1991	# of Stories: 2	Email: ldistefano@grsmgt.com				
though 7. The insurer may ask additional	graph must accompany this form to validad I questions regarding the mitigated feature	te each attribute marked in questions 3 (s) verified on this form.				
the HVHZ (Miami-Dade or Broward cou	<u>Building Code</u> : Was the structure built in compliance with the Florida Building Code (FBC 2001 or later) OR for homes located in the HVHZ (Miami-Dade or Broward counties), South Florida Building Code (SFBC-94)?					
a date after 3/1/2002: Building Perm	it Application Date (MM/DD/YYYY)//	2002/2003 provide a permit application with

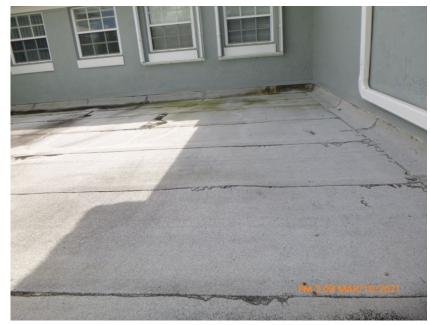
Built-Up/Rolled Asphalt Roof Covering

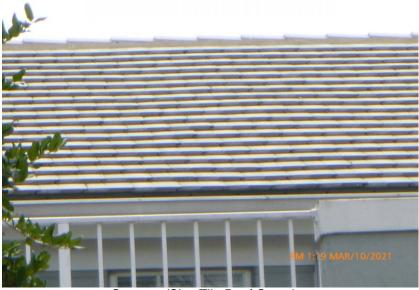
Concrete/Clay Tile Roof Covering

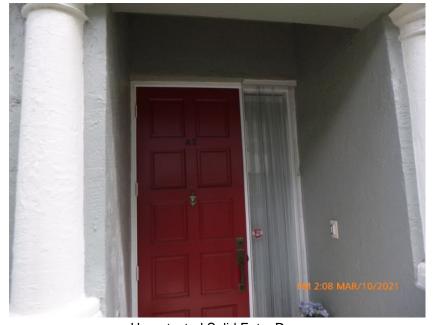
Unprotected Solid Entry Door

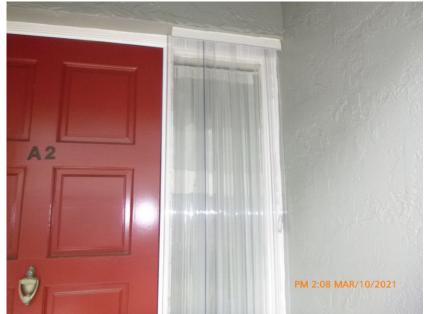
Impact Rated Corrugated Lexan Panel Shutters

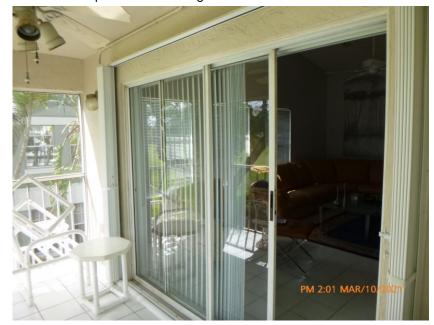
Impact Rated Accordion Shutter

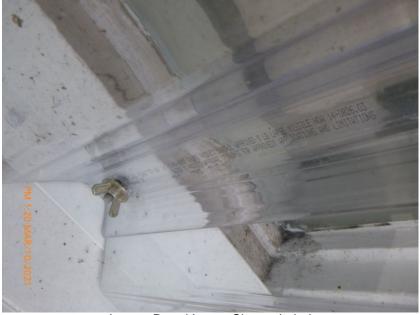
Impact Rated Lexan Shutter Label

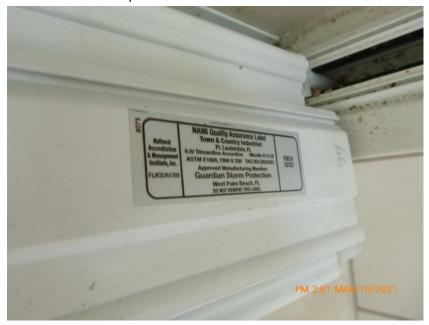
Impact Rated Accordion Shutter Label

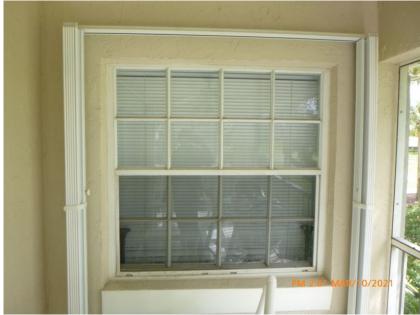
Impact Rated Accordion Shutter Label

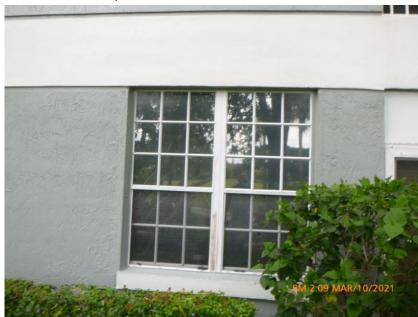
Unprotected Window

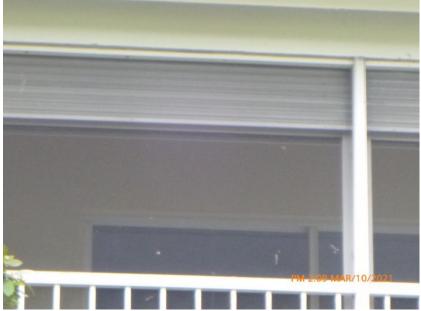
Rolldown Shutter - Unverified as Impact

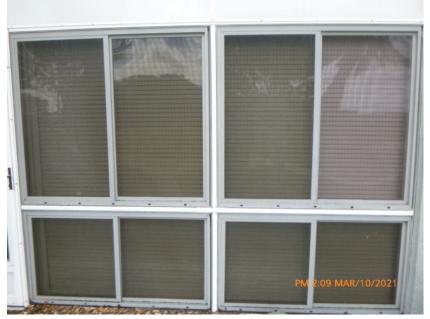
Unprotected Glazed Entry Door

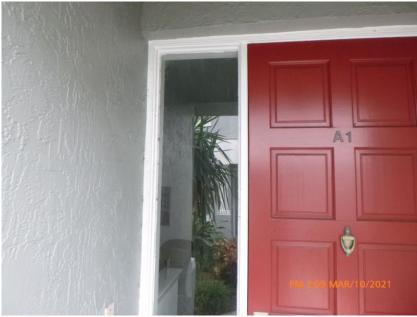
Unprotected Window

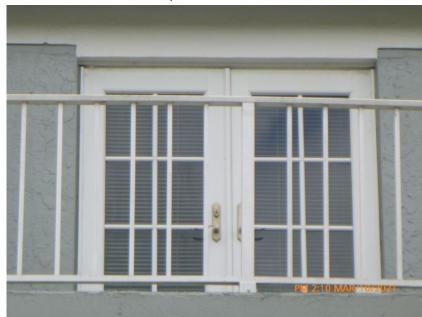
Unprotected Glazed Entry Door

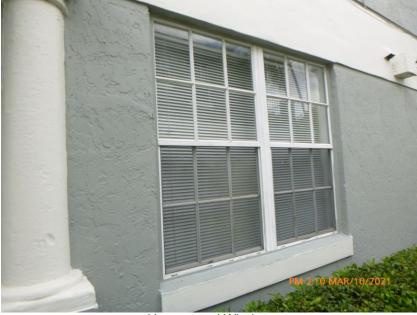
Unprotected Window

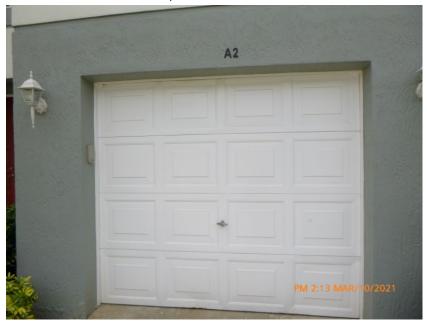
Unprotected Solid Garage Door

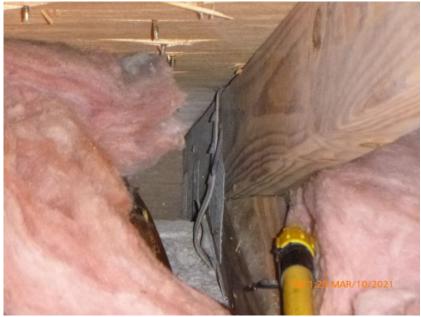
Single Wrap

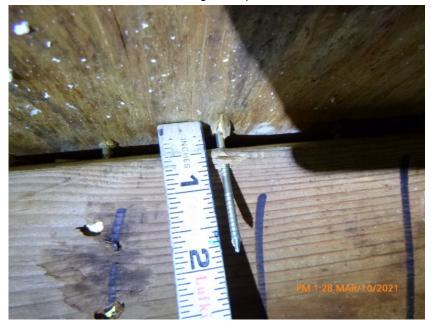
8d Nails or Greater in Size

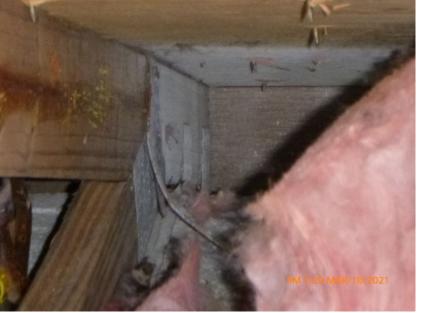
Single Wrap

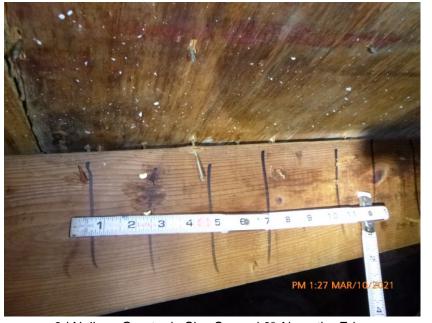
8d Nails or Greater in Size Spaced 6" Along the Edge

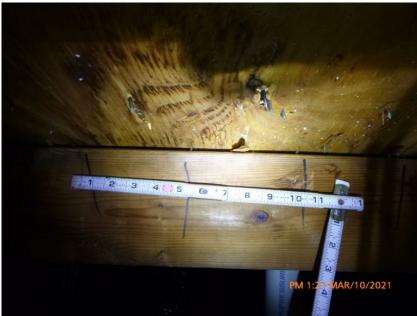
8d Nails or Greater in Size Spaced 6" in the Field

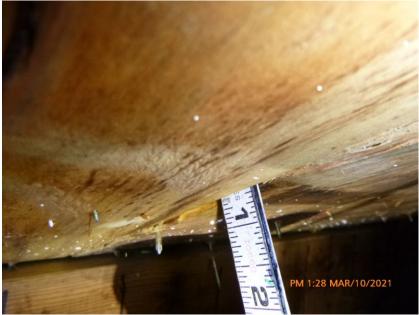
19/32" Deck Thickness Confirmed
