Uniform Mitigation Verification Inspection Form

Inspection Date: 3/11/2021		
Owner Information		
Owner Name: Andover at Wycliffe		Contact Person:
Address: 10124 Andover Coach Circle		Home Phone: (561) 215-9160
City: Lake Worth	Zip: 33449	Work Phone:
County: Palm Beach		Cell Phone:
Insurance Company:		Policy #:
Year of Home: 1991	# of Stories: 2	Email: ldistefano@grsmgt.com

Roof Mitigation Upgrade Report

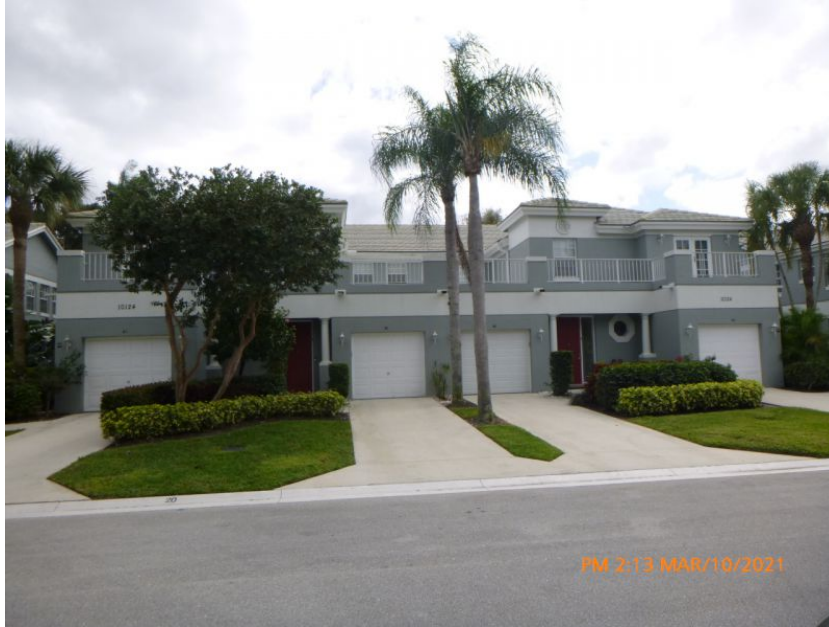
Front Elevation

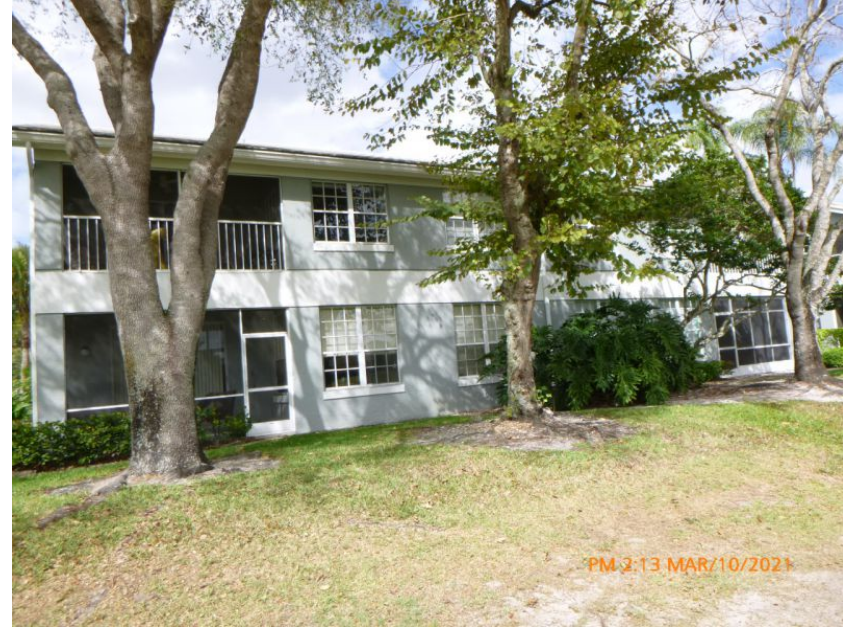
Back Elevation

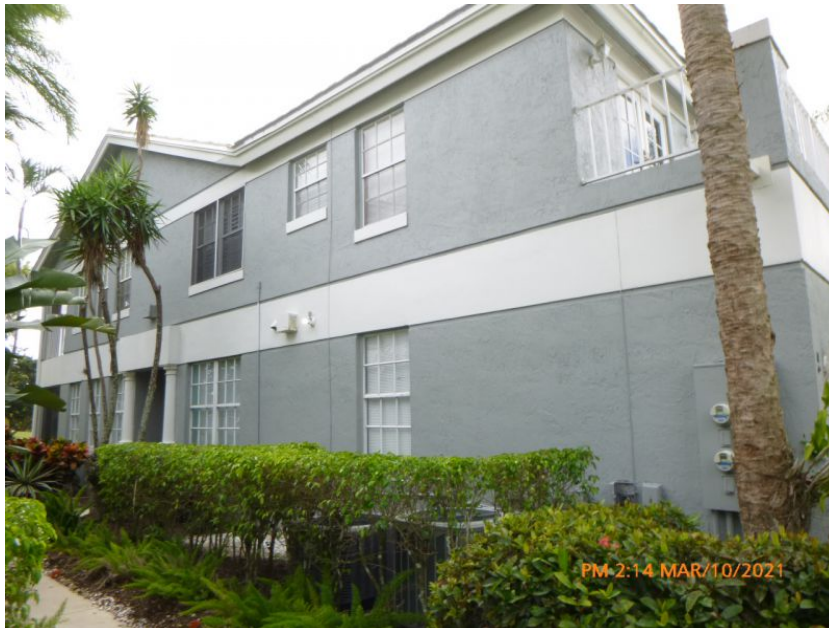
Left Elevation

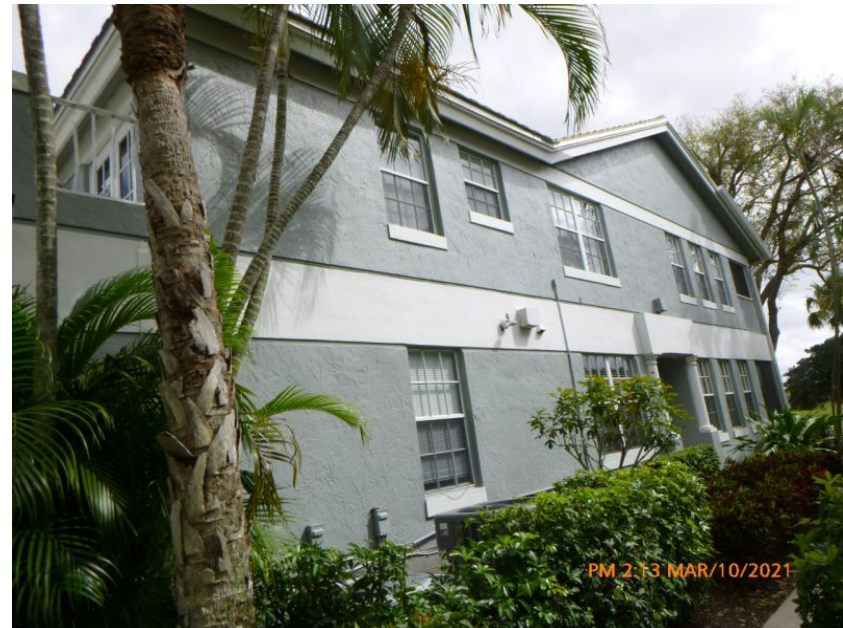
Right Elevation

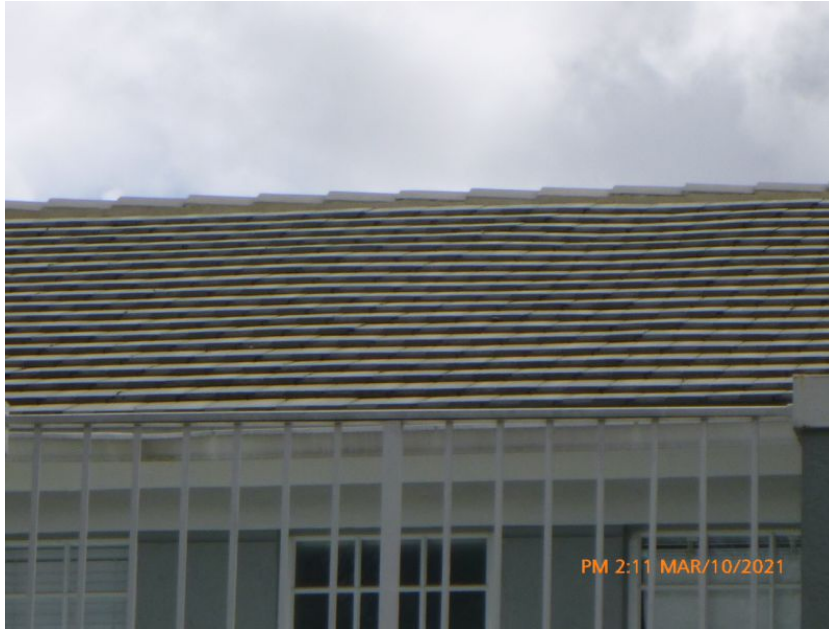
Concrete/Clay Tile Roof Covering

Secondary Water Resistant ("SWR") Barrier. Our report indicates that your roof does not currently have 1) strips or sheets of a self-adhering modified bitumen barrier attached directly to the top of the roof deck sheathing, or 2) a high-strength, closed-cell foam adhesive barrier on all the seams throughout your attic. The presence of either of these types of valid SWR barriers provides increased protection against water intrusion. Before having your roof replaced, be sure to inquire of your roofing professional regarding the cost of these options.

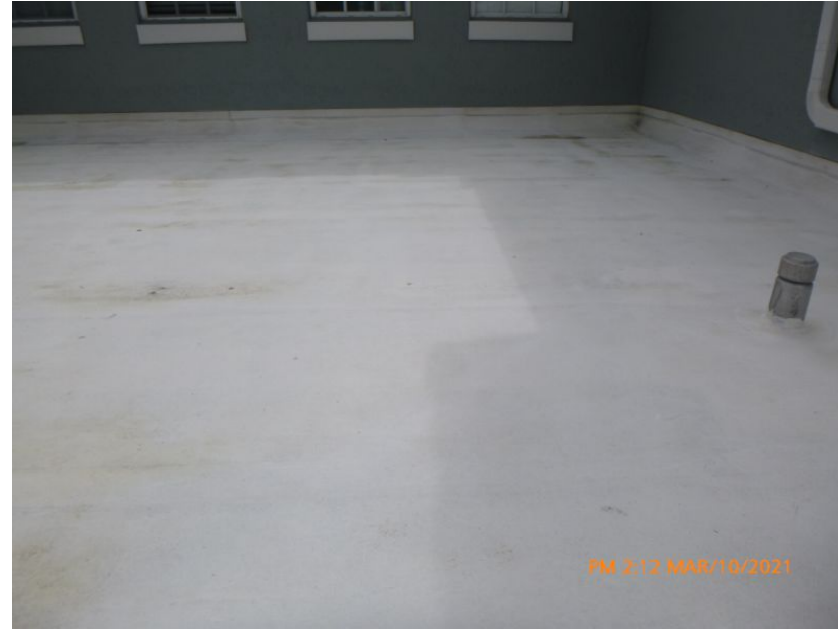
Built-Up/Rolled Asphalt Roof Covering

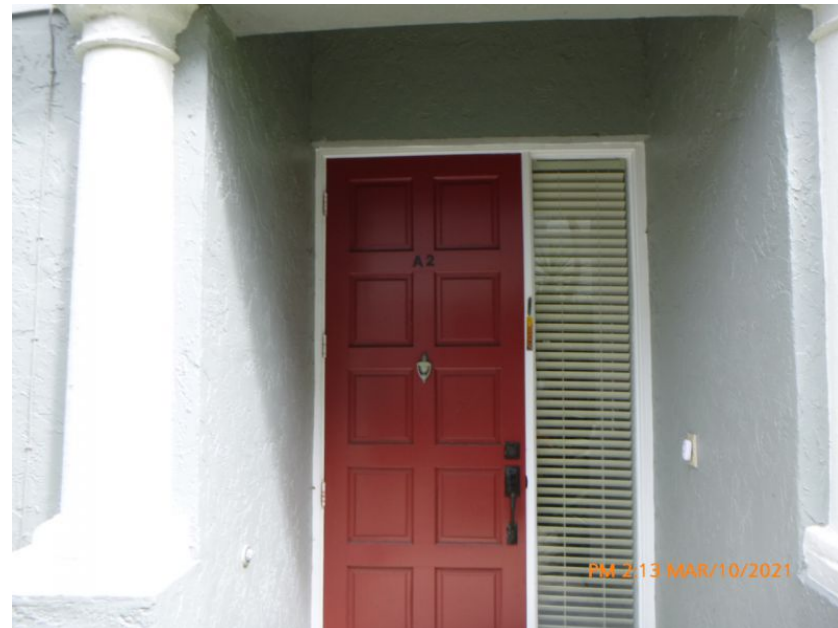
Unprotected Solid Entry Door

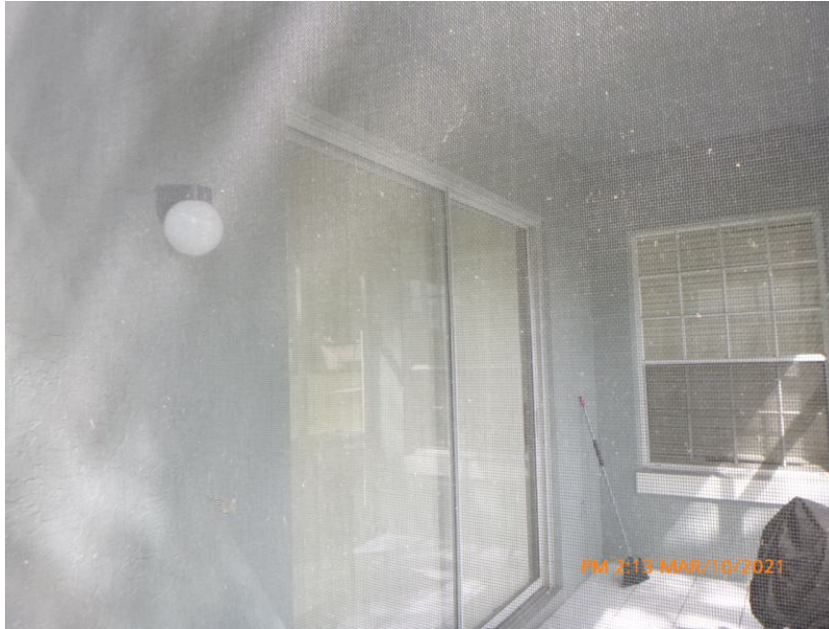
Unprotected Glazed Entry Door

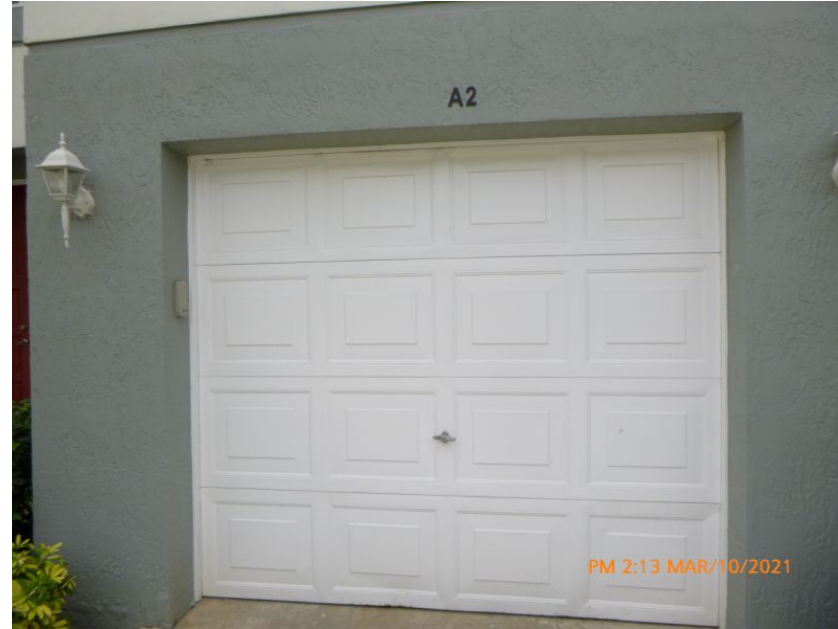
Unprotected Solid Garage Door

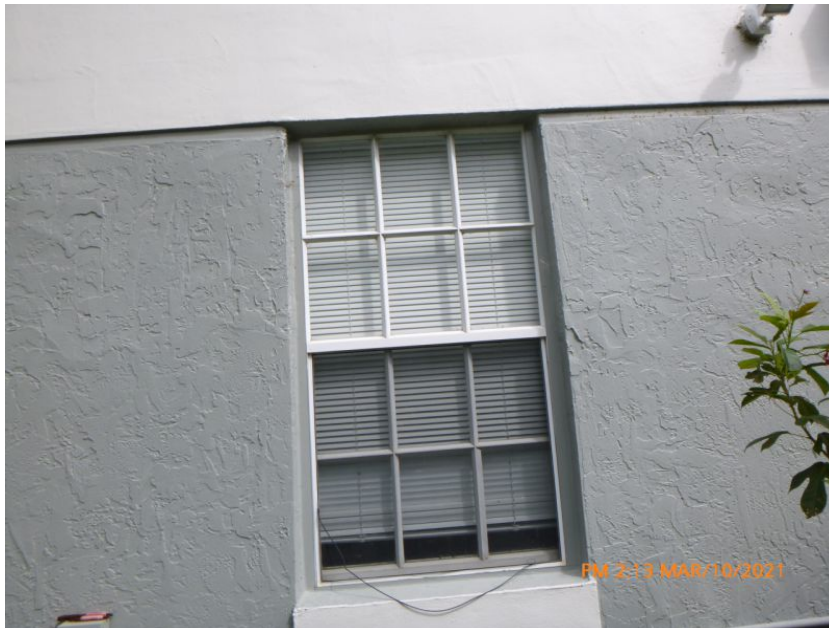
Unprotected Window

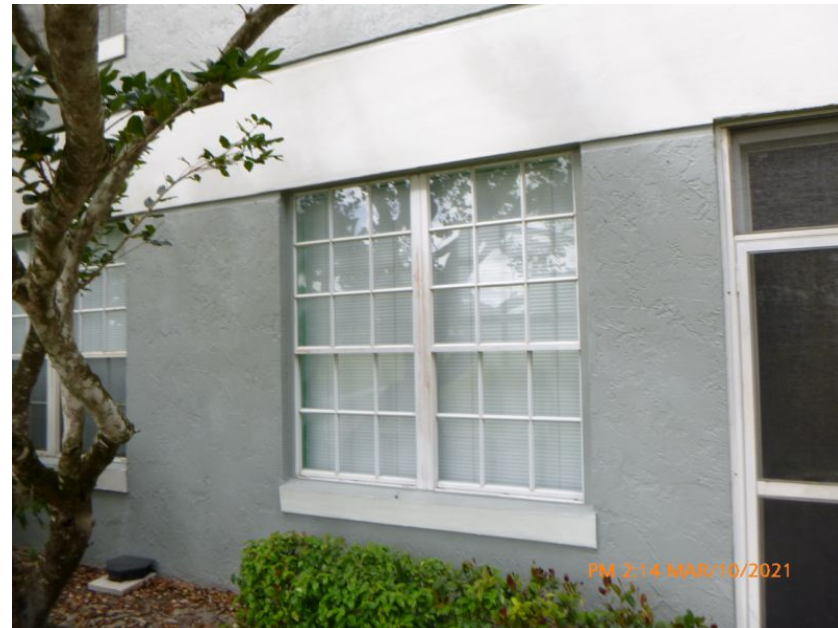
Unprotected Window

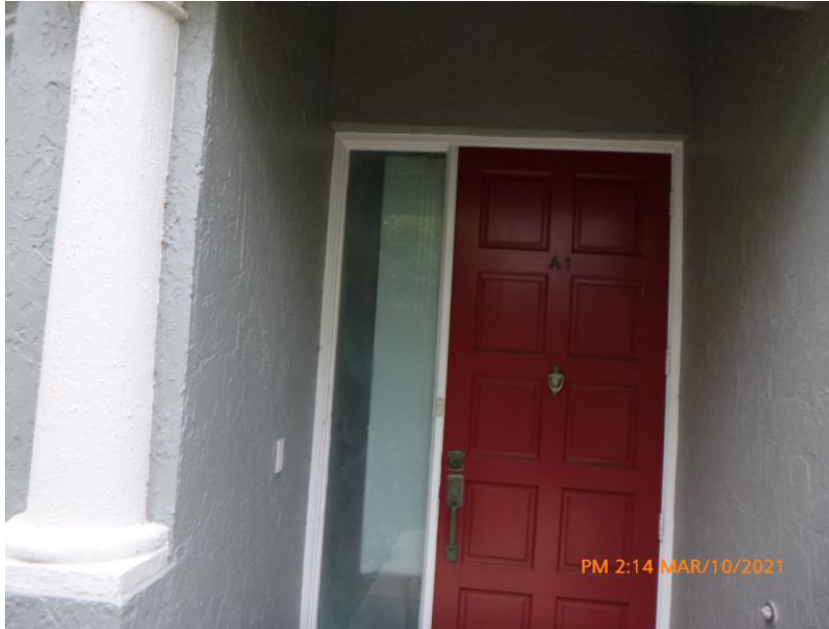
Unprotected Solid Entry Door

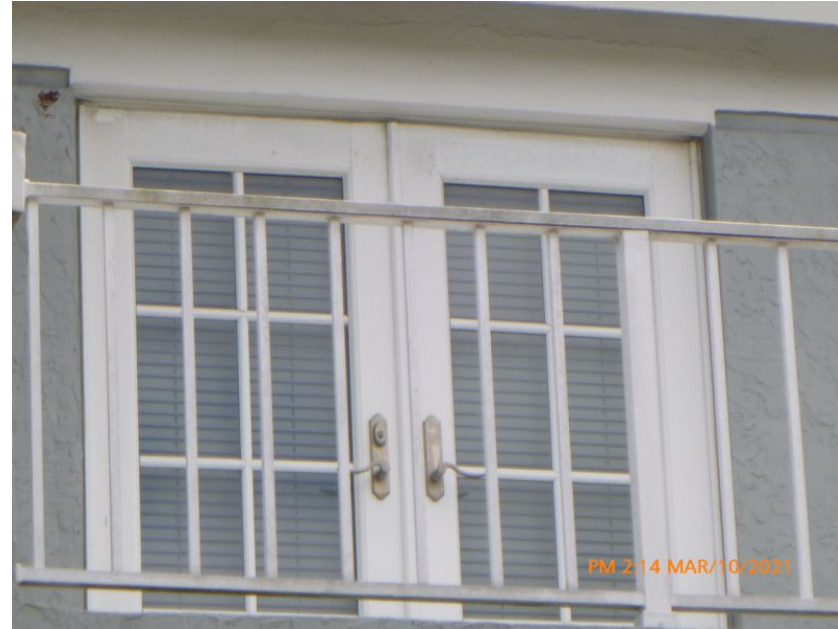
Unprotected Glazed Entry Door

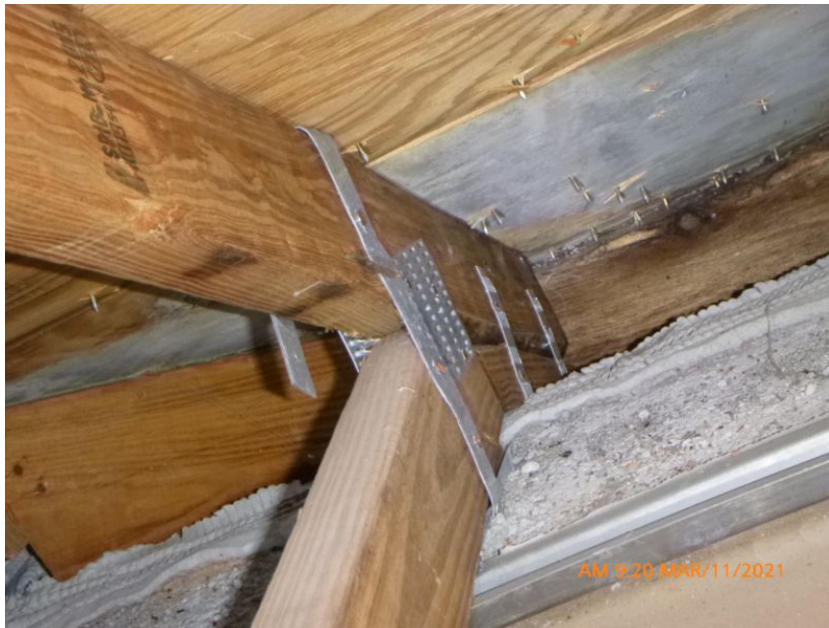
Single Wrap

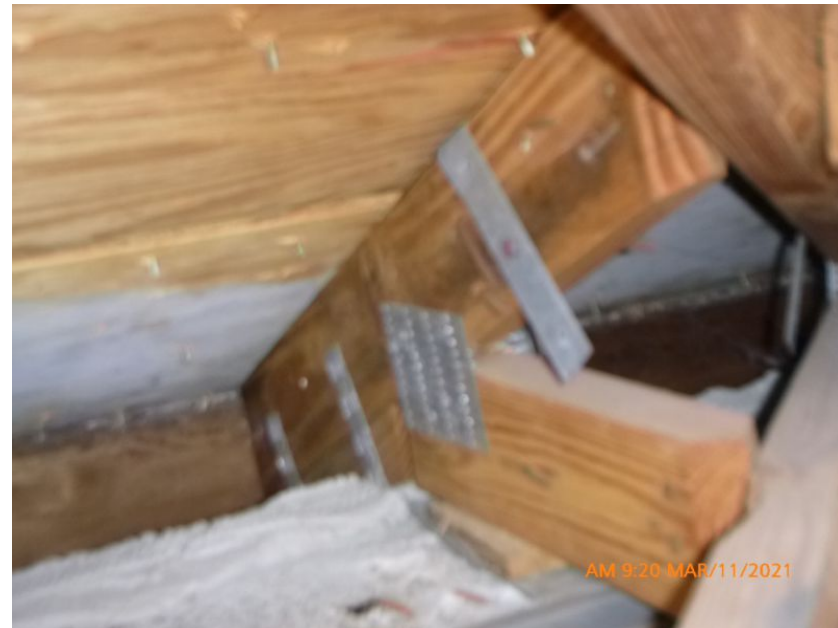
Single Wrap

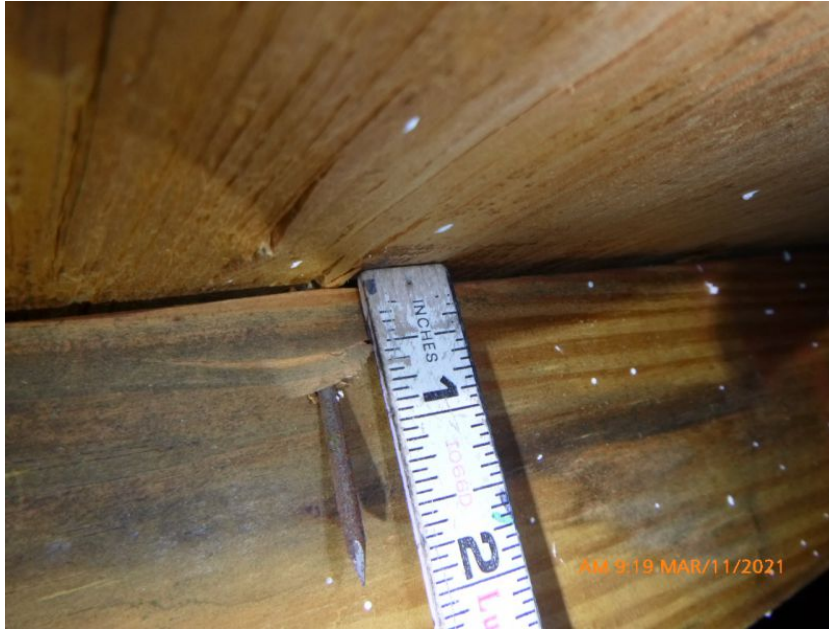
8d Nails or Greater in Size

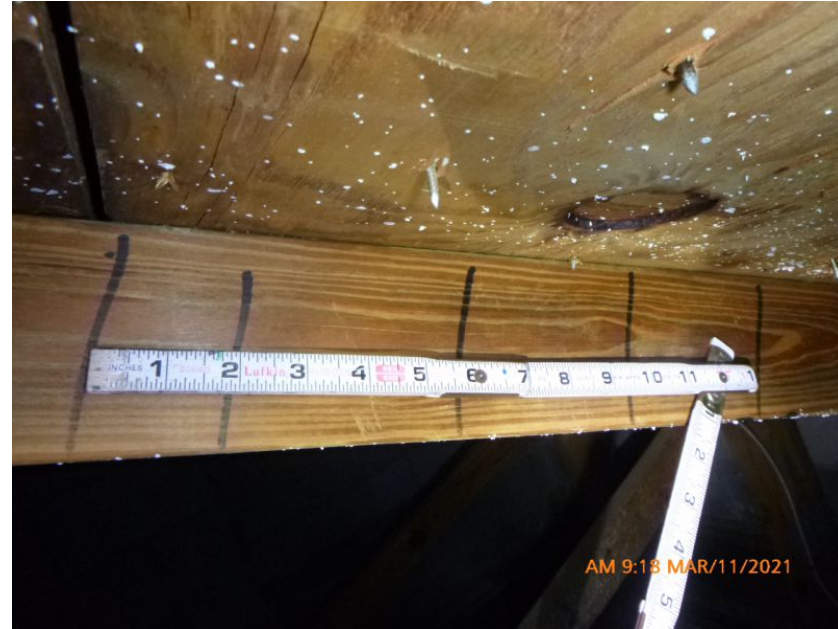
8d Nails or Greater in Size Spaced 6" Along the Edge

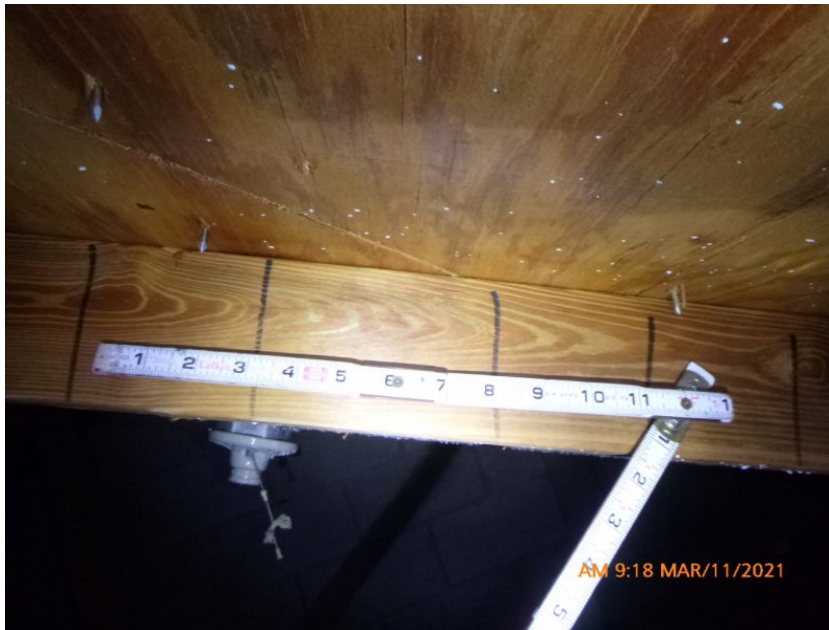
8d Nails or Greater in Size Spaced 6" in the Field

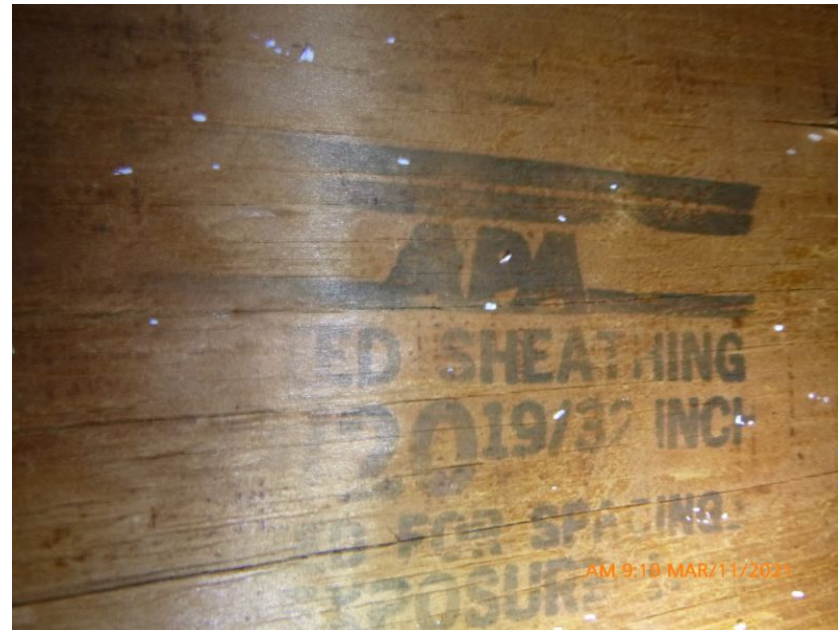
19/32" Deck Thickness Confirmed
