Uniform Mitigation Verification Inspection Form

Inspection Date: 3/11/2021					
Owner Information					
Owner Name: Andover at Wycliffe	e	Contact Person:			
Address: 10172 Andover Coach C	lircle	Home Phone: (561) 215-9160			
City: Lake Worth	Zip: 33449	Work Phone:			
County: Palm Beach		Cell Phone:			
Insurance Company:	· ·	Policy #:			
Year of Home: 1995	# of Stories: 2	Email: ldistefano@grsmgt.com

Inspectors Initials BD Property Address 10172 Andover Coach Circle Lake Worth, FL 33449 DMI: 1363031

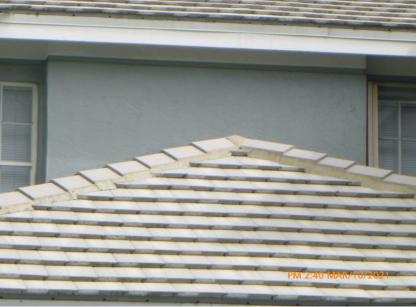
Concrete/Clay Tile Roof Covering

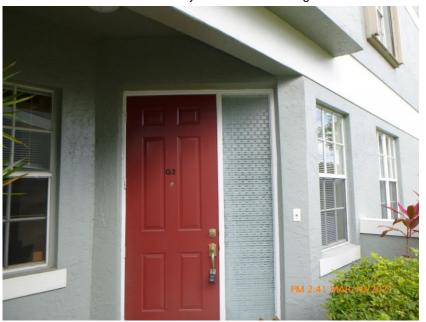
Unprotected Solid Entry Door

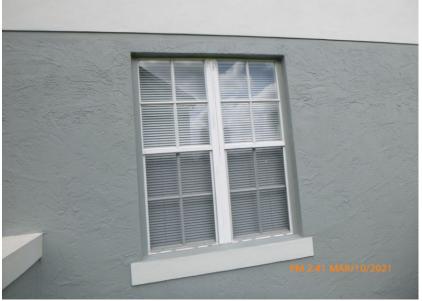
Unprotected Window

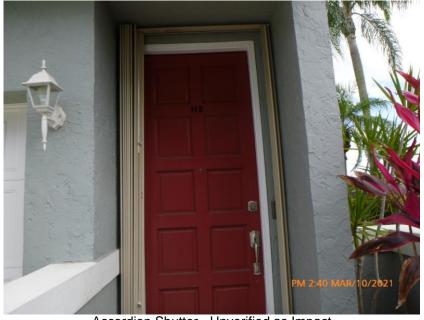
Accordion Shutter - Unverified as Impact

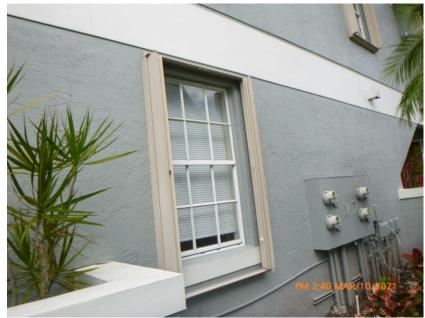
Accordion Shutter - Unverified as Impact

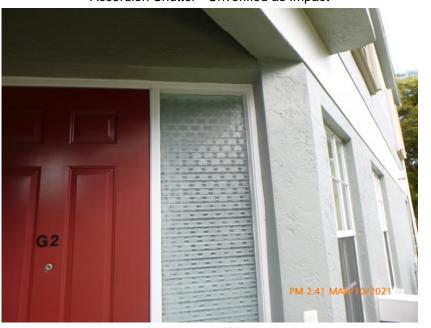
Unprotected Window

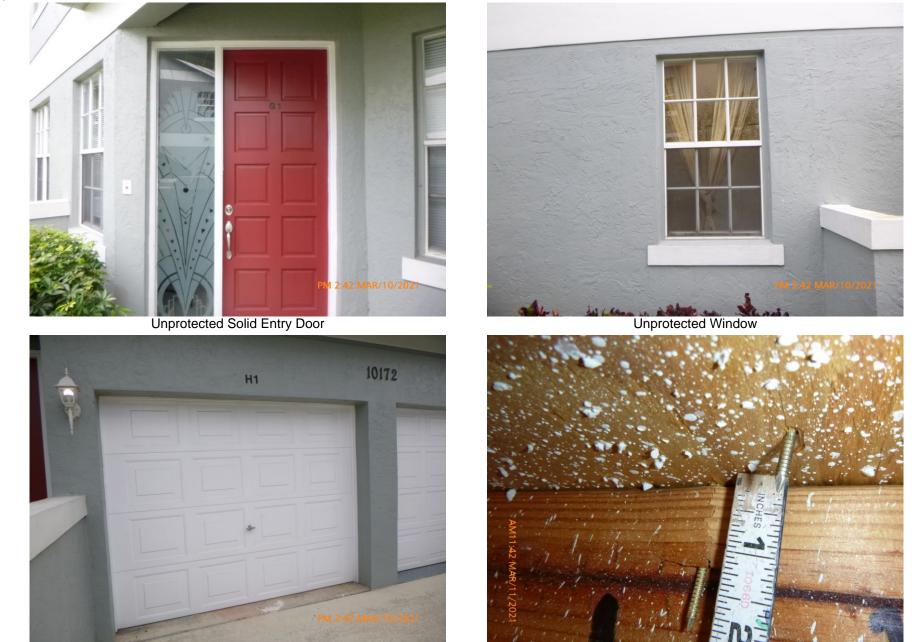
Unprotected Solid Garage Door

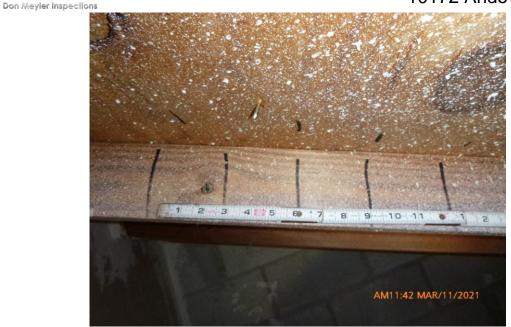
8d Nails or Greater in Size Spaced 6" Along the Edge

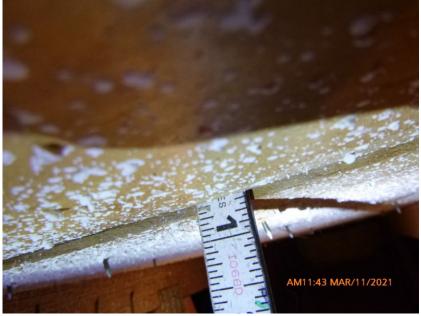
19/32" Deck Thickness Confirmed

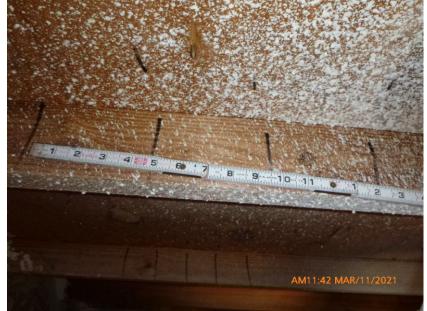
8d Nails or Greater in Size Spaced 6" in the Field

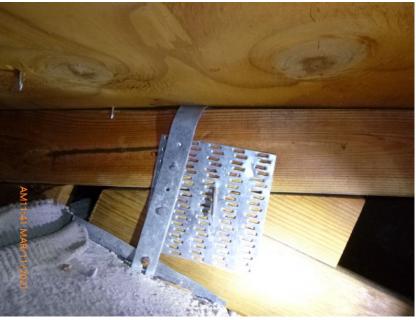
Single Wrap

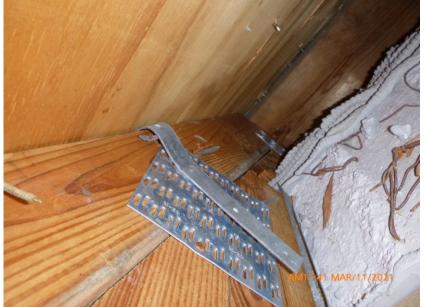
Single Wrap
