Uniform Mitigation Verification Inspection Form

Inspection Date: 3/11/2021		
Owner Information		
Owner Name: Andover at Wycliffe		Contact Person:
Address: 10173 Andover Coach Circle		Home Phone: (561) 215-9160
City: Lake Worth	Zip: 33449	Work Phone:
County: Palm Beach		Cell Phone:
Insurance Company:		Policy #:
Year of Home: 1995	# of Stories: 2	Email: ldistefano@grsmgt.com

10173 Andover Coach Circle

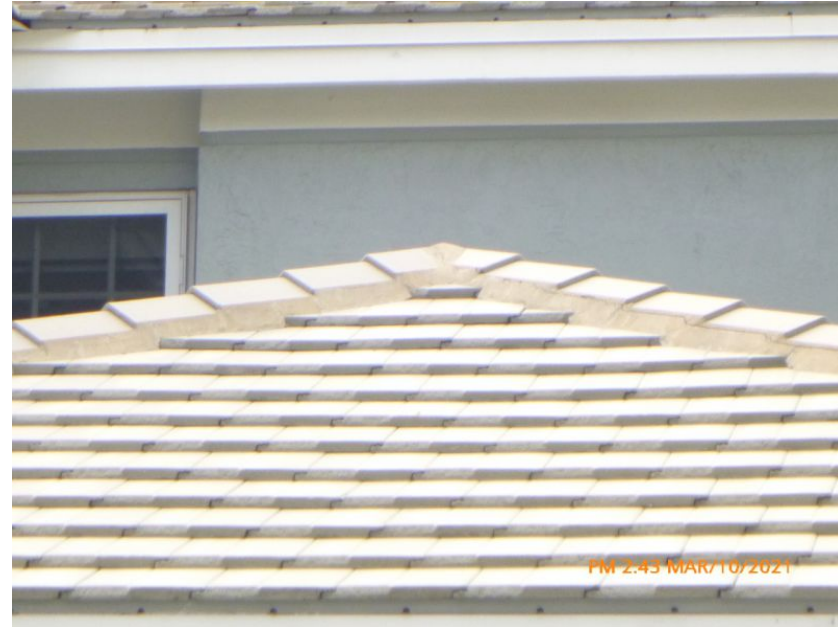
Concrete/Clay Tile Roof Covering

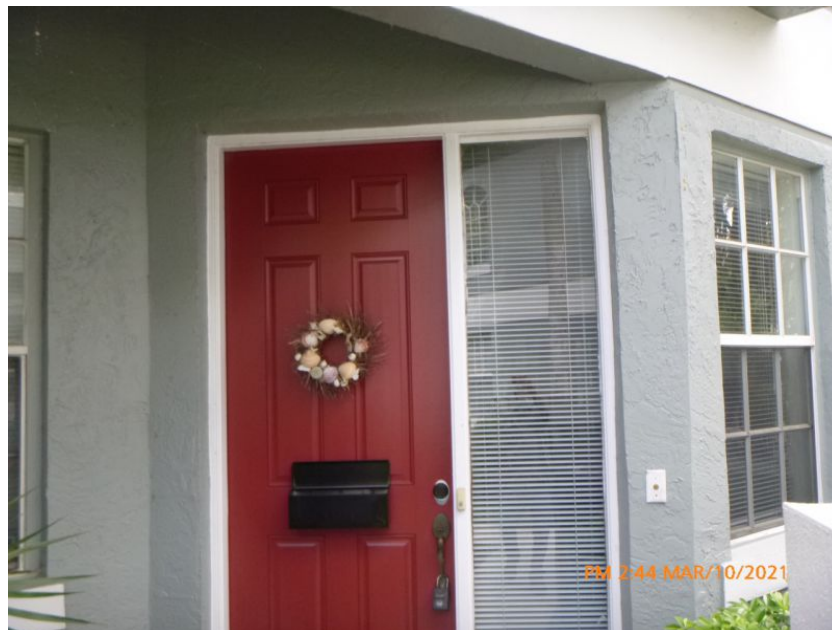
Unprotected Solid Entry Door

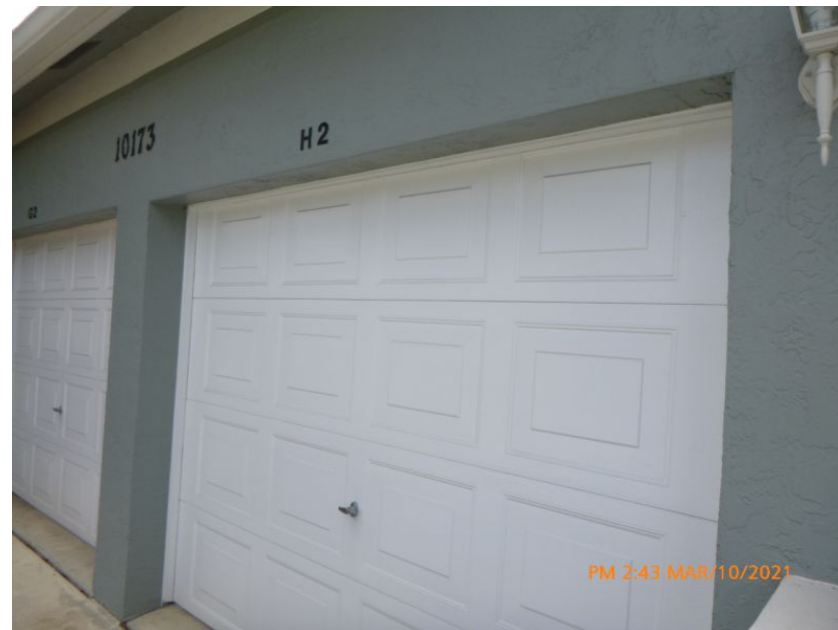
Unprotected Solid Garage Door

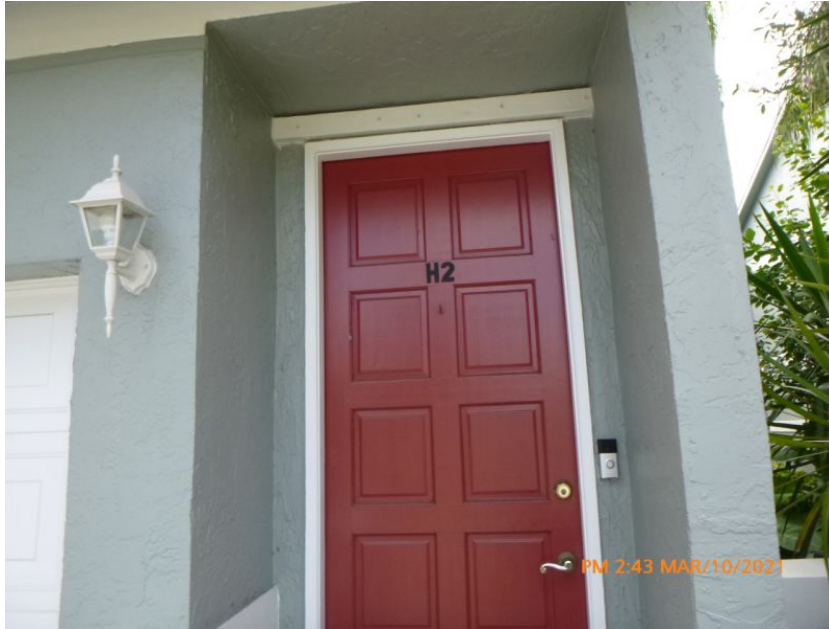
Panel Shutter - Unverified as Impact

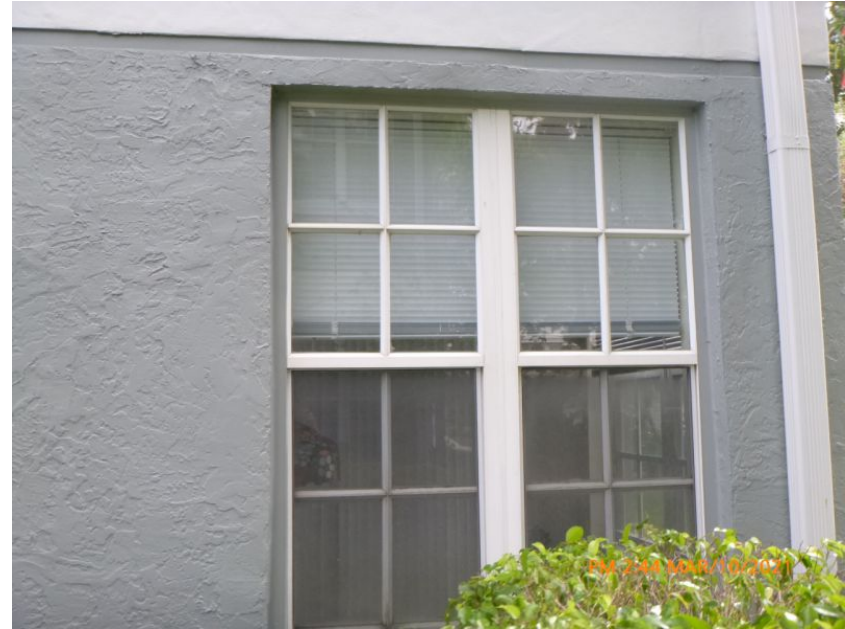
Unprotected Window

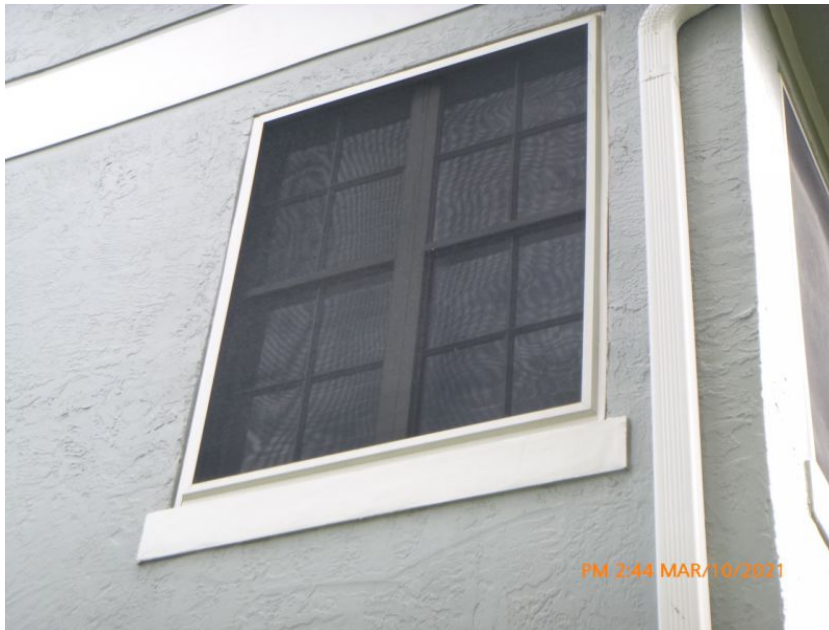
Screen Shutter - Unverified as Impact

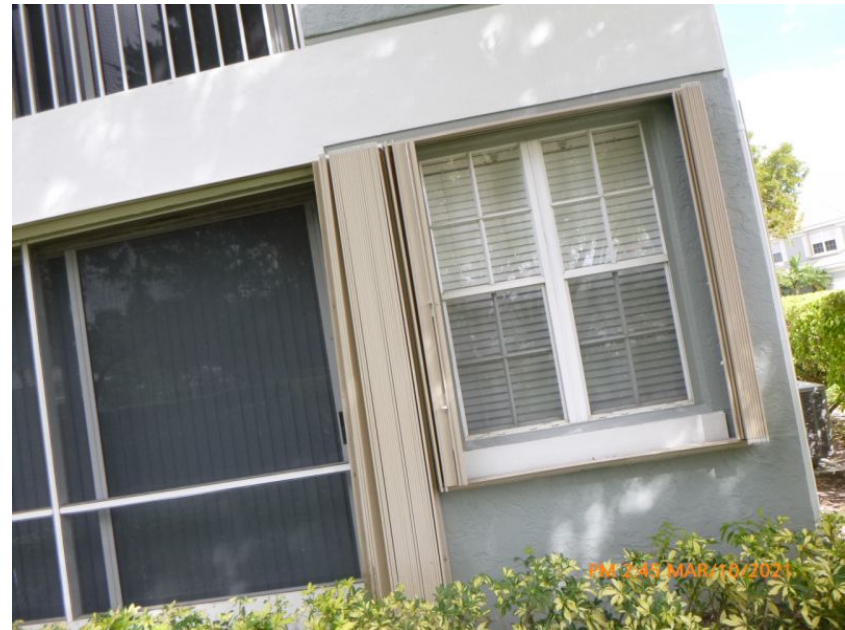
Accordion Shutter - Unverified as Impact

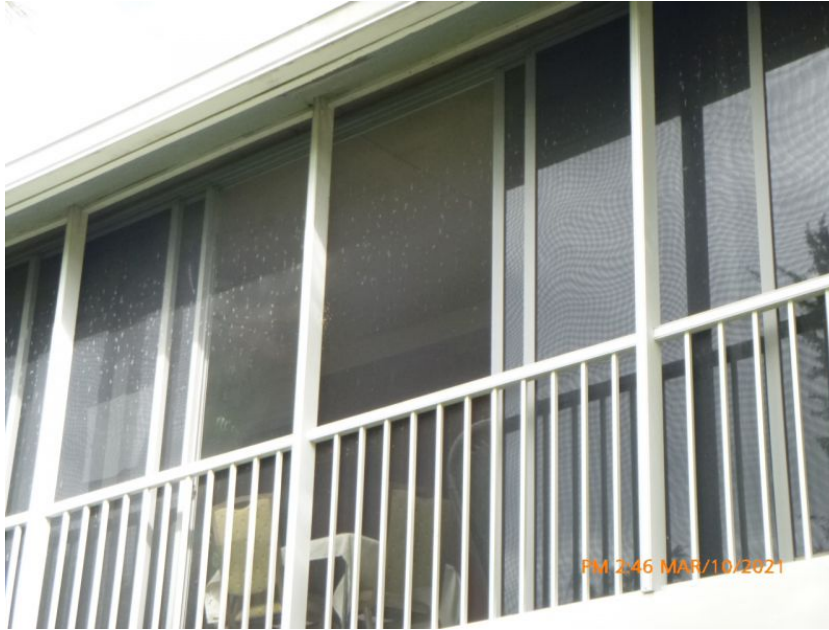
Unprotected Glazed Entry Door

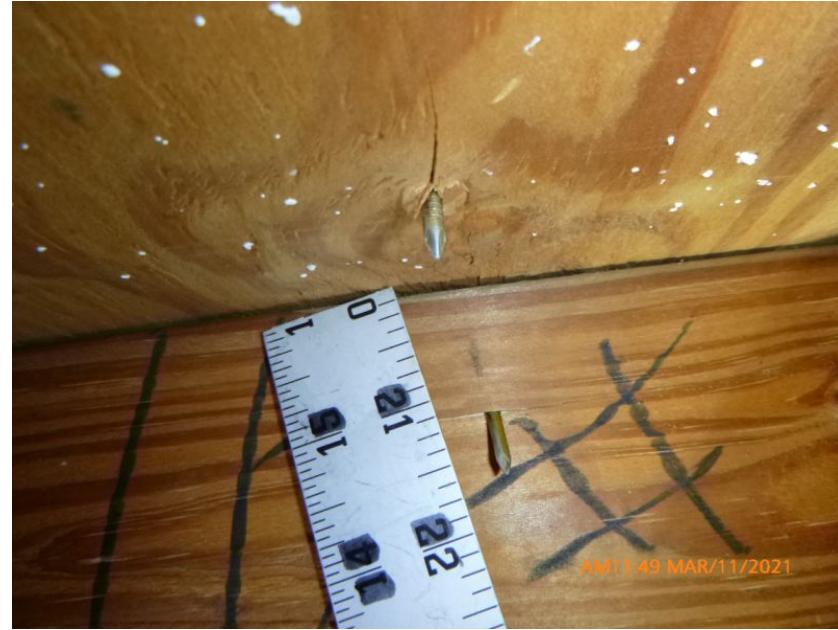
8d Nails or Greater in Size

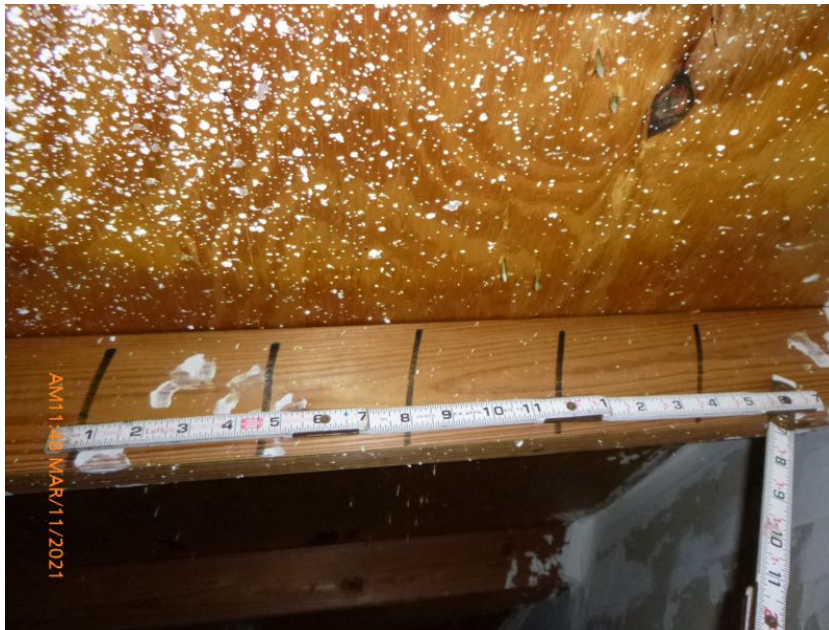
8d Nails or Greater in Size Spaced 6" Along the Edge

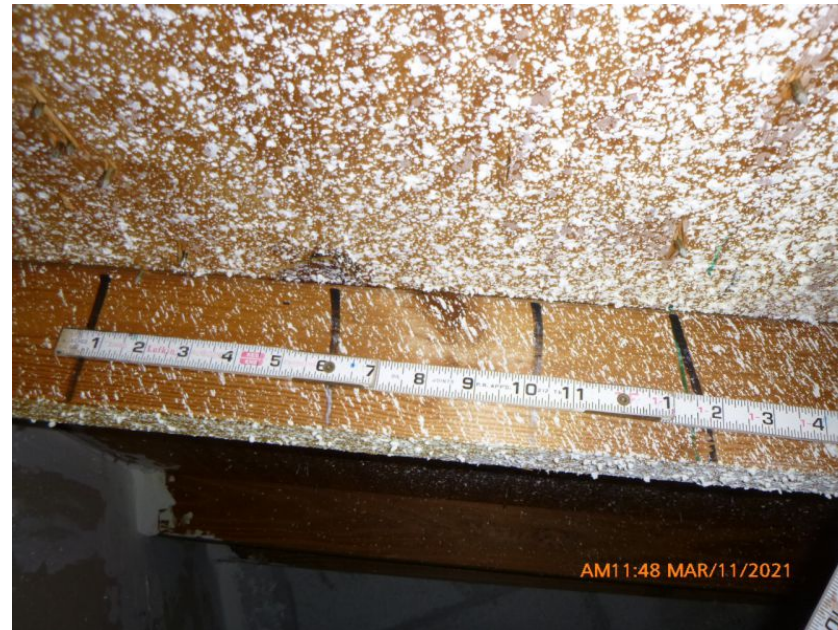
8d Nails or Greater in Size Spaced 6" in the Field

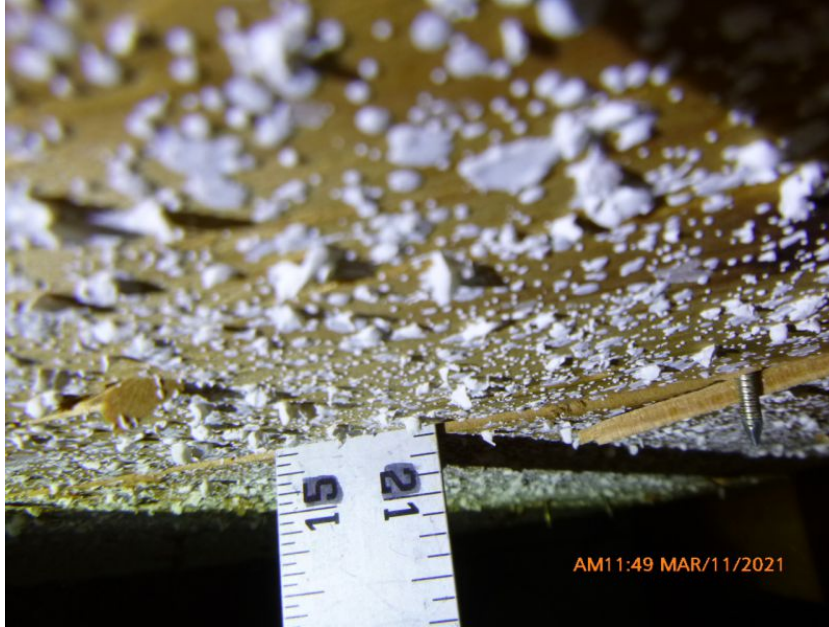
19/32" Deck Thickness Confirmed

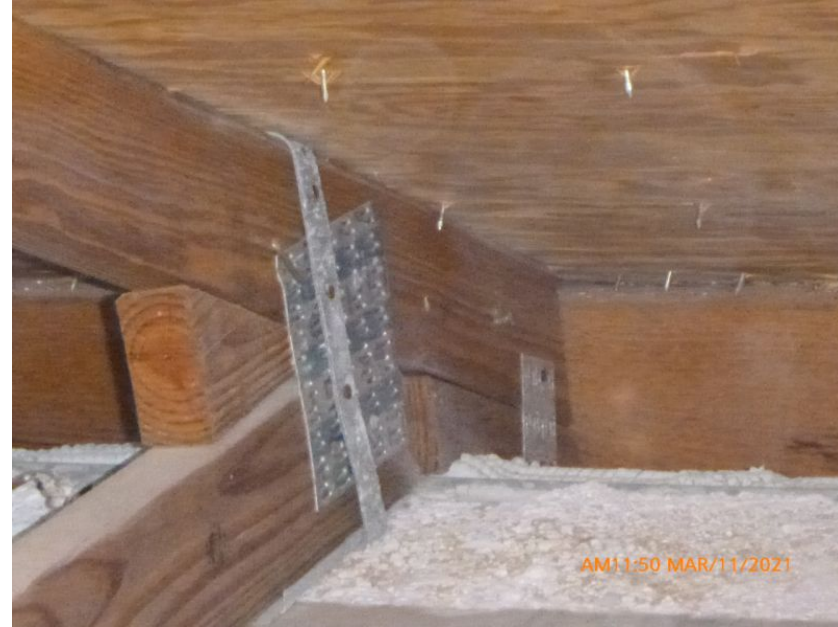
Single Wrap

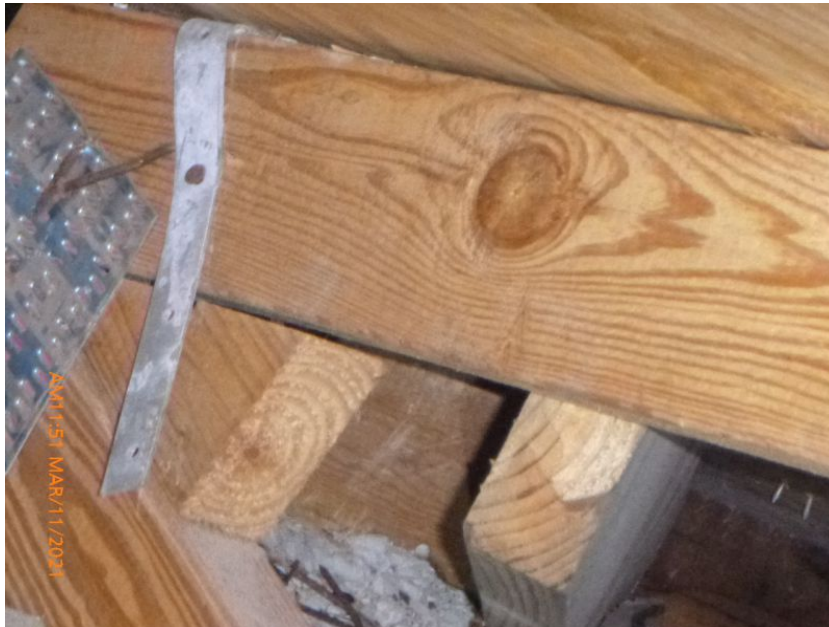
Single Wrap
