Uniform Mitigation Verification Inspection Form

Inspection Date: 3/11/2021		
Owner Information		
Owner Name: Andover at Wycliffe		Contact Person:
Address: 10184 Andover Coach Circle		Home Phone: (561) 215-9160
City: Lake Worth	Zip: 33449	Work Phone:
County: Palm Beach		Cell Phone:
Insurance Company:		Policy #:
Year of Home: 1995	# of Stories: 2	Email: ldistefano@grsmgt.com

10184 Andover Coach Circle

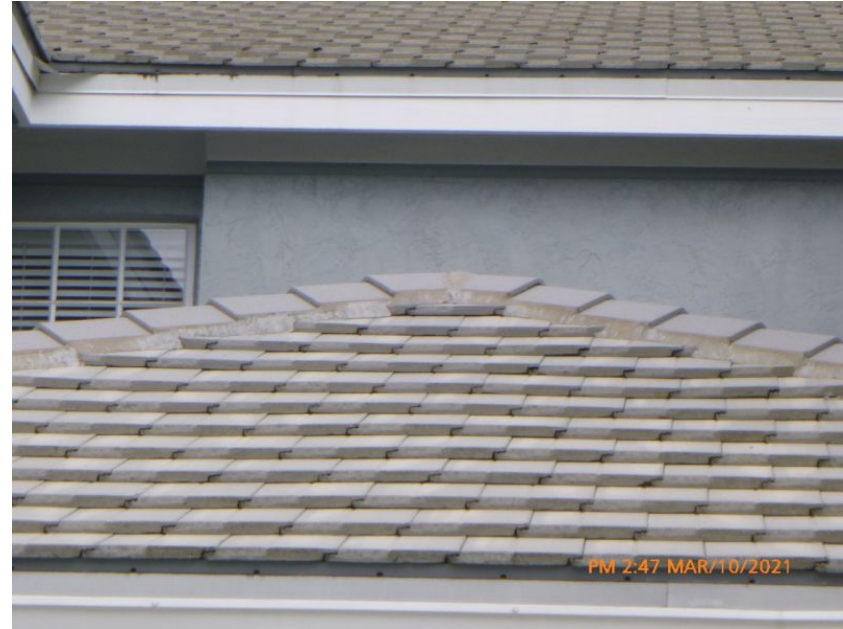
Concrete/Clay Tile Roof Covering

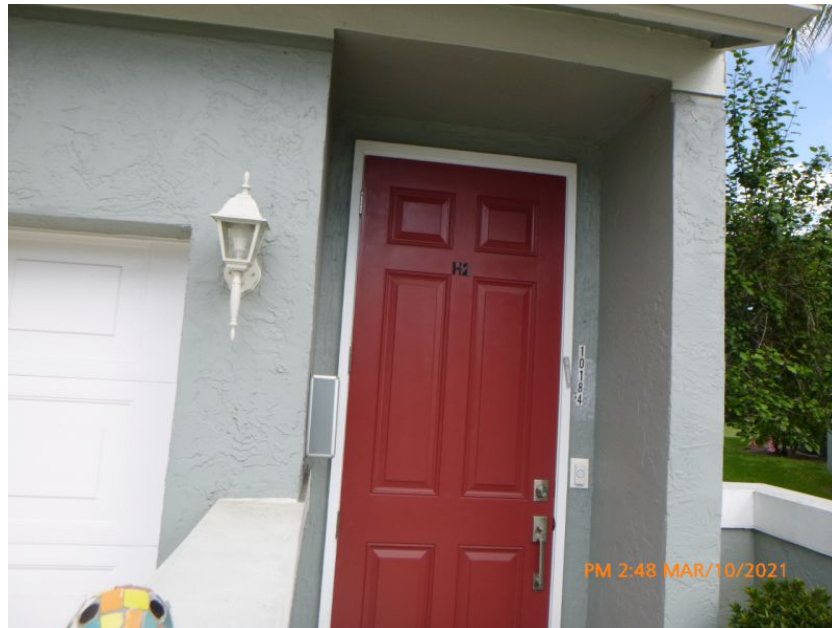
Unprotected Solid Entry Door

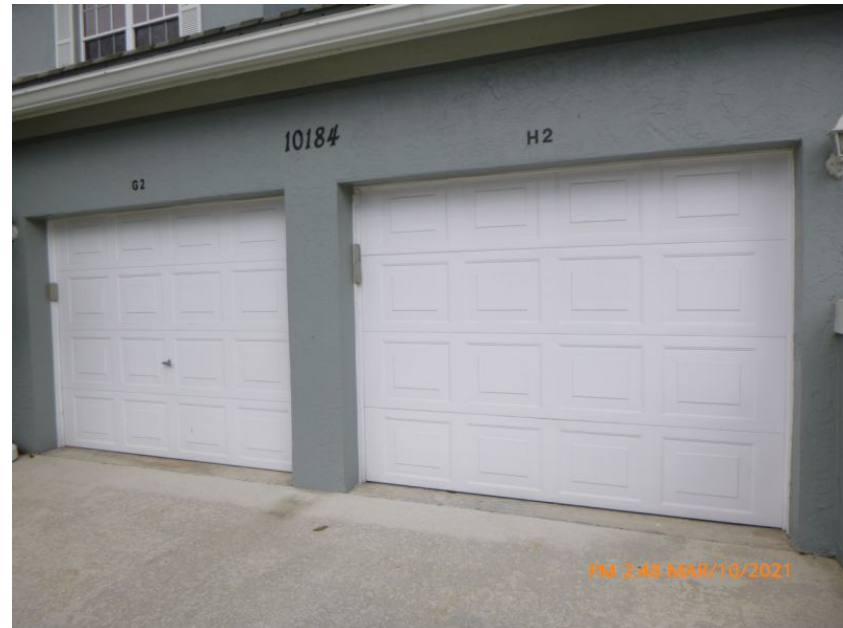
Unprotected Solid Garage Door

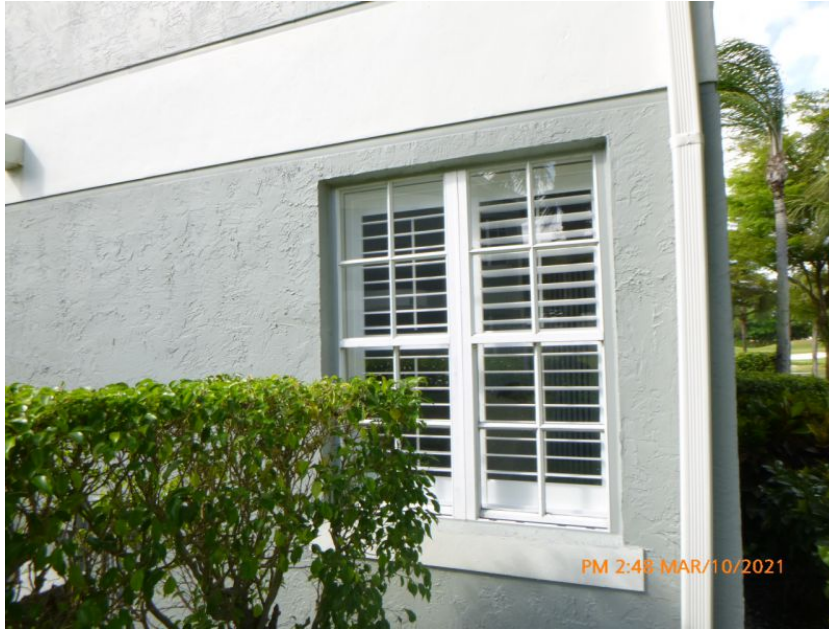
Unprotected Window

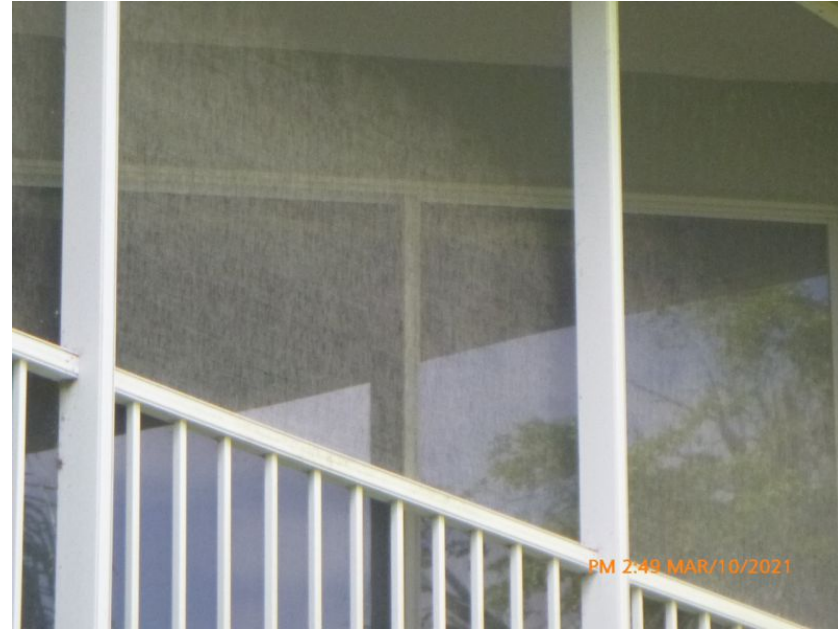
Unprotected Glazed Entry Door

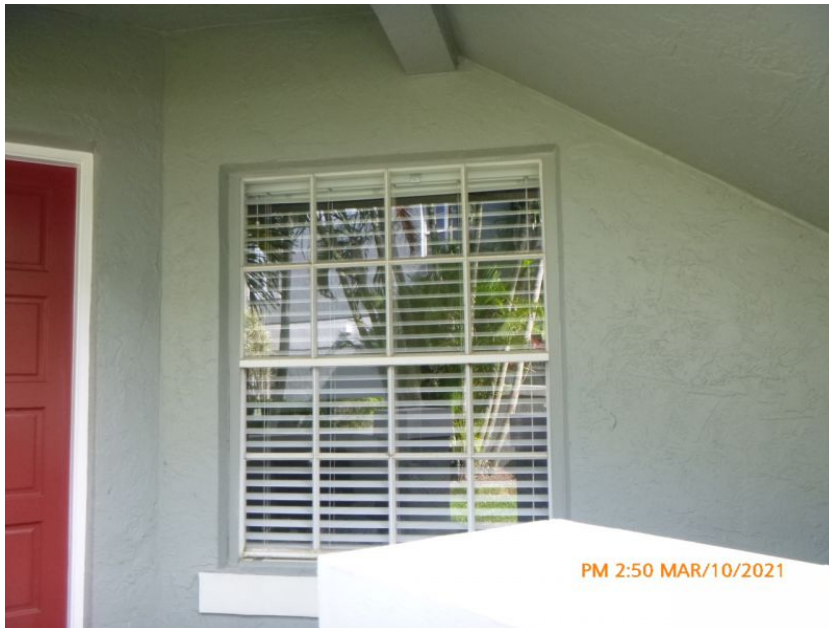
Unprotected Window

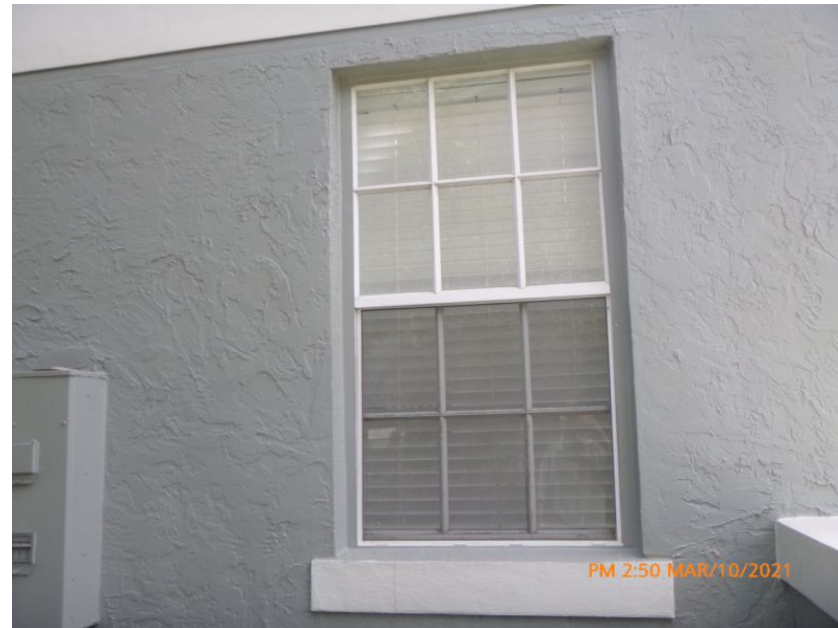
Unprotected Window

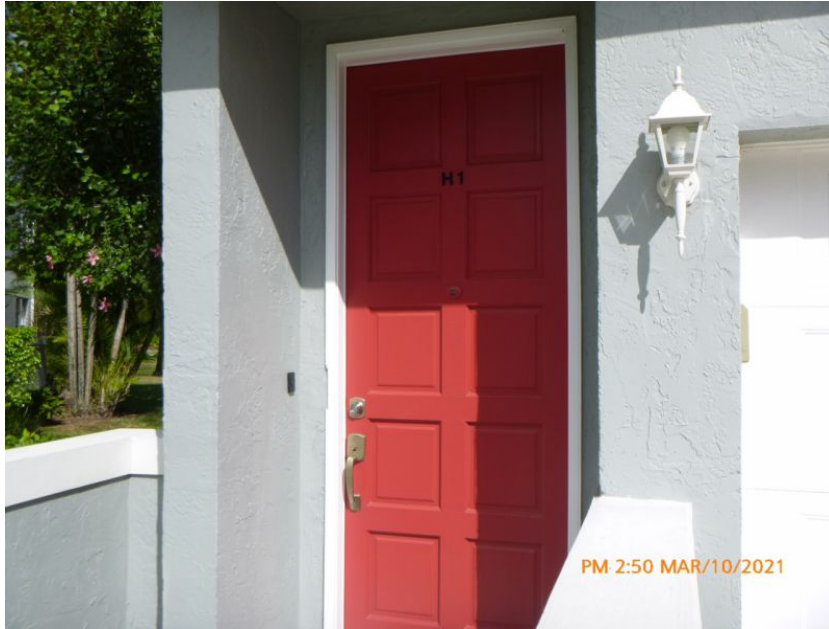
Unprotected Solid Entry Door

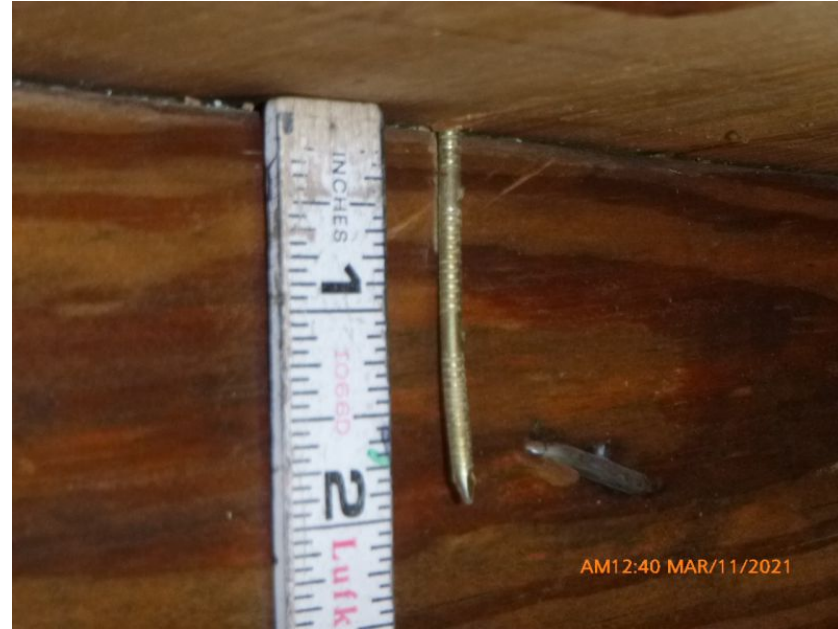
8d Nails or Greater in Size

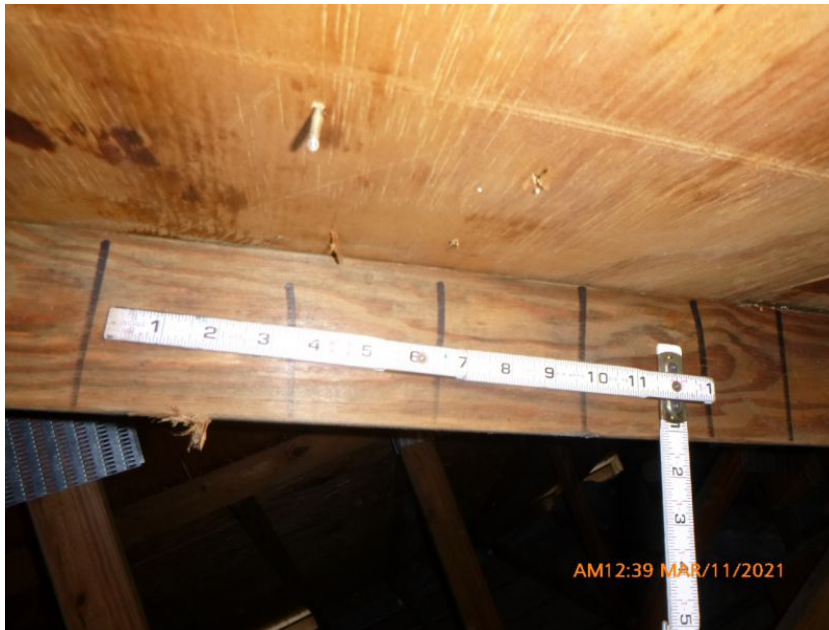
8d Nails or Greater in Size Spaced 6" Along the Edge

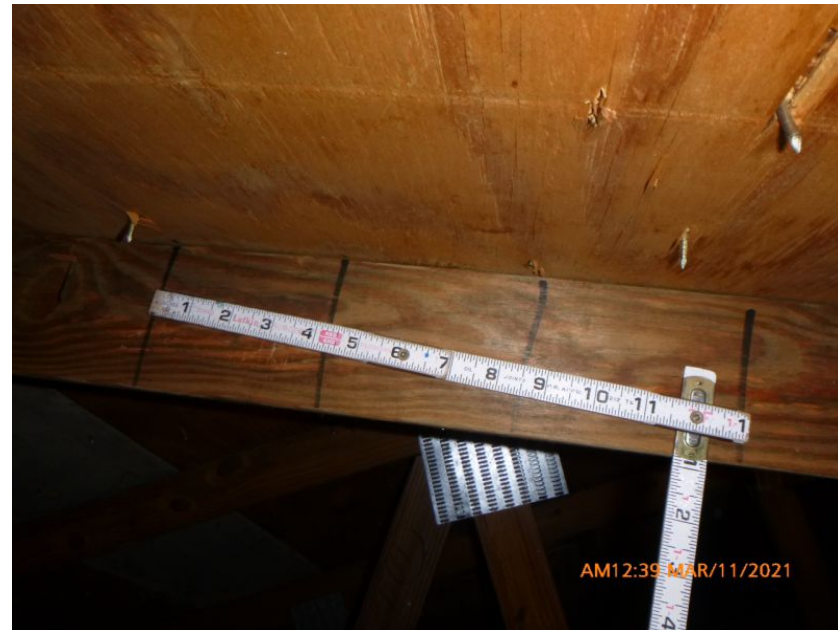
8d Nails or Greater in Size Spaced 6" in the Field

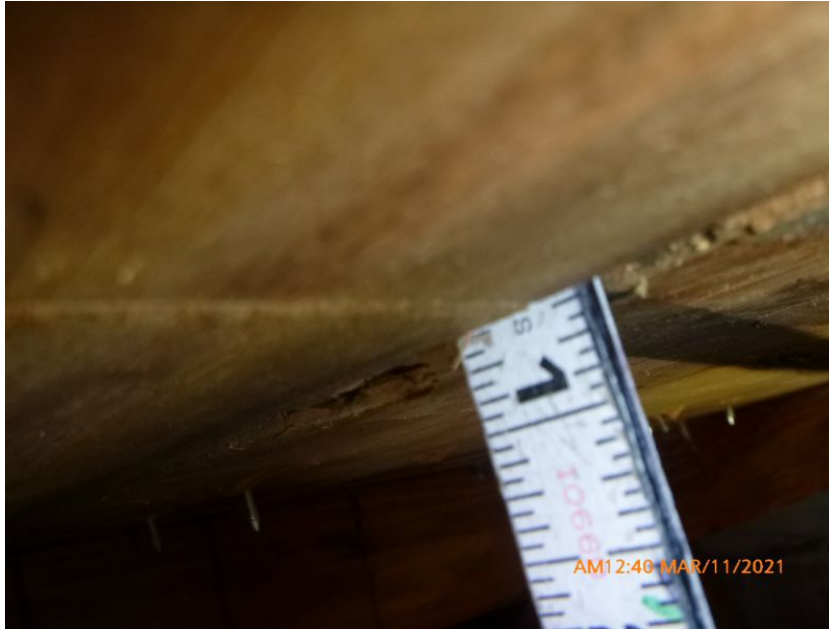
19/32" Deck Thickness Confirmed

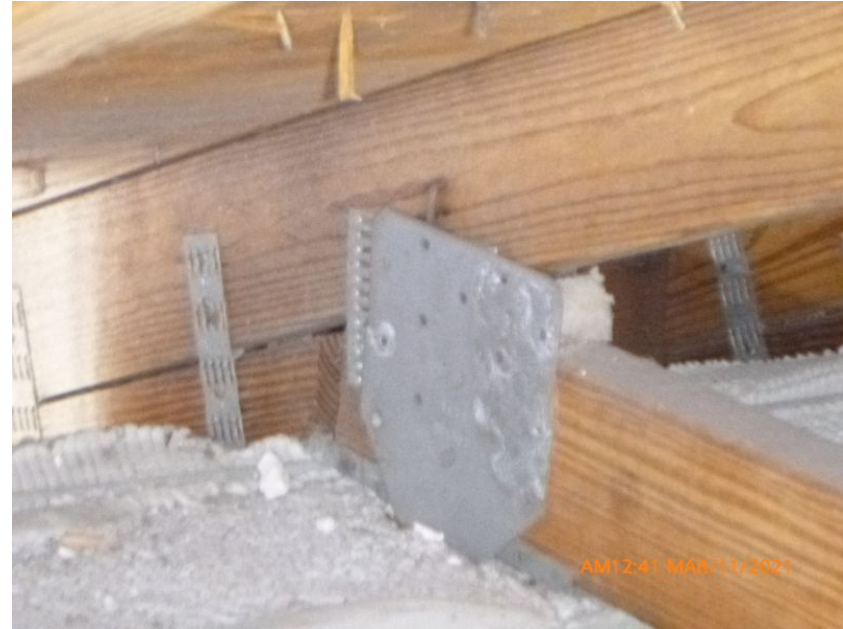
Metal Connector with 3 Nails on the Front Side & 0 Nails on the Opposing Side

Roof-to-Wall Attachment Our report indicates that the existing roof-to-wall attachment(s) do not meet the requirements on the Uniform Mitigation Verification Inspection form for Single Wrap Straps. This definition requires at least two nails on the front side and at least one on the other of every strap in the attic, on every truss or rafter. As it is often difficult to access every truss or rafter, the ideal time to upgrade this feature is when the roof deck is being replaced. In some circumstances, this work can be done on its own; consult a professional for details. Retrofits to existing roof to wall connections should be permitted with the local building department, and installations should follow the manufacturer's guidelines.

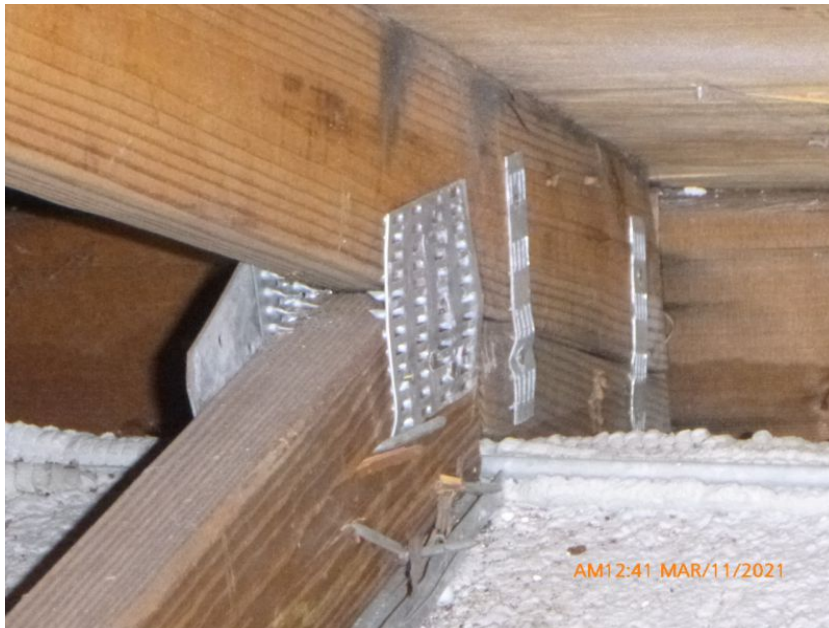
Metal Connector with 3 Nails on the Front Side & 0 Nails on the Opposing Side
