Uniform Mitigation Verification Inspection Form

Inspection Date: 3/11/2021		
Owner Information		
Owner Name: Andover at Wycliffe		Contact Person:
Address: 10185 Andover Coach Circle		Home Phone: (561) 215-9160
City: Lake Worth	Zip: 33449	Work Phone:
County: Palm Beach		Cell Phone:
Insurance Company:		Policy #:
Year of Home: 1995	# of Stories: 2	Email: ldistefano@grsmgt.com

Inspectors Initials BD Property Address 10185 Andover Coach Circle Lake Worth, FL 33449 DMI: 1363034

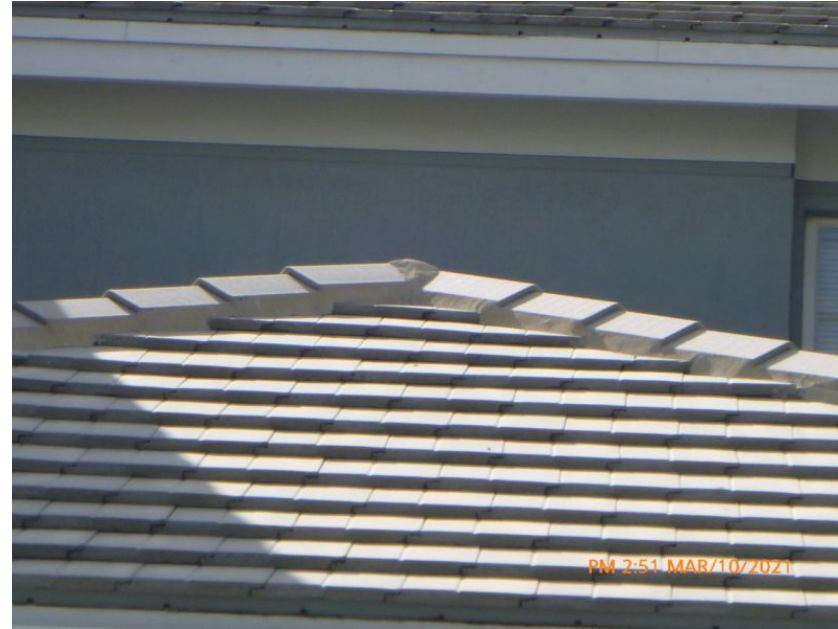
Concrete/Clay Tile Roof Covering

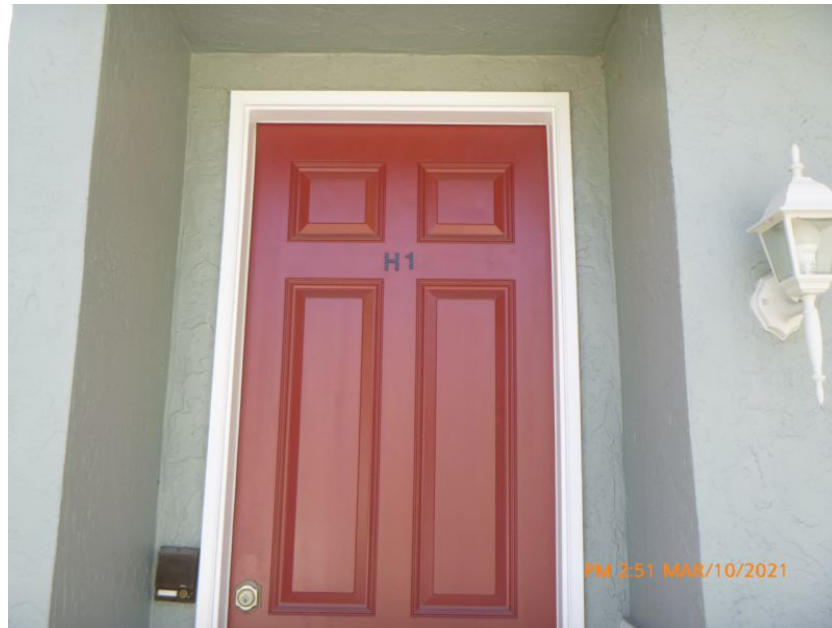
Unprotected Solid Entry Door

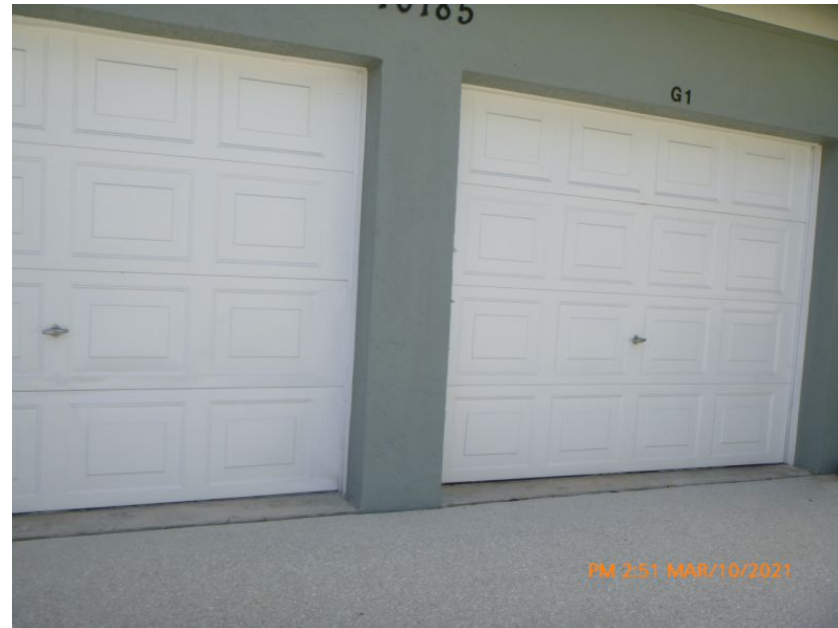
Unprotected Solid Garage Door

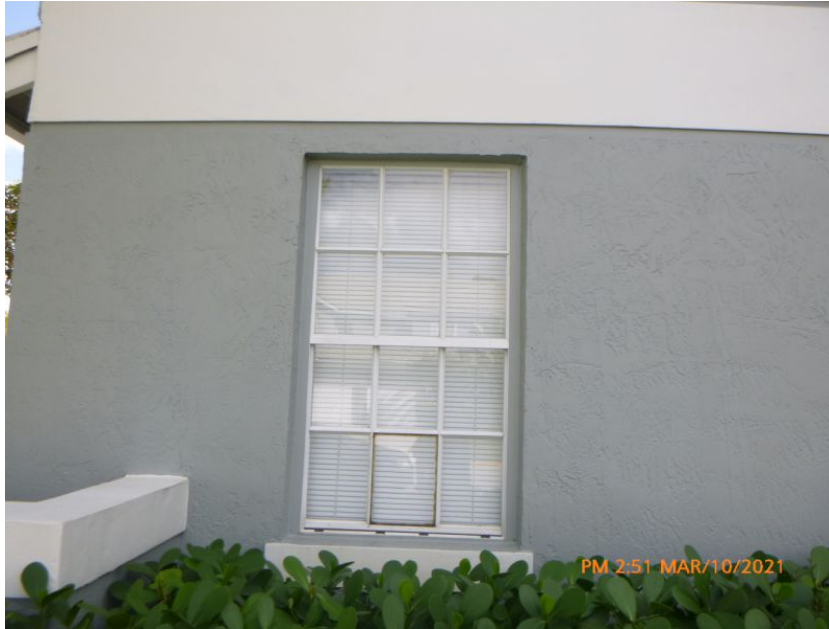
Unprotected Window

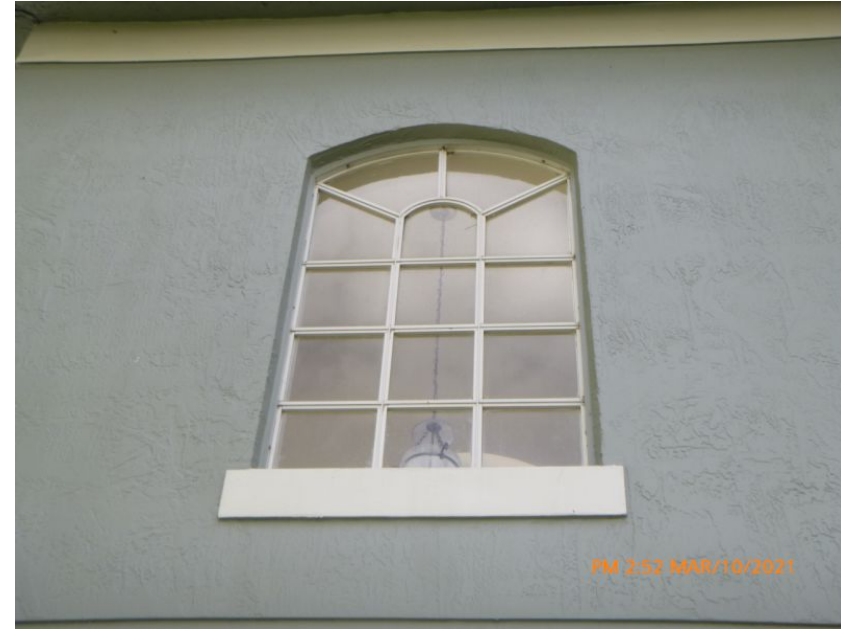
Unprotected Window

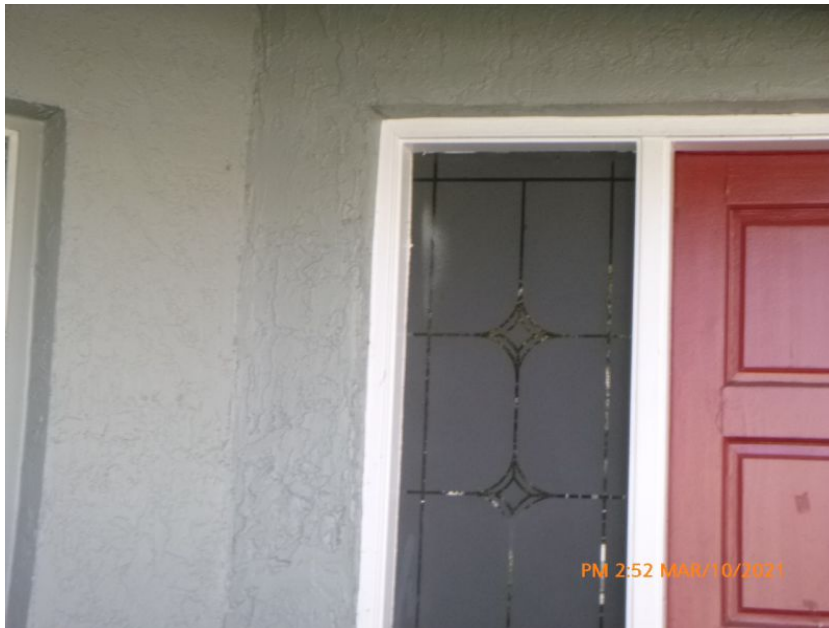
Unprotected Window

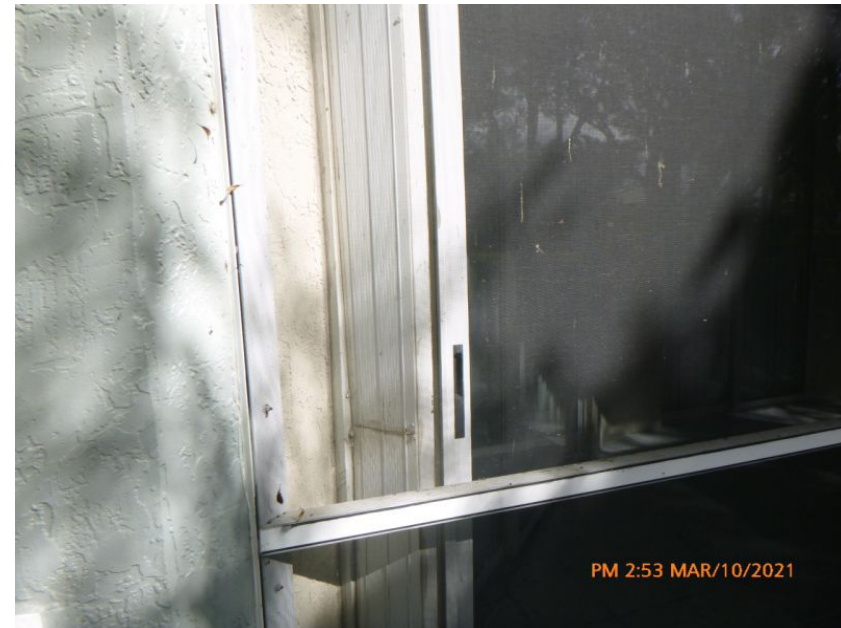
Accordion Shutter - Unverified as Impact

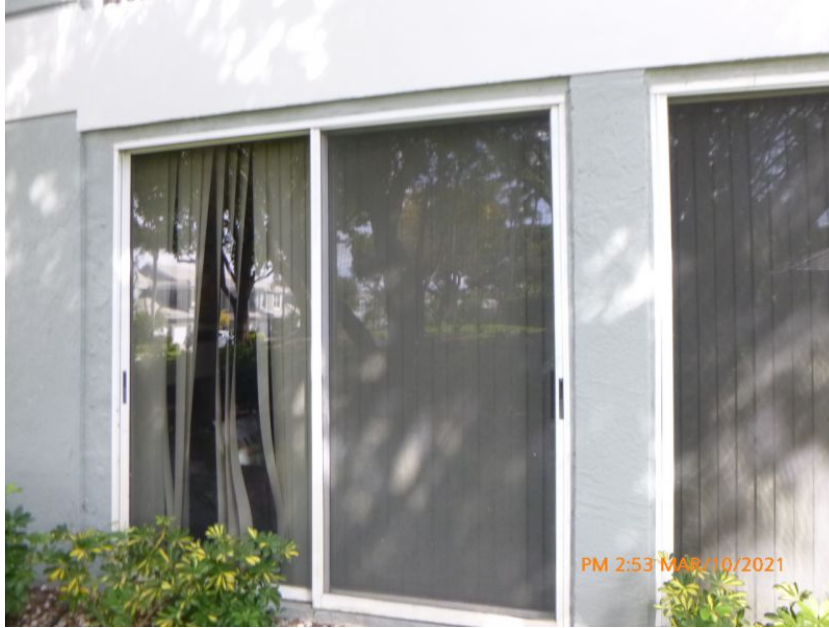
Unprotected Glazed Entry Door

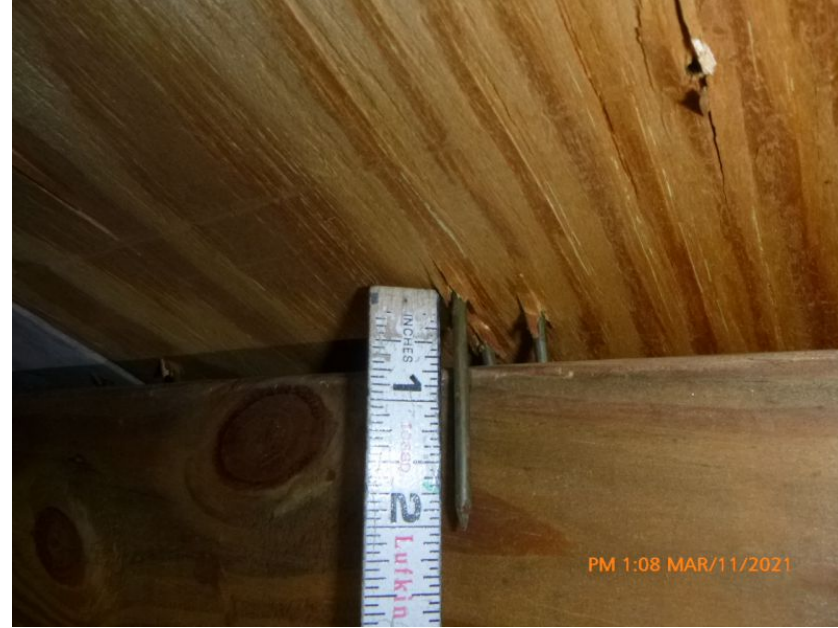
8d Nails or Greater in Size

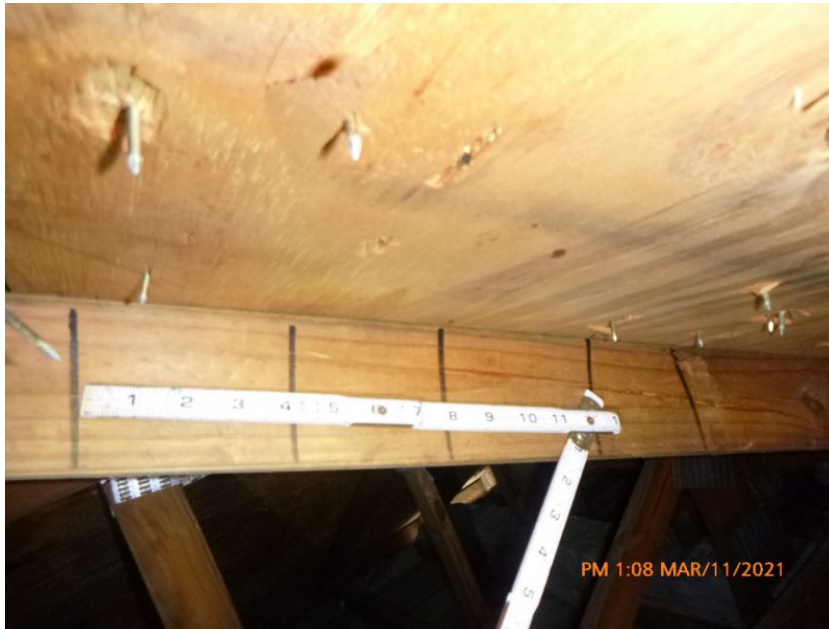
8d Nails or Greater in Size Spaced 6" Along the Edge

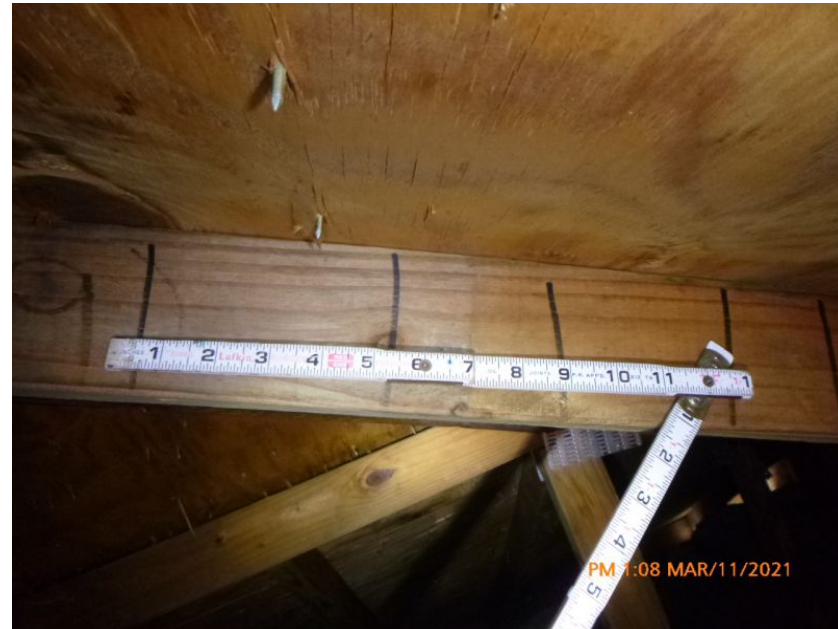
8d Nails or Greater in Size Spaced 6" in the Field

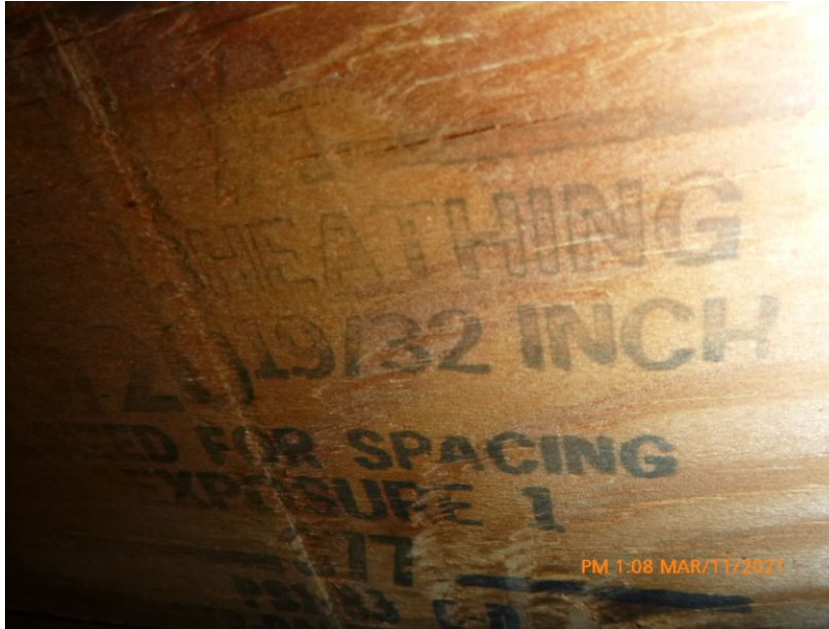
19/32" Deck Thickness Confirmed

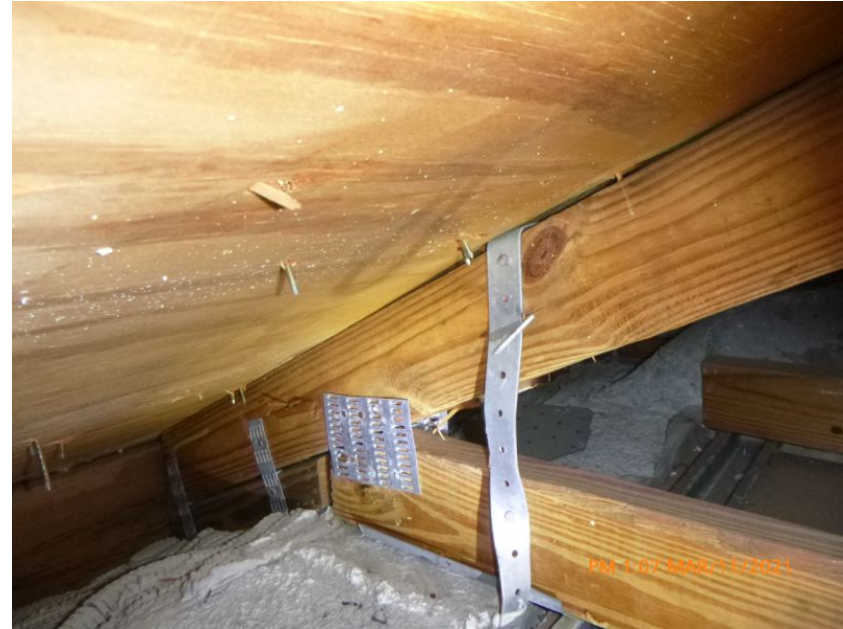
Single Wrap

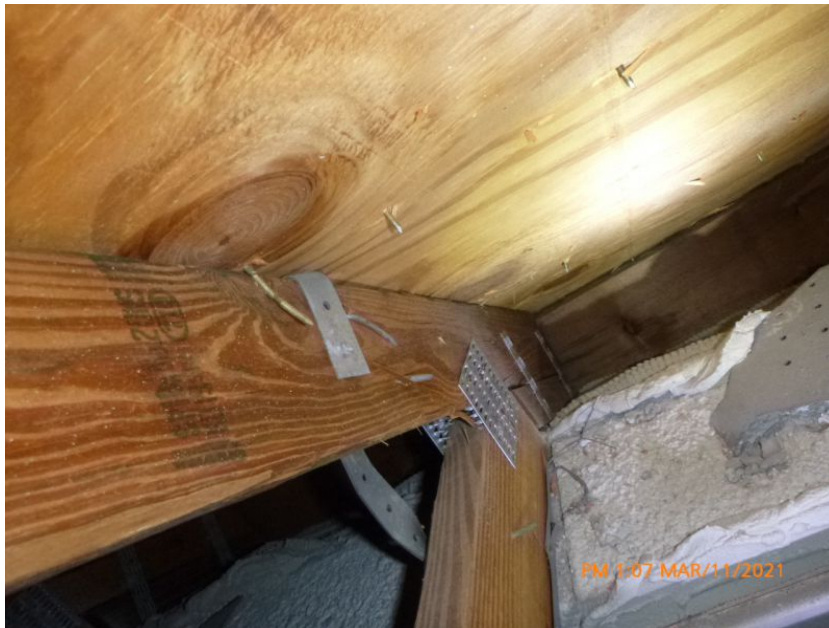
Single Wrap
