Uniform Mitigation Verification Inspection Form

Inspection Date: 3/11/2021							
Owner Information							
Owner Name: Andover at Wycliffe				Contact Person:			
Address: 10208 Andover Coach Circle				Home Phone: (561) 215-9160			
City: 1	Lake Worth	Zip: 33449		Work Phone:			
Count	y: Palm Beach			Cell Phone:			
Insurance Company:				Policy #:			
Year of Home: 1995 # of Stories:2				Email: ldistefano@grsmgt.com			
accom thoug	E: Any documentation used in the control of the con	photograph must accomp ditional questions regardi	oany this form to validing the mitigated featu	date each attribute marke ure(s) verified on this form	d in questions 3 1.		
	ilding Code: Was the structure HVHZ (Miami-Dade or Brown	vard counties), South Florid	a Building Code (SFB)	C-94)?

10208 Andover Coach Circle

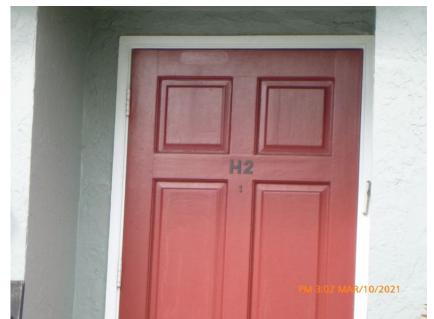
Unprotected Solid Entry Door

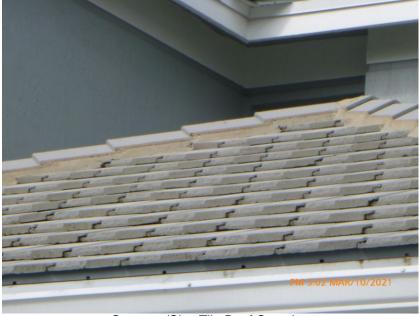
Concrete/Clay Tile Roof Covering

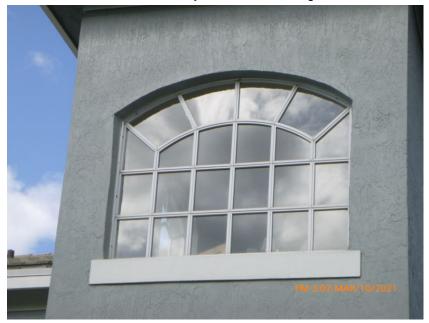
Unprotected Window

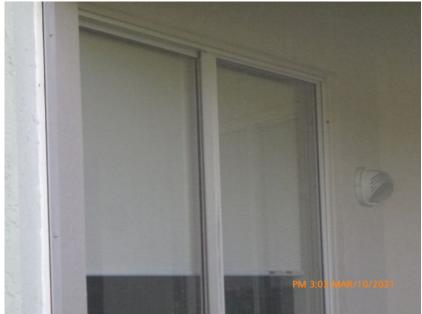
Unprotected Glazed Entry Door

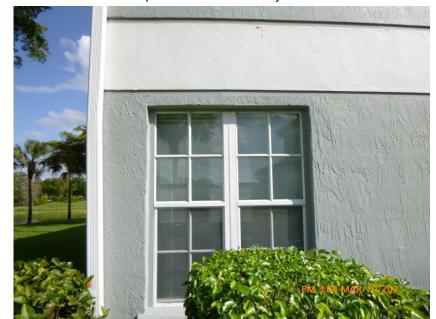
Unprotected Window

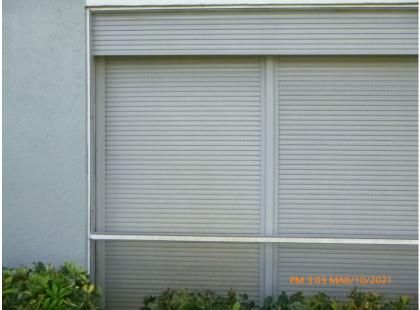
Rolldown Shutter - Unverified as Impact

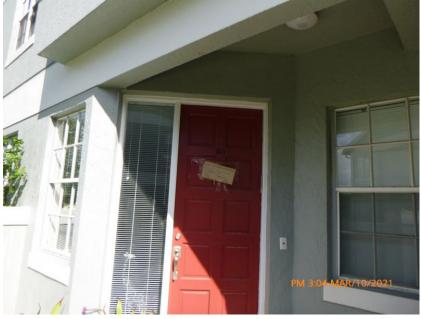
Unprotected Solid Entry Door

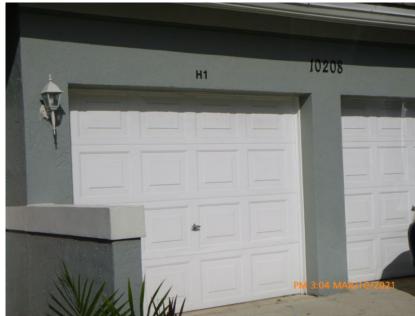
Unprotected Solid Garage Door

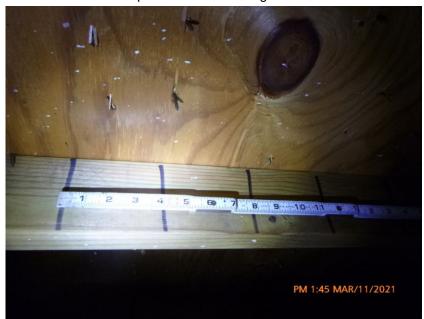
8d Nails or Greater in Size Spaced 6" Along the Edge

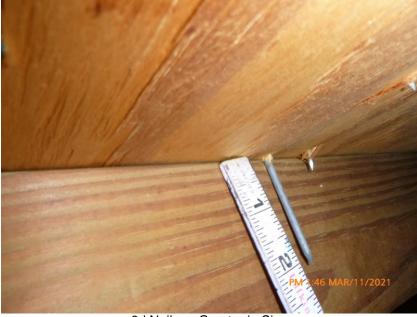
8d Nails or Greater in Size

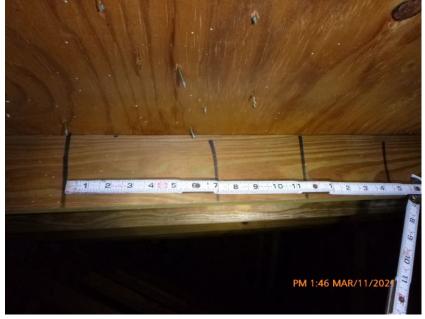
8d Nails or Greater in Size Spaced 6" in the Field

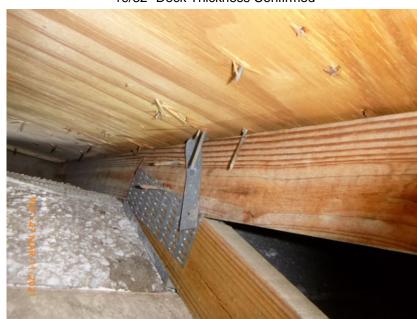
Single Wrap

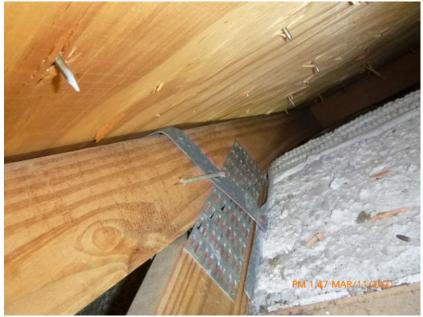
Single Wrap
