Uniform Mitigation Verification Inspection Form

Inspection Date: 3/10/2021						
Owner Information						
Owner Name: Andover at Wycliff	e	Contact Person:				
Address: 10232 Andover Coach C	Circle	Home Phone: (561) 215-9160				
City: Lake Worth	Zip: 33449	Work Phone:				
County: Palm Beach		Cell Phone:				
Insurance Company:		Policy #:				
Year of Home: 1994	# of Stories:2	Email: ldistefano@grsmgt.com

Inspectors Initials BD Property Address 10232 Andover Coach Circle Lake Worth, FL 33449 DMI: 1363009

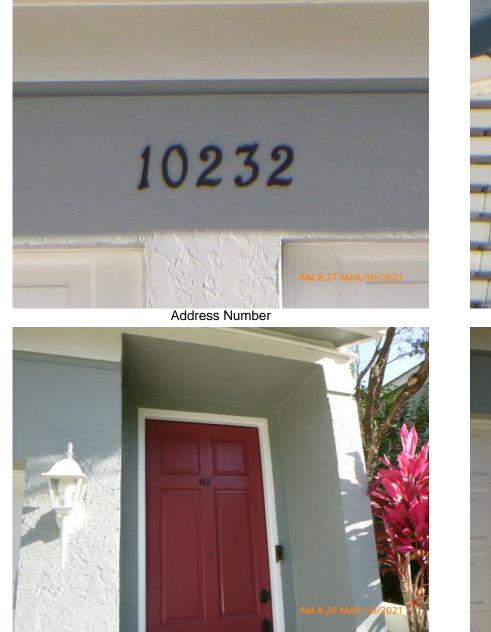
Unprotected Solid Entry Door

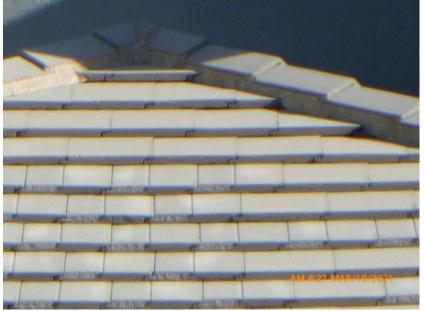
Concrete/Clay Tile Roof Covering

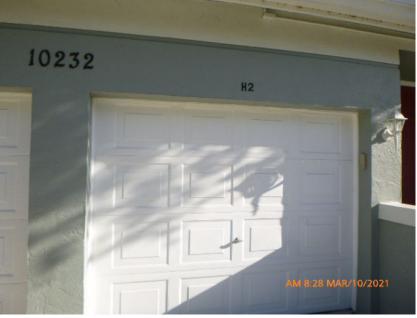
Unprotected Solid Garage Door

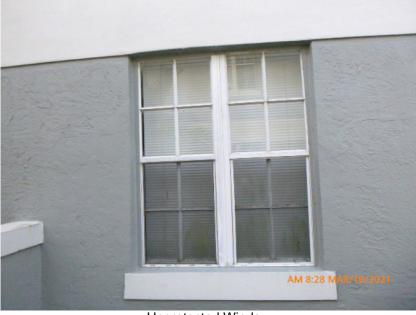
Unprotected Window

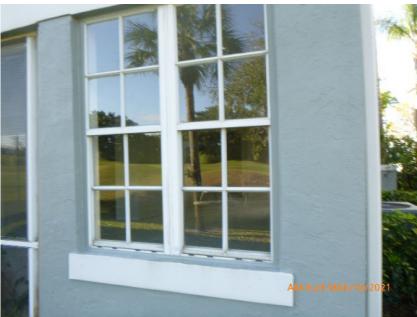
Unprotected Window

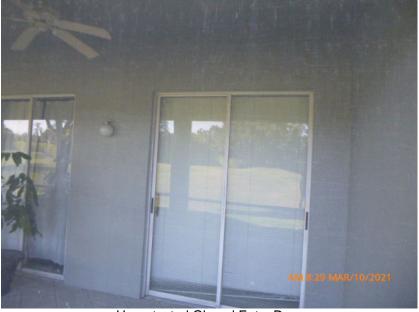
Unprotected Glazed Entry Door

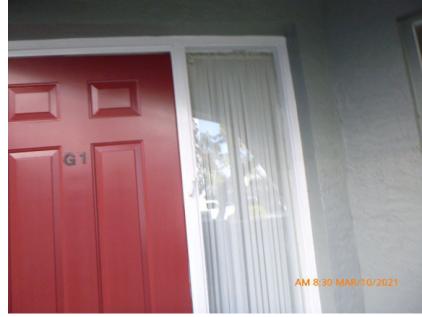
Unprotected Window

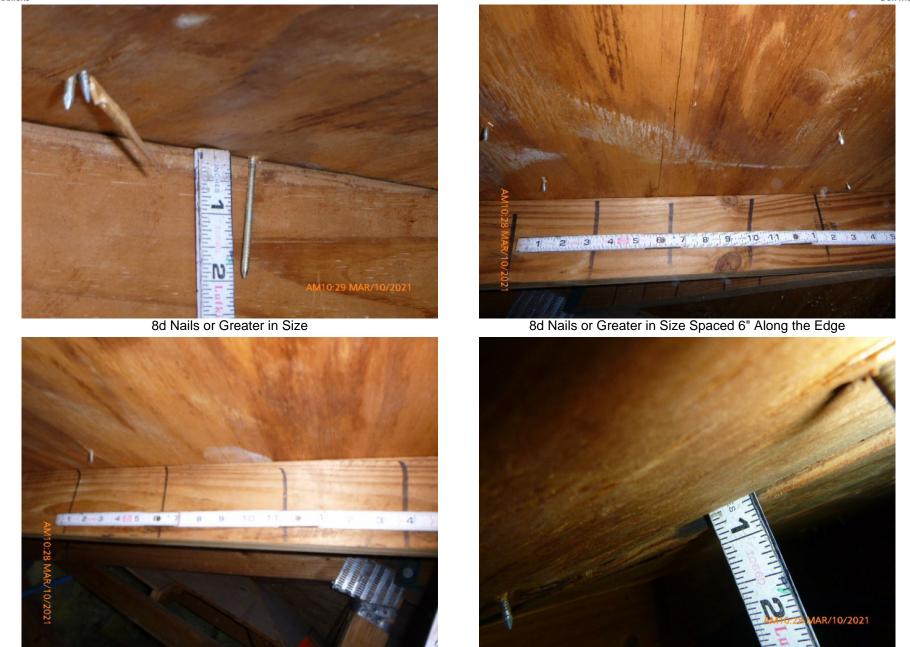
8d Nails or Greater in Size Spaced 6" in the Field

19/32" Deck Thickness Confirmed

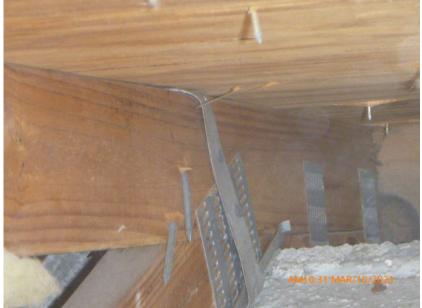
Single Wrap

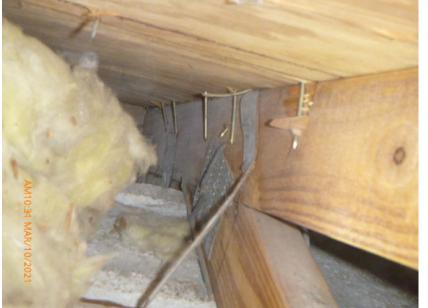
Single Wrap
