## **Uniform Mitigation Verification Inspection Form**

Inspection Date: 3/10/2021					
Owner Information					
Owner Name: Andover at Wycliffe Contact Person:					
Address: 10244 Andover Coach C	lircle	Home Phone: (561) 215-9160			
City: Lake Worth	Zip: 33449	Work Phone:			
County: Palm Beach		Cell Phone:			
Insurance Company:		Policy #:			
Year of Home: 1994	# of Stories: 2	Email: ldistefano@grsmgt.com

## Elevation Photos 10244 Andover Coach Circle

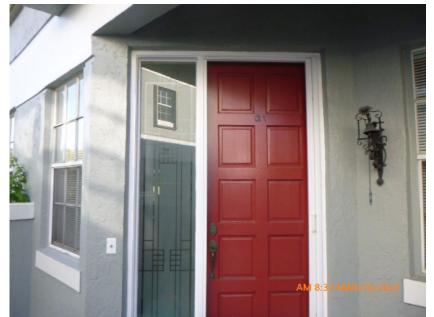
Unprotected Solid Entry Door

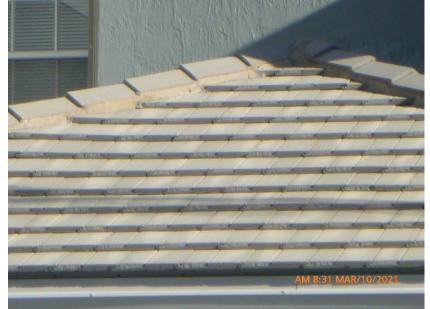
Concrete/Clay Tile Roof Covering

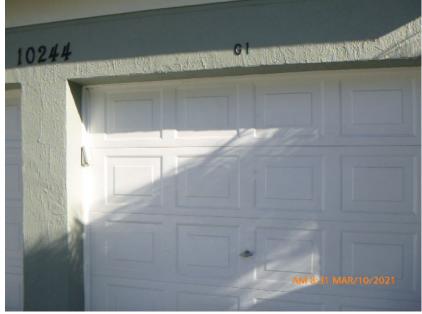
Unprotected Solid Garage Door

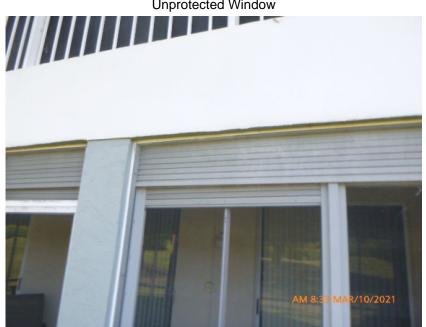
Rolldown Shutter - Unverified as Impact

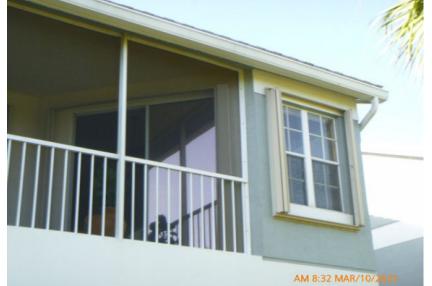
Accordion Shutter - Unverified as Impact

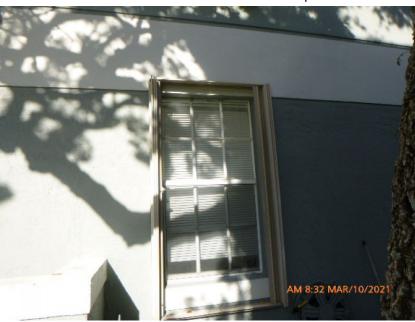
Non-Impact Rated Accordion Shutter

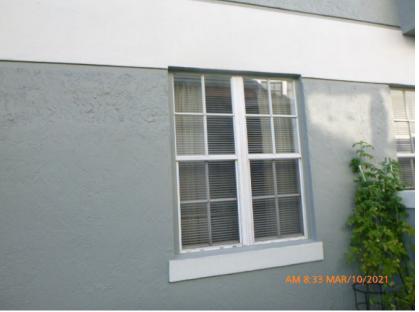
Unprotected Window

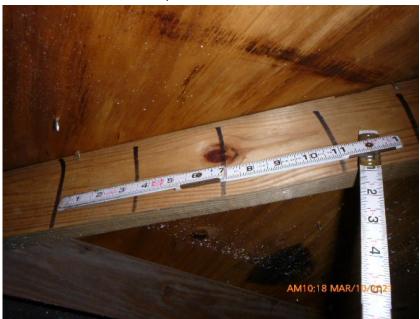
8d Nails or Greater in Size Spaced 6" Along the Edge

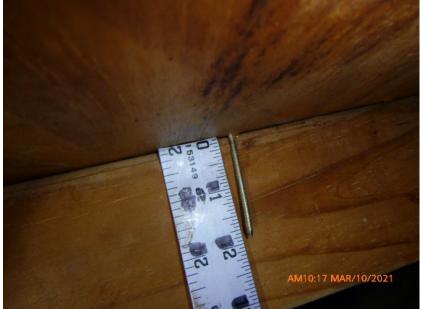
8d Nails or Greater in Size

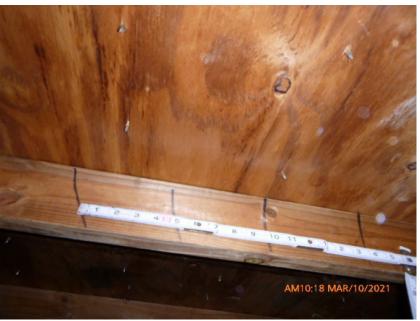
8d Nails or Greater in Size Spaced 6" in the Field

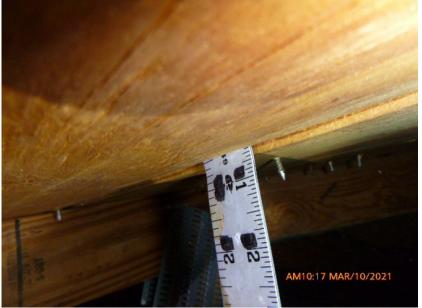
19/32" Deck Thickness Confirmed

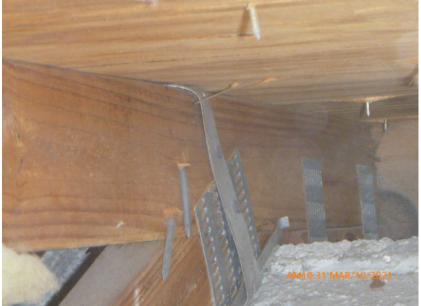
Single Wrap

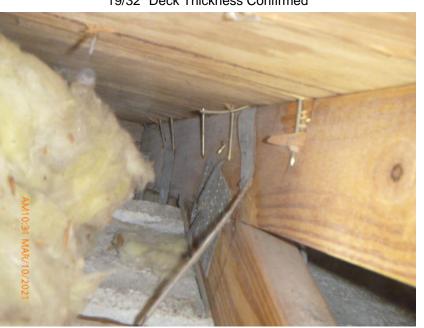
Single Wrap
