Uniform Mitigation Verification Inspection Form

Inspection Date: 3/10/2021		
Owner Information		
Owner Name: Andover at Wycliffe		Contact Person:
Address: 10256 Andover Coach Circle		Home Phone: (561) 215-9160
City: Lake Worth	Zip: 33449	Work Phone:
County: Palm Beach		Cell Phone:
Insurance Company:		Policy #:
Year of Home: 1994	# of Stories: 2	Email: ldistefano@grsmgt.com

Inspectors Initials BD Property Address 10256 Andover Coach Circle Lake Worth, FL 33449 DMI: 1363014

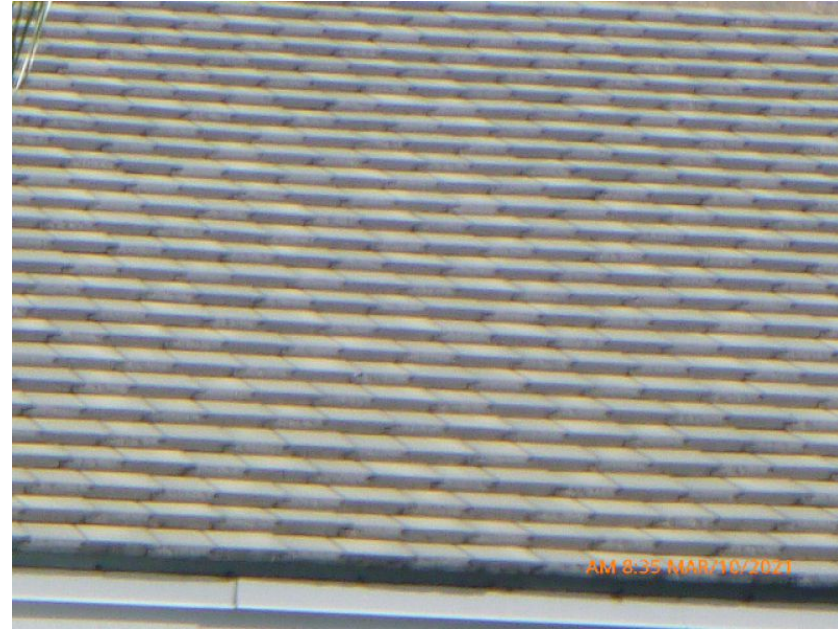
Concrete/Clay Tile Roof Covering

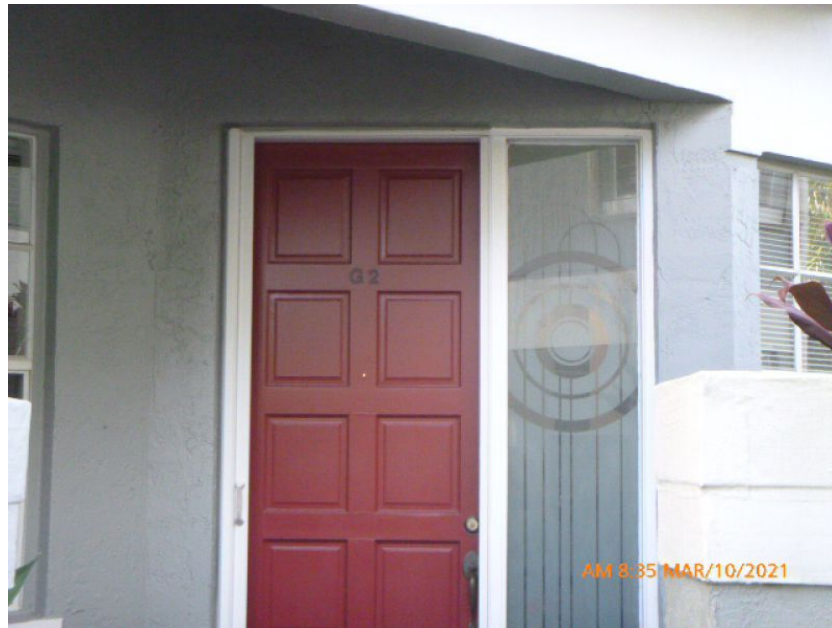
Unprotected Solid Entry Door

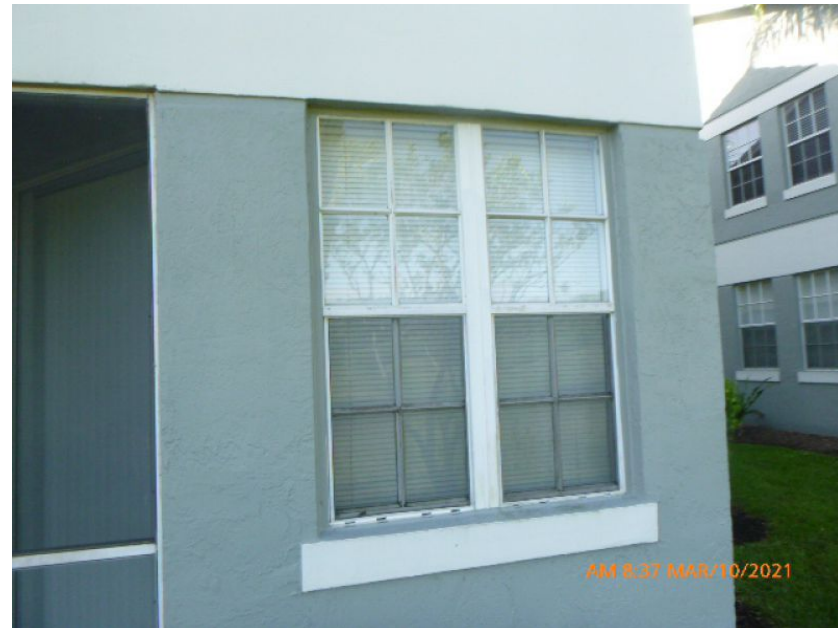
Unprotected Window

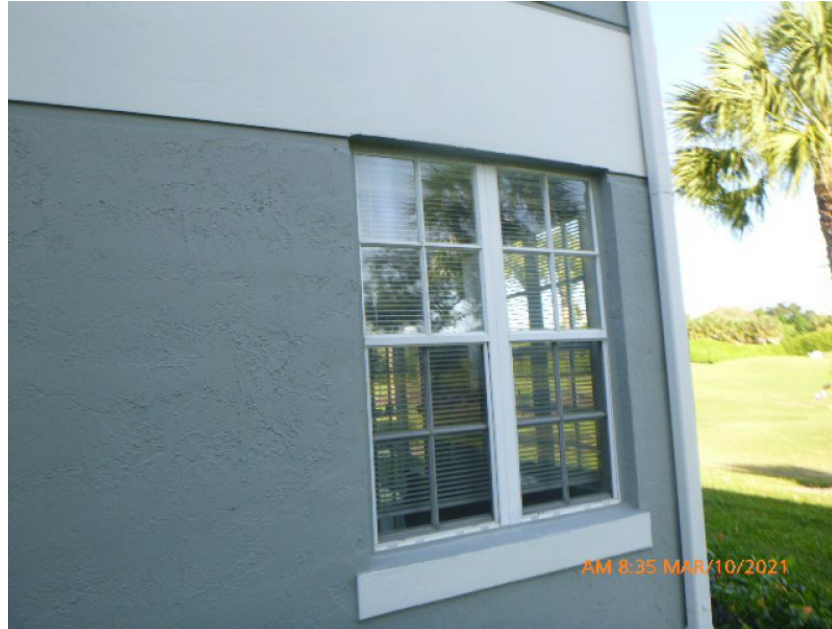
Unprotected Window

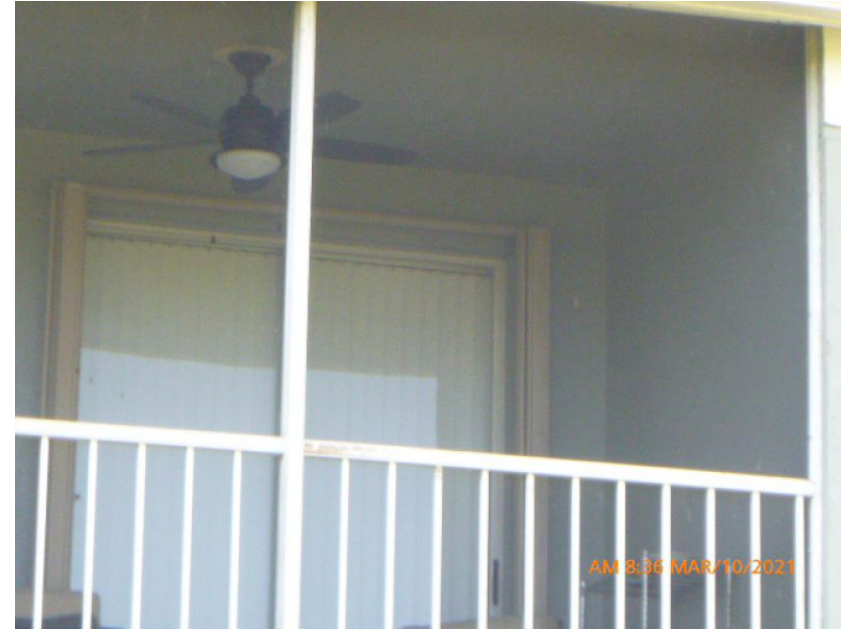
Accordion Shutter - Unverified as Impact

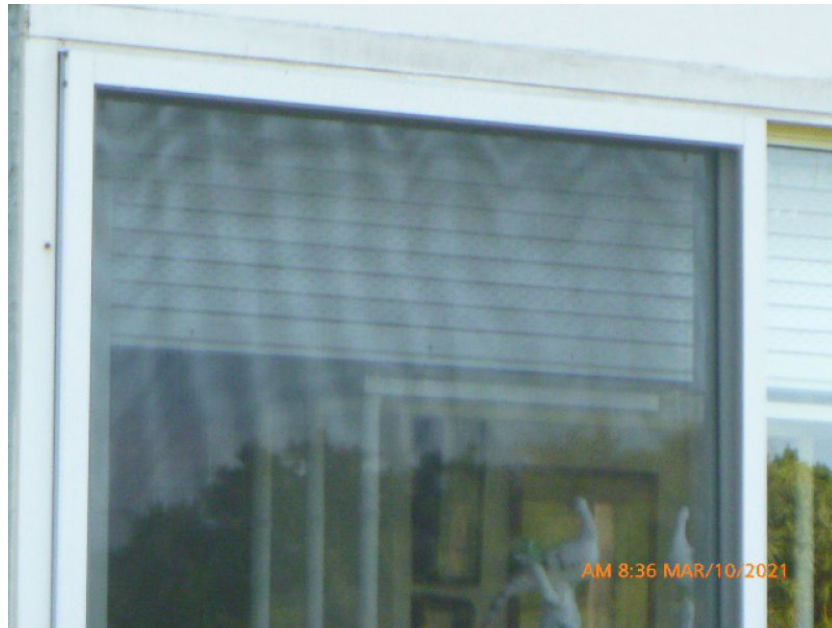
Rolldown Shutter - Unverified as Impact

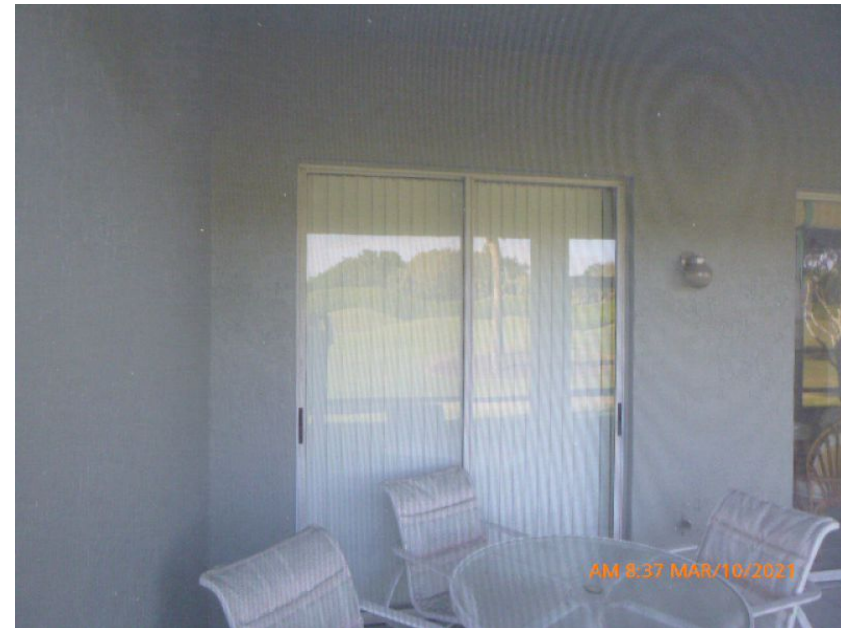
Unprotected Glazed Entry Door

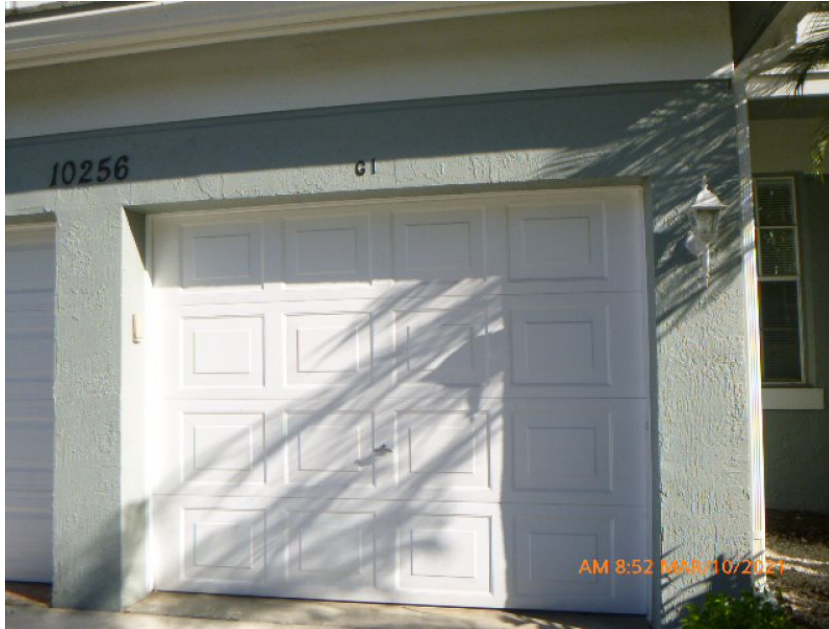
Unprotected Solid Garage Door

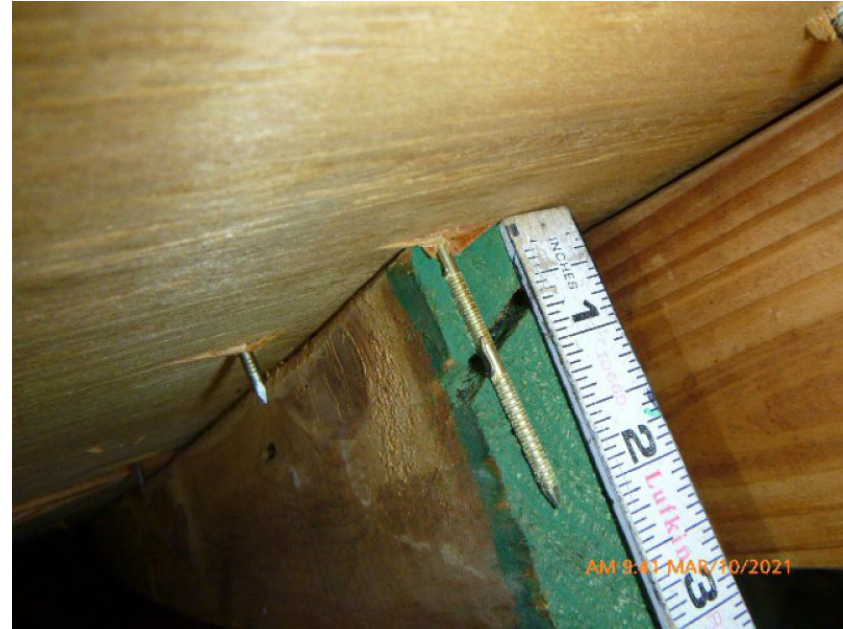
8d Nails or Greater in Size

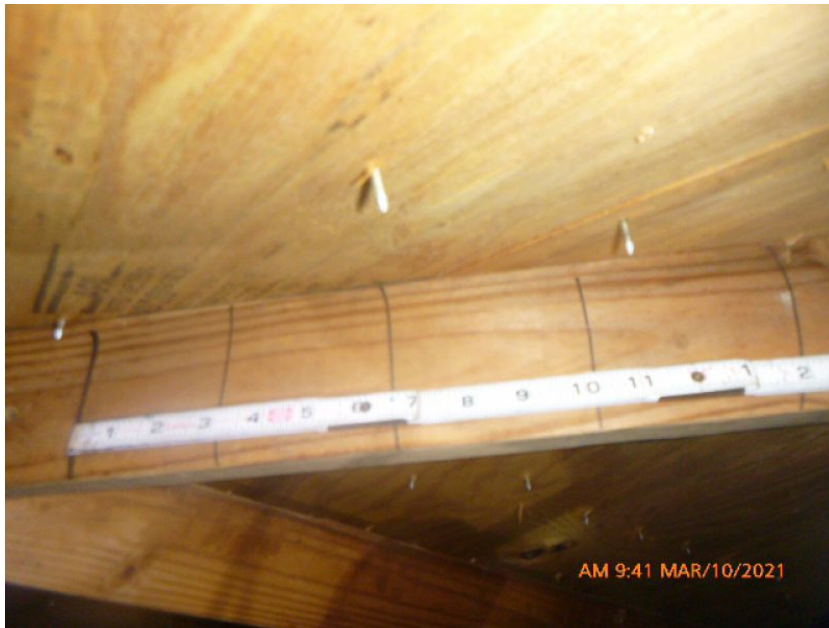
8d Nails or Greater in Size Spaced 6" Along the Edge

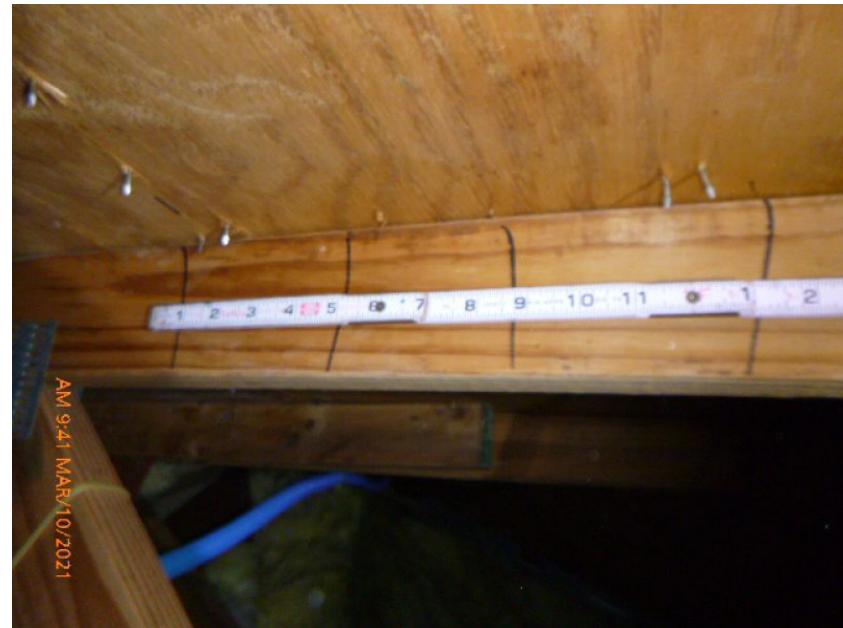
8d Nails or Greater in Size Spaced 6" in the Field

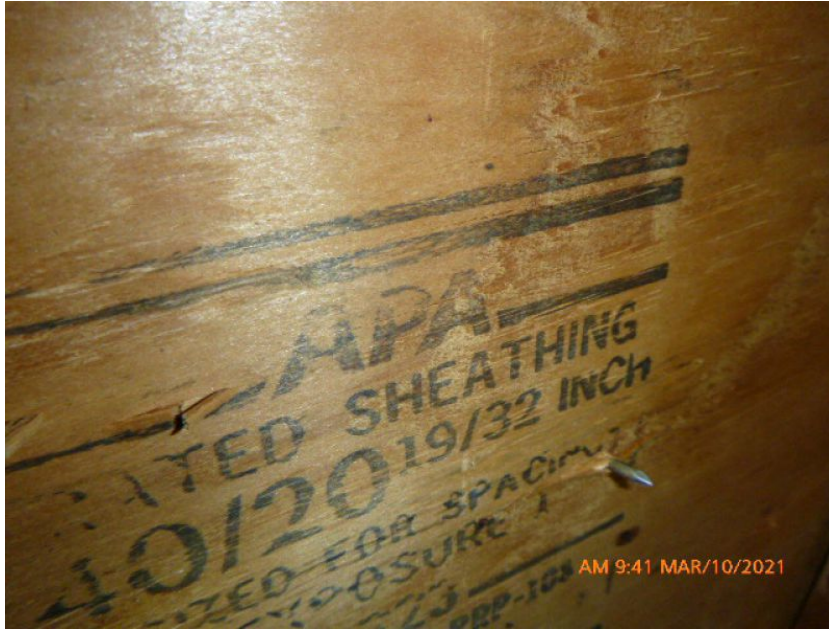
19/32" Deck Thickness Confirmed

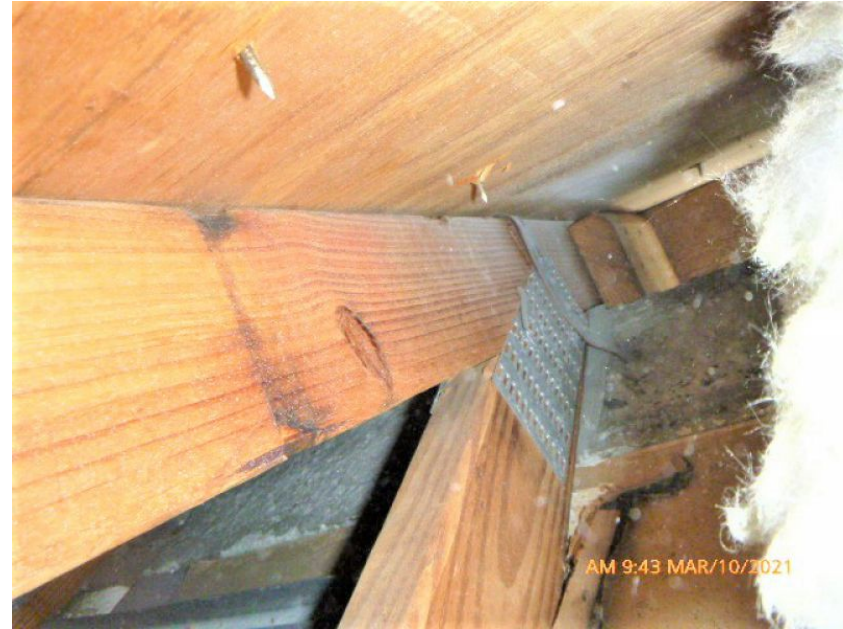
Single Wrap

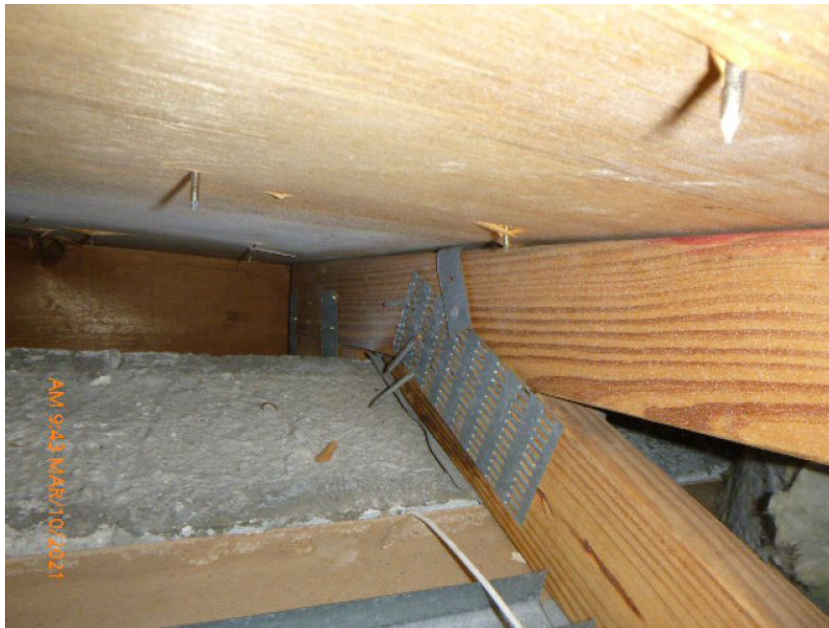
Single Wrap
