Uniform Mitigation Verification Inspection Form

Inspection Date: 3/10/2021						
Owner Information						
Owner Name: Andover at Wycliffe Contact Person:						
Address: 10280 S. Andover Coacl	n Lane	Home Phone: (561) 215-9160				
City: Lake Worth	Zip: 33449	Work Phone:				
County: Palm Beach		Cell Phone:				
Insurance Company:	· · · ·	Policy #:				
Year of Home: 1990	# of Stories:2	Email: ldistefano@grsmgt.com

Inspectors Initials BD Property Address 10280 S. Andover Coach Lane Lake Worth, FL 33449 DMI: 1363023

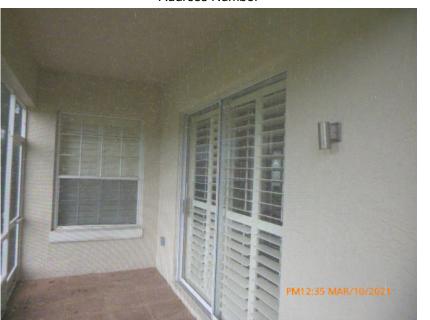
Unprotected Glazed Entry Door

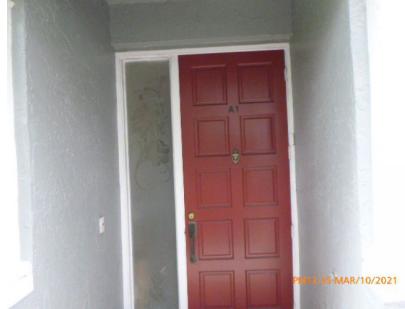
Unprotected Solid Entry Door

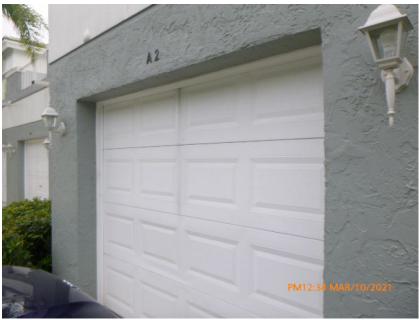
Unprotected Solid Garage Door

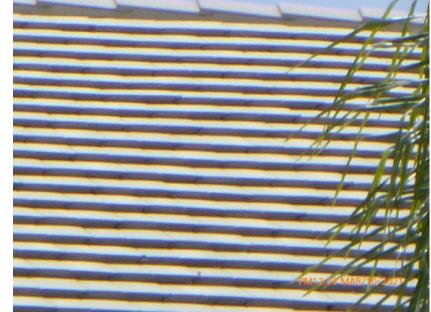
Concrete/Clay Tile Roof Covering

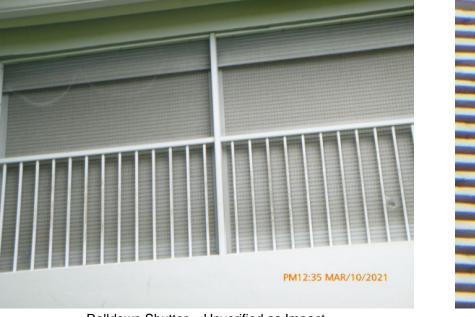
Rolldown Shutter - Unverified as Impact

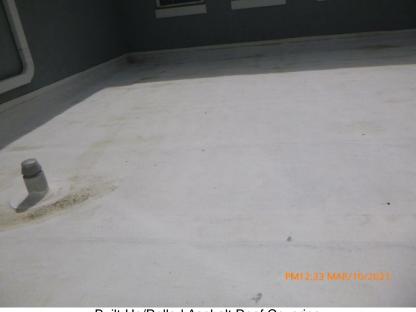
Built-Up/Rolled Asphalt Roof Covering

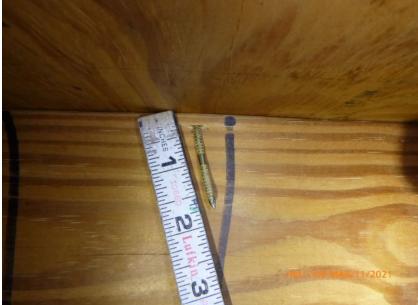
8d Nails or Greater in Size

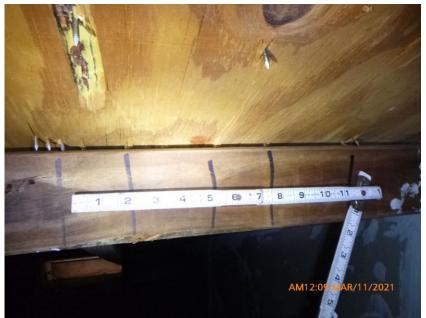
8d Nails or Greater in Size Spaced 6" Along the Edge

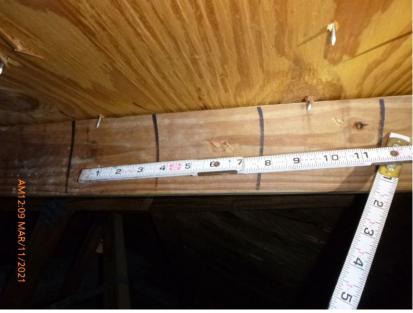
8d Nails or Greater in Size Spaced 6" in the Field

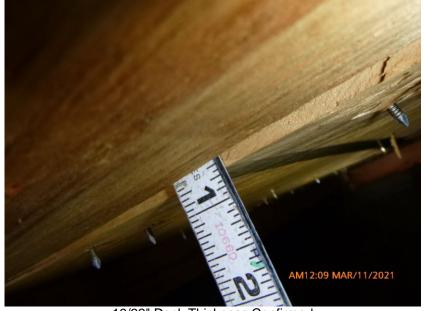
19/32" Deck Thickness Confirmed

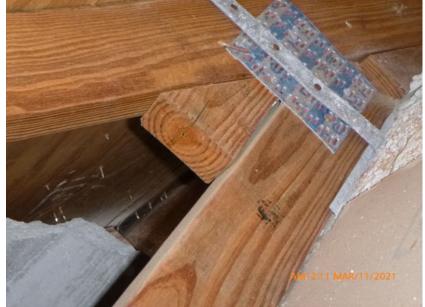
Single Wrap

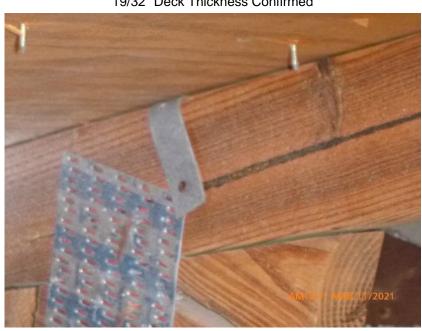
Single Wrap
