Uniform Mitigation Verification Inspection Form

Inspection Date: 3/10/2021						
Owner Information						
Owner Name: Andover at Wycliffe Contact Person:						
Address: 10292 S. Andover Coad	ch Lane	Home Phone: (561) 215-9160				
City: Lake Worth	Zip: 33449	Work Phone:				
County: Palm Beach		Cell Phone:				
Insurance Company:	· · · · · ·	Policy #:				
Year of Home: 1990	# of Stories:2	Email: ldistefano@grsmgt.com

Inspectors Initials BD Property Address 10292 S. Andover Coach Lane Lake Worth, FL 33449 DMI: 1363024

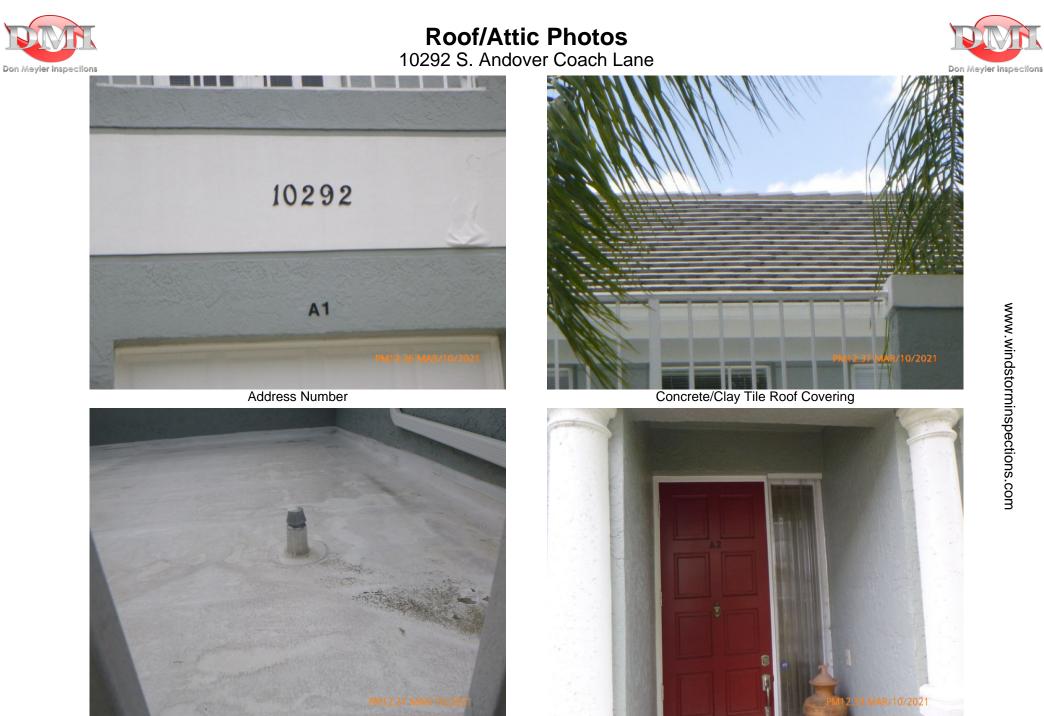
Built-Up/Rolled Asphalt Roof Covering

Unprotected Solid Entry Door

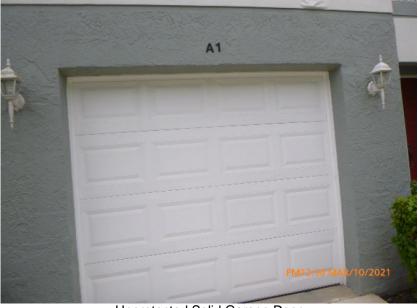
Unprotected Solid Garage Door

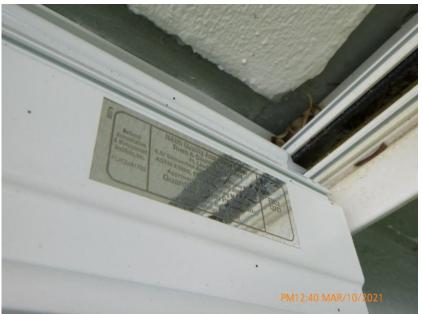
Impact Rated Accordion Shutter Label

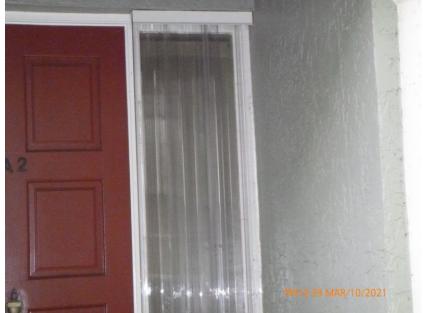
Lexan Shutter - Unverified as Impact

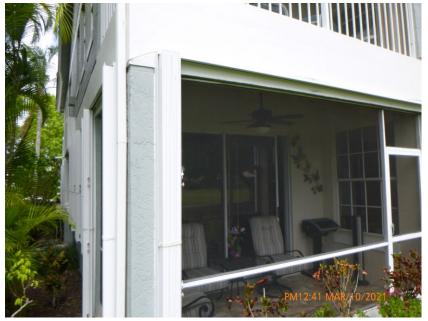
Impact Rated Accordion Shutter

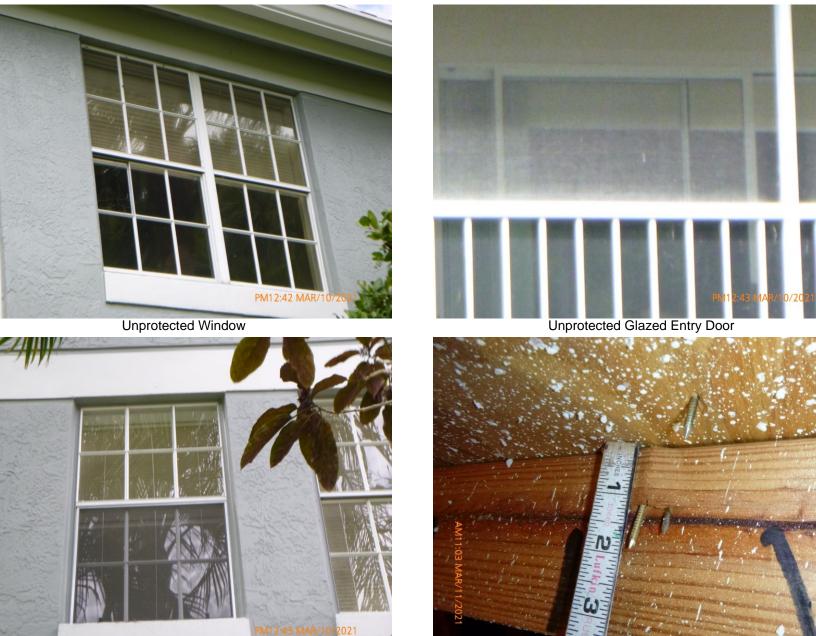
Unprotected Window

8d Nails or Greater in Size

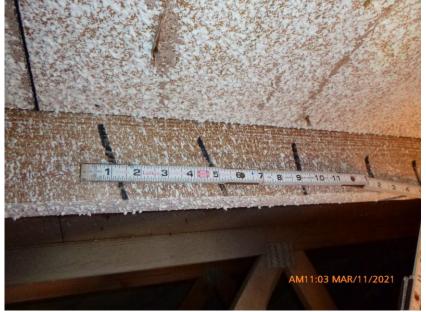
8d Nails or Greater in Size Spaced 6" Along the Edge

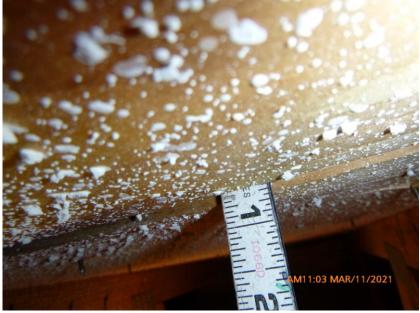
19/32" Deck Thickness Confirmed

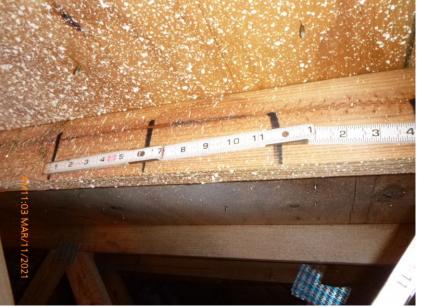
8d Nails or Greater in Size Spaced 6" in the Field

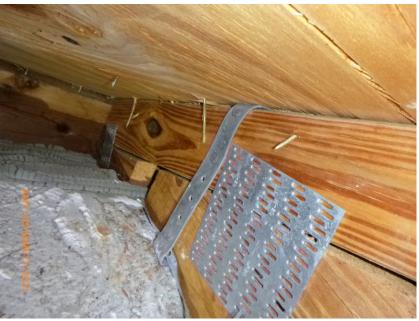
Single Wrap

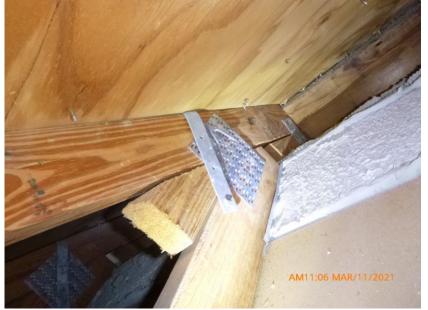
Single Wrap
