Uniform Mitigation Verification Inspection Form

Inspection Date: 3/10/2021						
Owner Information						
Owner Name: Andover at Wycliffe Contact Person:						
Address: 10304 S. Andover Coac	h Lane	Home Phone: (561) 215-9160				
City: Lake Worth	Zip: 33449	Work Phone:				
County: Palm Beach		Cell Phone:				
Insurance Company:		Policy #:				
Year of Home: 1990	# of Stories:2	Email: ldistefano@grsmgt.com

Inspectors Initials BD Property Address 10304 S. Andover Coach Lane Lake Worth, FL 33449 DMI: 1363025

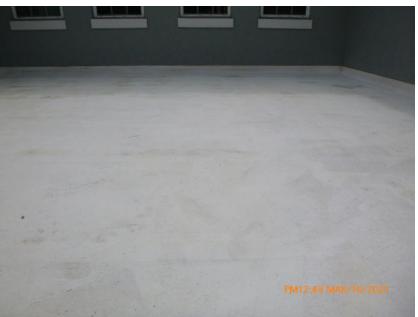
Built-Up/Rolled Asphalt Roof Covering

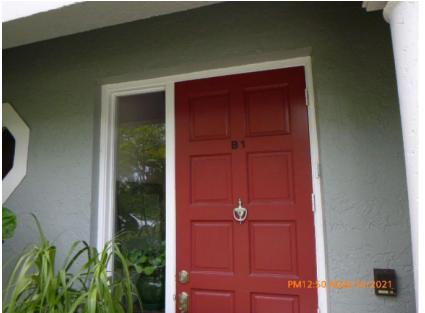
Unprotected Solid Entry Door

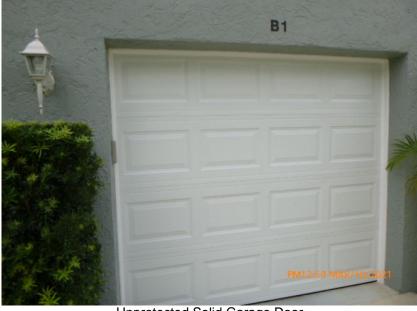
Unprotected Solid Garage Door

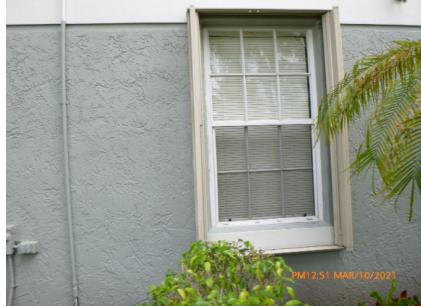
Accordion Shutter - Unverified as Impact

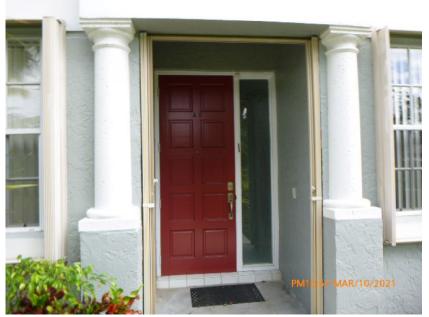
Accordion Shutter - Unverified as Impact

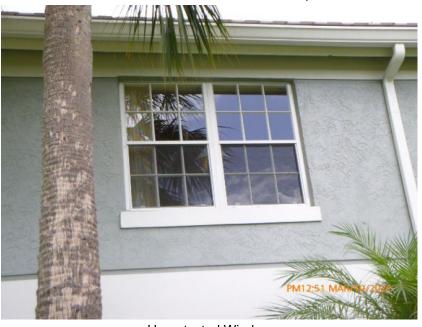
Unprotected Window

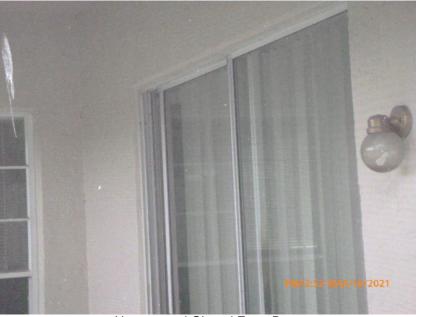
Unprotected Glazed Entry Door

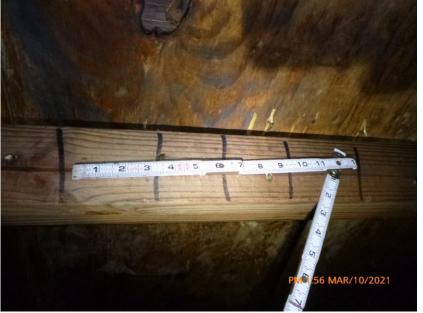
8d Nails or Greater in Size Spaced 6" Along the Edge

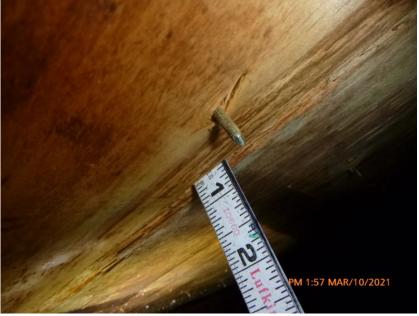
19/32" Deck Thickness Confirmed

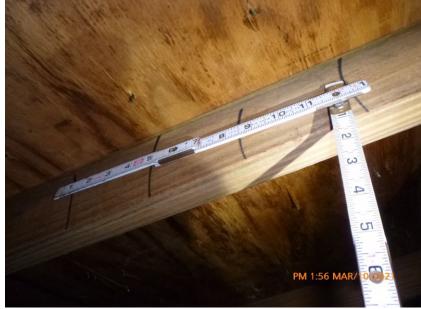
8d Nails or Greater in Size Spaced 6" in the Field

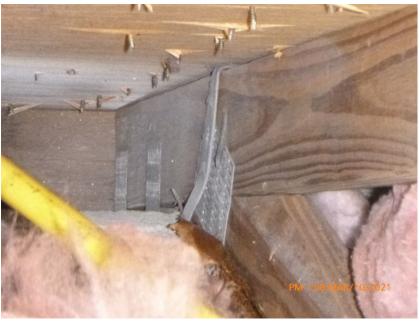
Single Wrap
