Uniform Mitigation Verification Inspection Form

Inspection Date: 3/10/2021						
Owner Information						
Owner Name: Andover at Wycliffe	Contact Person:					
Address: 10327 N. Andover Coach	Lane	Home Phone: (561) 215-9160				
City: Lake Worth	Zip: 33449	Work Phone:				
County: Palm Beach		Cell Phone:				
Insurance Company:	· ·	Policy #:				
Year of Home: 1995	# of Stories:2	Email: ldistefano@grsmgt.com

Inspectors Initials BD Property Address 10327 N. Andover Coach Lane Lake Worth, FL 33449 DMI: 1363021

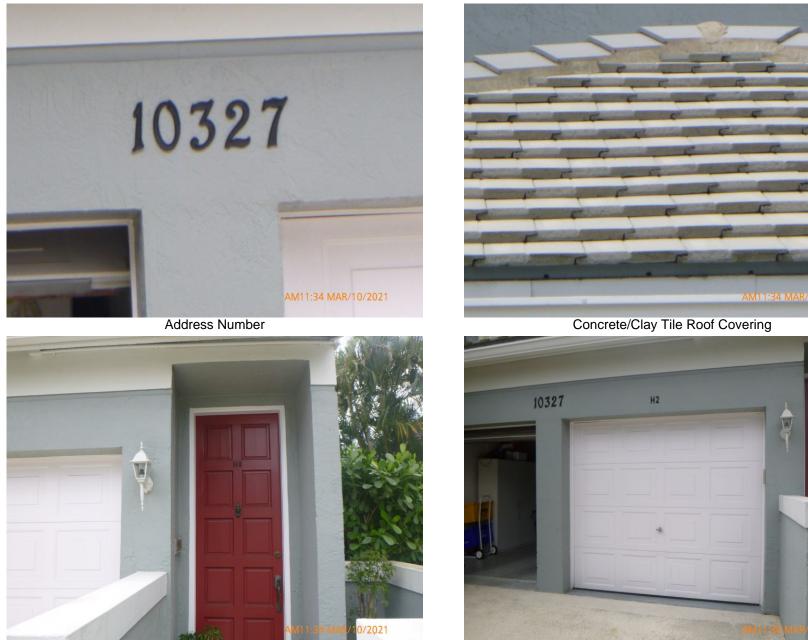
Unprotected Solid Entry Door

Unprotected Solid Garage Door

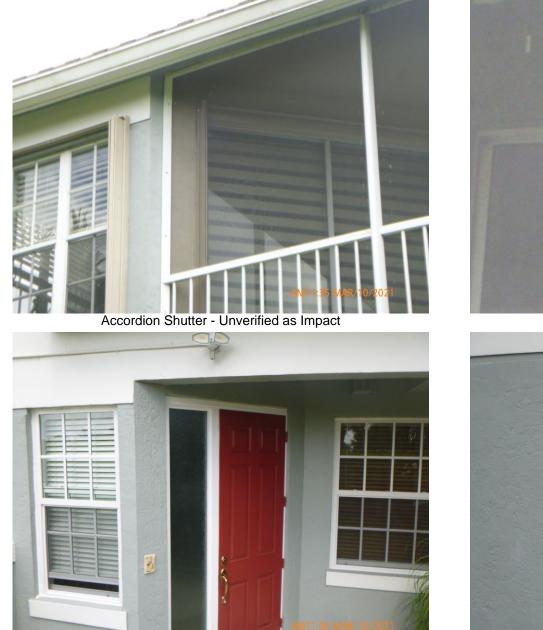
Unprotected Windows

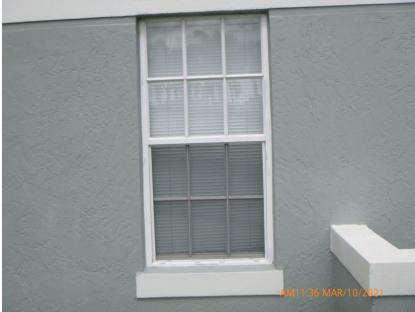
Unprotected Window

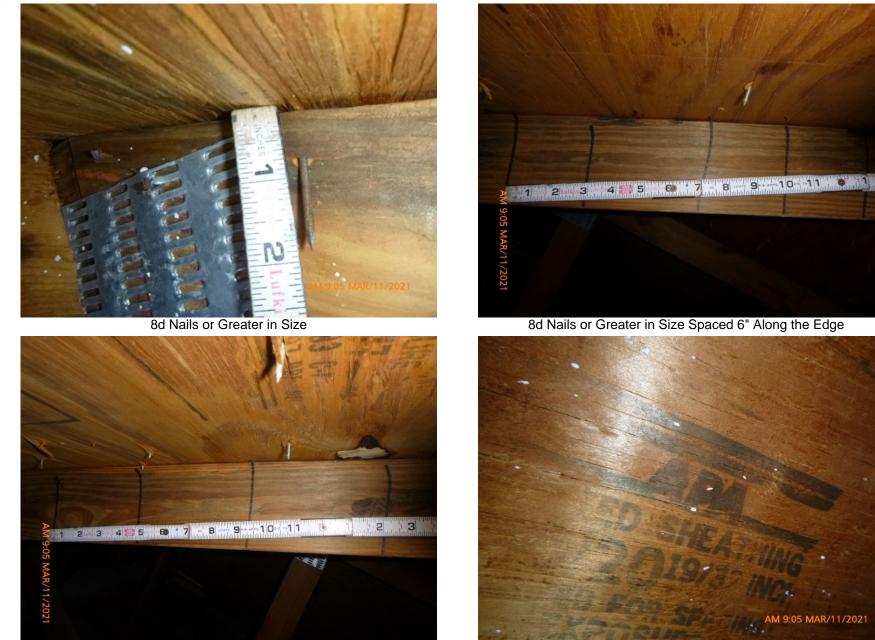
8d Nails or Greater in Size Spaced 6" in the Field

19/32" Deck Thickness Confirmed

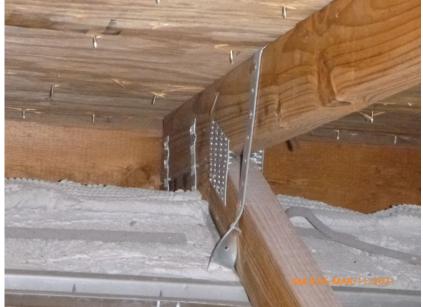
Metal Connector with 3 Nails on the Front Side & 0 Nails on the Opposing Side

Roof-to-Wall Attachment Our report indicates that the existing roof-to-wall attachment(s) do not meet the requirements on the Uniform Mitigation Verification Inspection form for Single Wrap Straps. This definition requires at least two nails on the front side and at least one on the other of every strap in the attic, on every truss or rafter. As it is often difficult to access every truss or rafter, the ideal time to upgrade this feature is when the roof deck is being replaced. In some circumstances, this work can be done on its own; consult a professional for details. Retrofits to existing roof to wall connections should be permitted with the local building department, and installations should follow the manufacturer's guidelines.

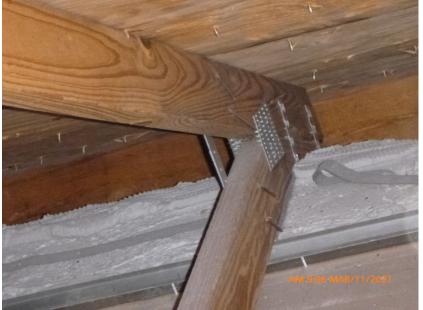
Metal Connector with 3 Nails on the Front Side & 0 Nails on the Opposing Side
