PHASE 1 MILESTONE REPORT

THE SENATE CONDOMINIUM

2550 PRESIDENTIAL Way

MILESTONE INSPECTION REPORT

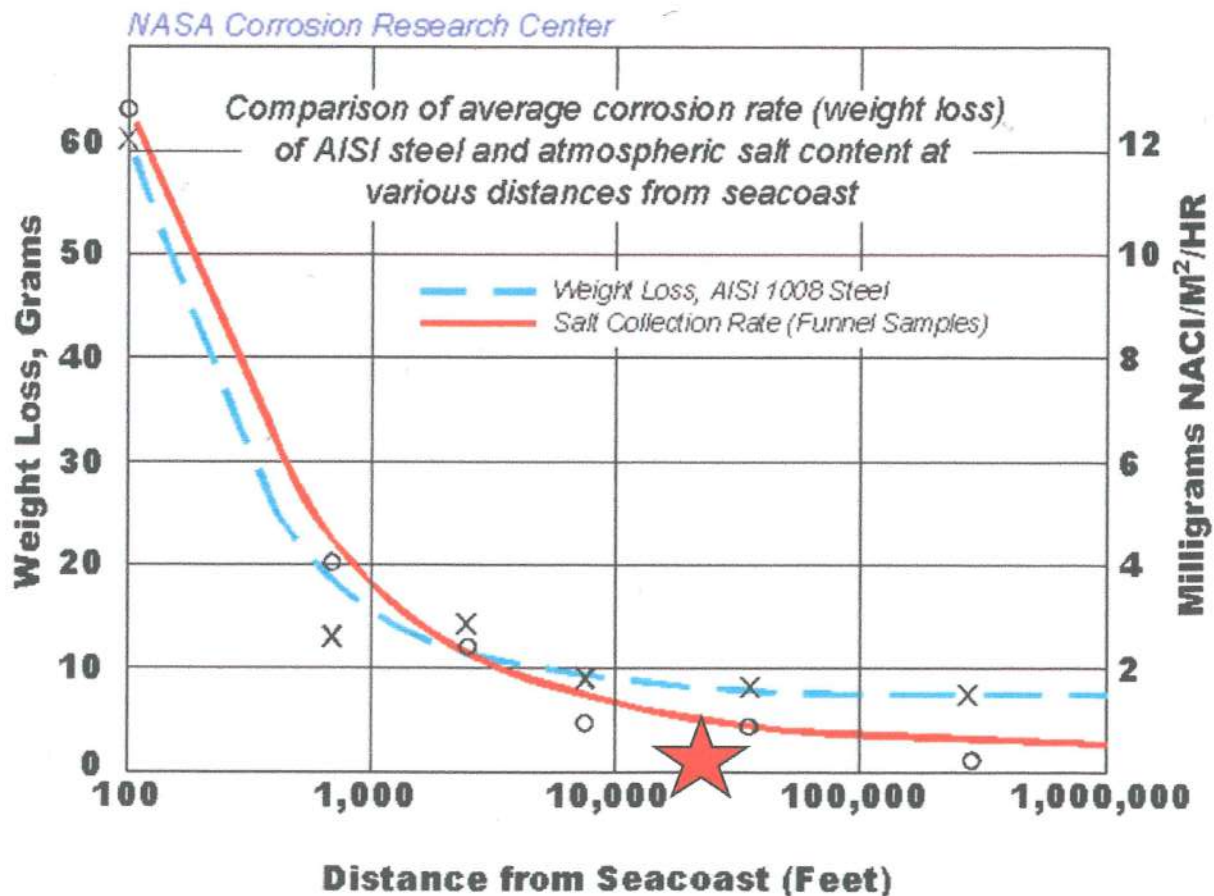
Chloride Damage vs Distance from Ocean: Below is a graph created by NASA several years ago based on data obtained from testing done at their research center here in Florida. The key take away here is that corrosion rates due to the coastal salt environment drop exponentially as you move inland, but the effects can still be significant 10 miles inland. These buildings are about 17,500 feet inland (3.3 Miles), giving you a salt collection rate of about 1.2 milligrams square / Hr. This is substantially less than a building right on the ocean, but salts are still present. The lower rate just means the salts accumulate much slower on the flat decks, delaying the start of corrosion damage until the building are older. We've seen edge damage associated with screened edges as far West as Wellington on similar buildings.

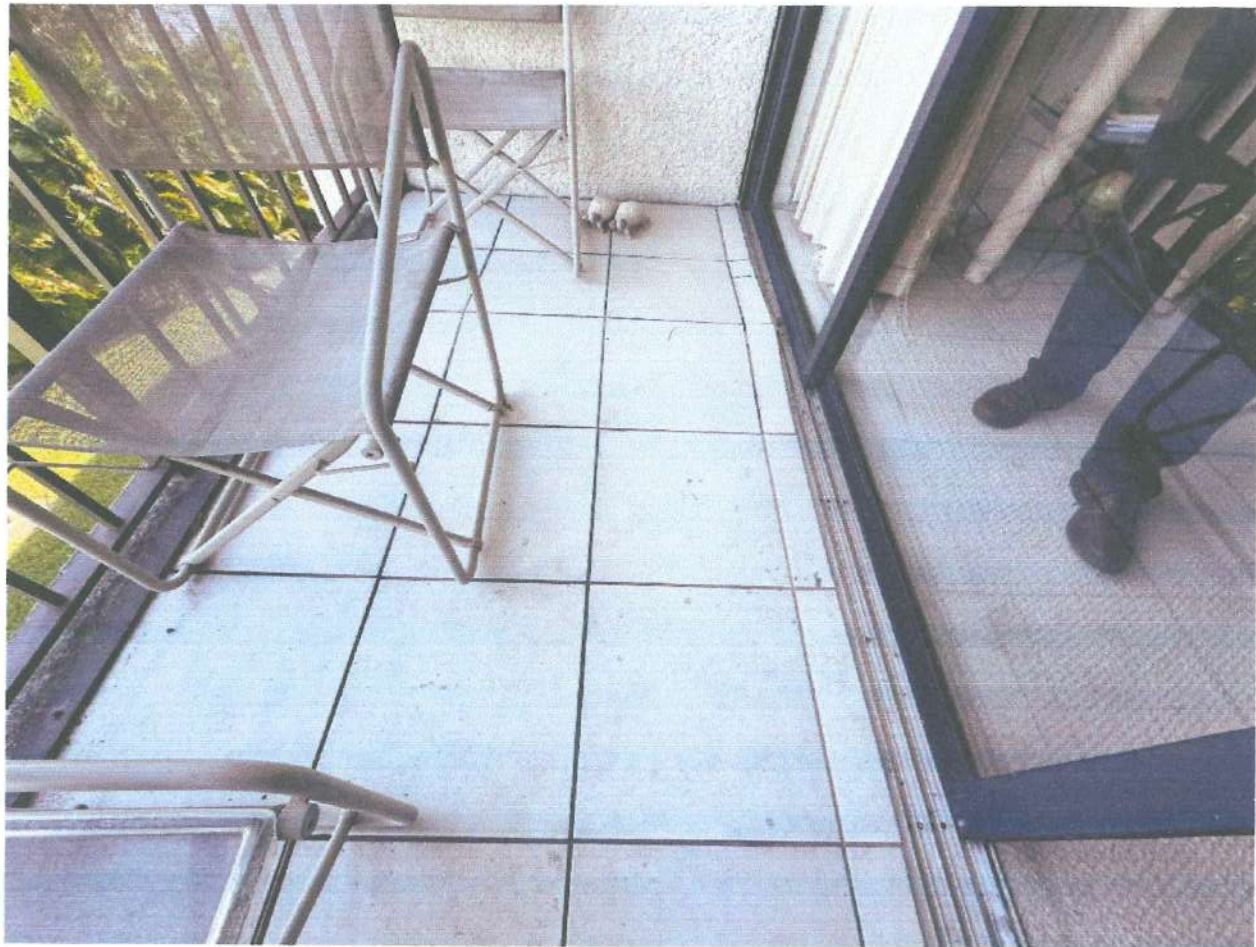
Screen / Shutter Fasteners: Typically, the screen enclosure and / or shutters along the edge cause edge problems eventually. The fasteners are typically Tapcons made from hardened steel that may or may not have had a sacrificial coating. Even though the fasteners may have been sealed with caulk when the screen was new, that sealant usually breaks down after 5 to 8 years. As the water starts to seep down past the fastener, the fastener will typically start to rust. As the rust happens, the fastener will first expand because rust is seven times the volume of steel. It will then lose volume and the salt water due to rain will seep down into the hole and out into the edge concrete, eventually causing the horizontal rebar along the edge to corrode. We did not observe much edge damage at this point, but you can expect to find some as time goes on.

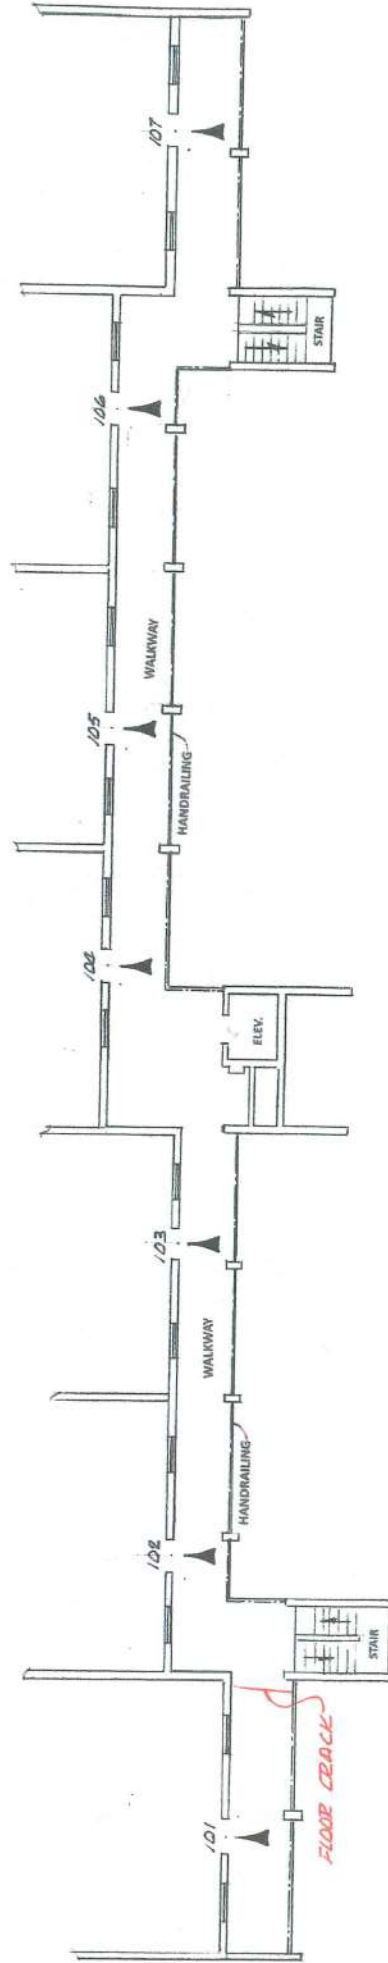
BUILDING 2550: FIRST FLOOR WALKWAY

The first-floor slab on grade appears to be structurally sound with only one floor crack noted. The other two floor walkways exhibit numerous hairline cracks which should be repaired before any water intrusion reaches the reinforced concrete walkway and causes major spalls within the structure. Reference the walkway survey drawings for each walkway

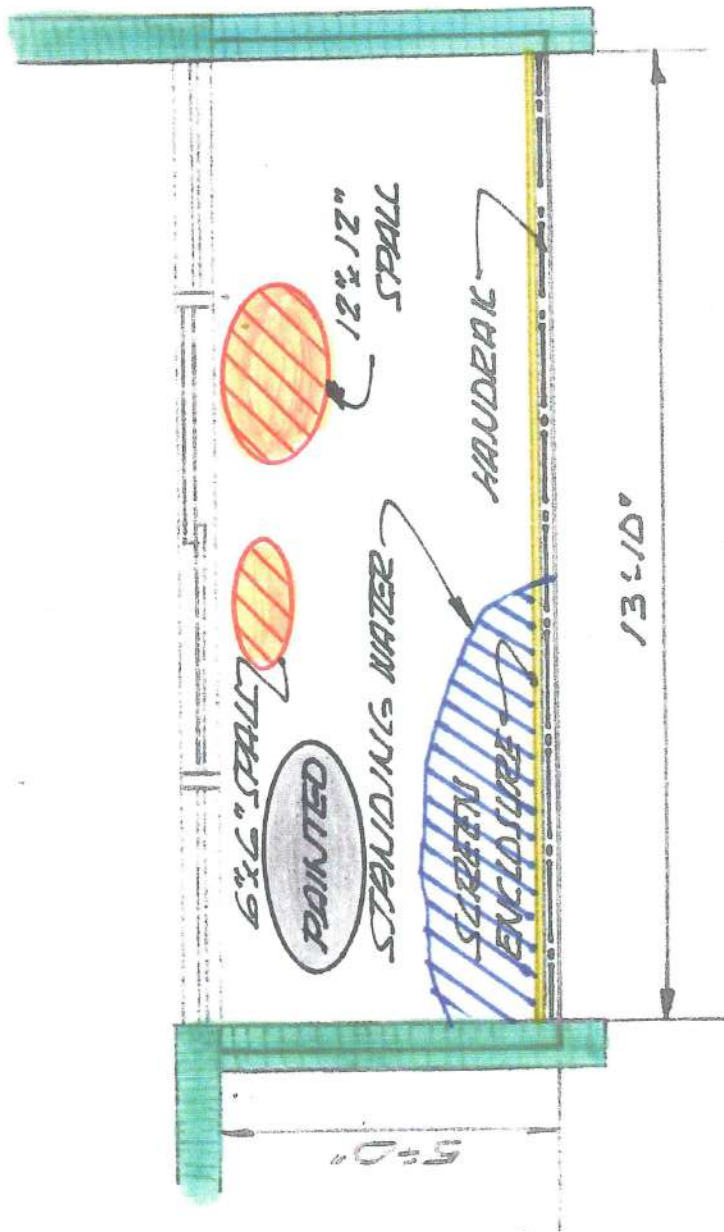
NOTE: STANDING WATER ALONG SIDE
SCREEN TRACK DUE TO LACK
OF WEED HOLES IN BOTTOM
OF TRACK.

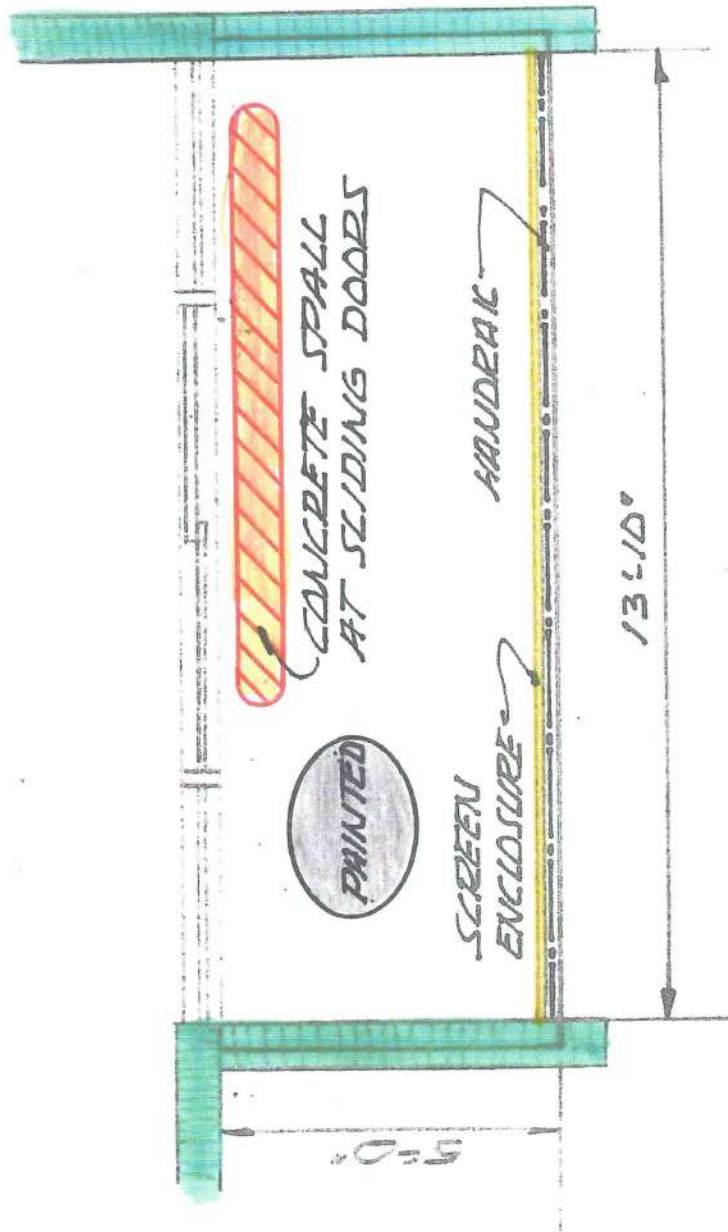
EXISTING CONCRETE SPALL AT SLIDING DOORS
COULD RESULT IN INVASION OF UNIT TO REPAIR.
TO MUCH DIET ON BALCONY TO INSPECT
REMAINING AREAS. BALCONY TO BE CLEANED
AND REINSPECTED FOR ADDITIONAL AREAS
OF REPAIR.

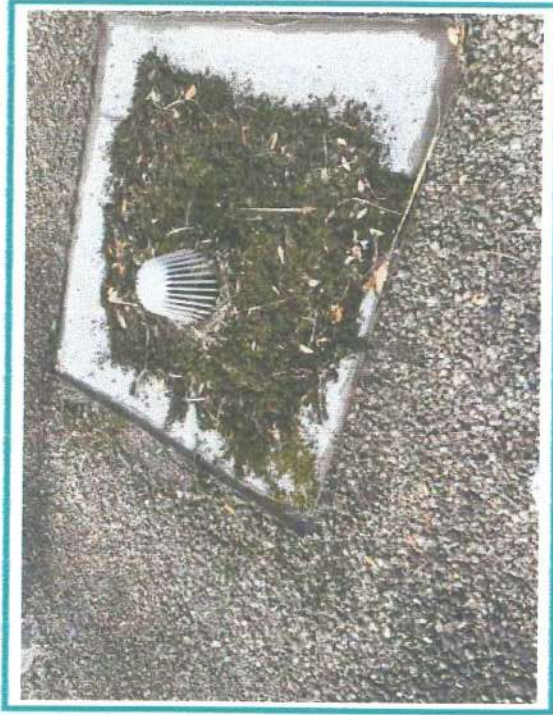
9. Interior drain clogged with vegetation/algae, clear out

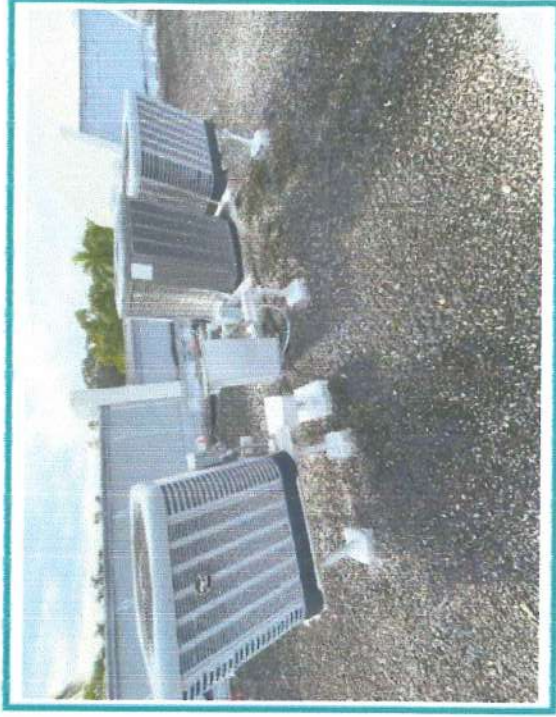
10. View of typical AC stand/chase detail, well maintained

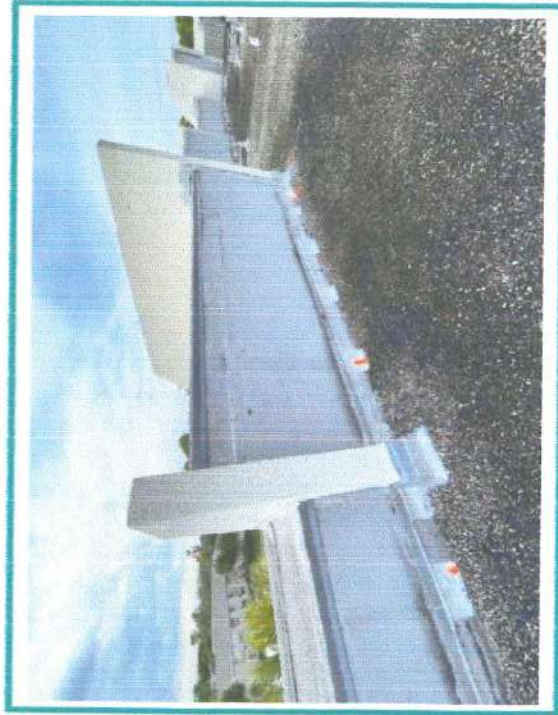
11. View of typical termination base detail, well maintained

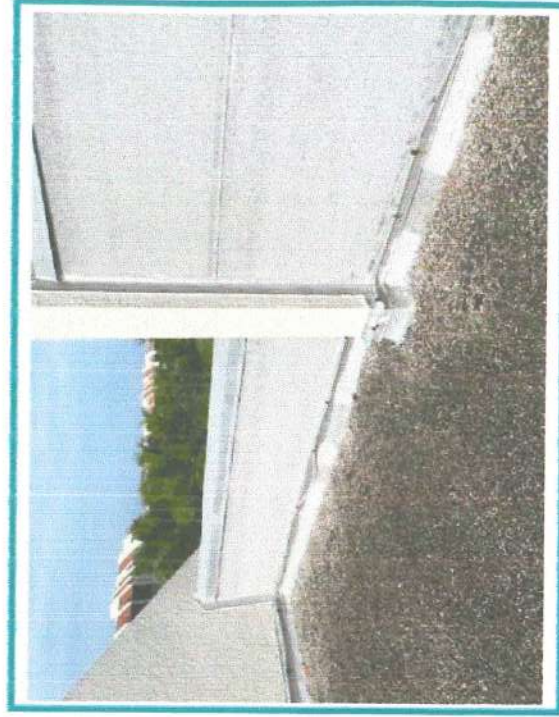
12. View of typical flashed parapet detail, well maintained

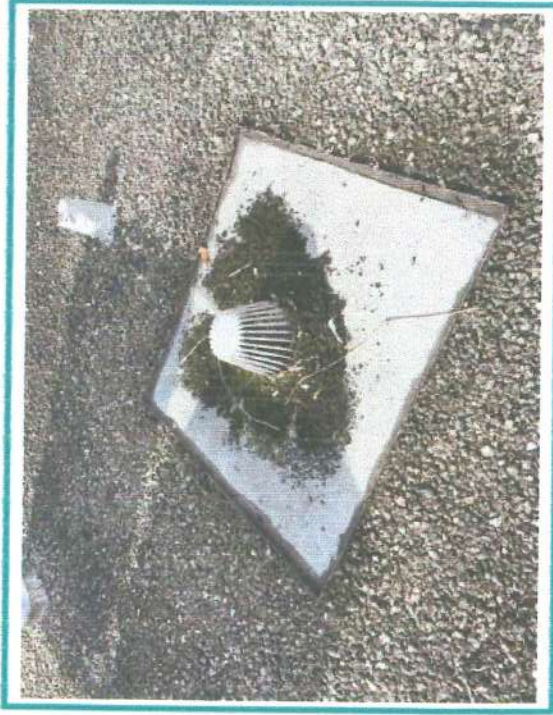
13 Interior drain hampered with algae/debris, clear out

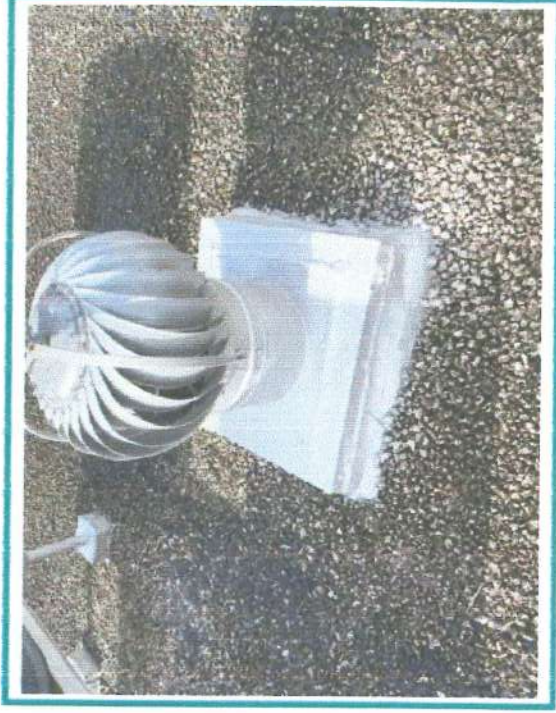
14 View of typical ventilator curb detail, well maintained
