**STRUCTURAL ENGINEERING PROFESSIONALS, INC.**

# **PHASE 1 MILESTONE REPORT**

## **SENATE CONDOMINIUM**

**3000 PRESIDENTIAL WAY**

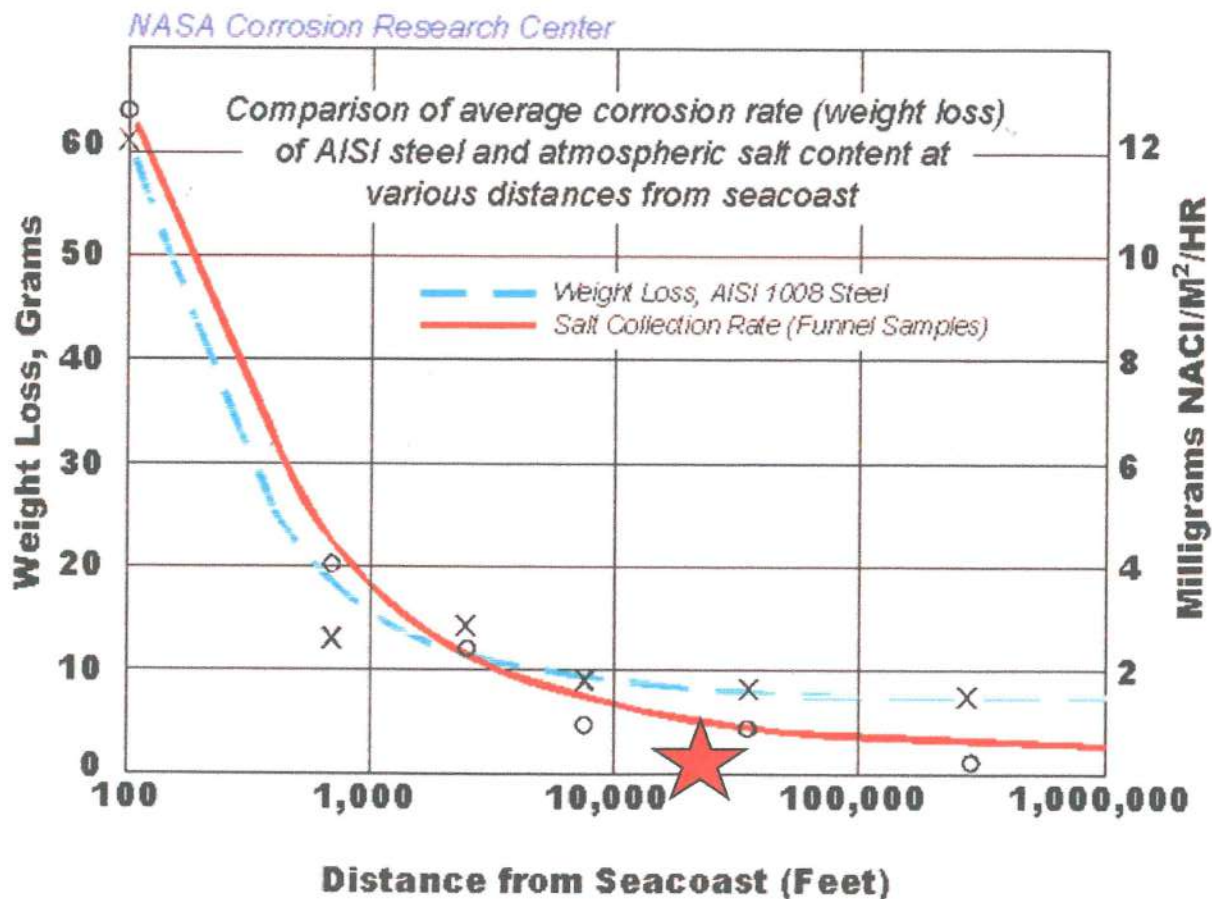
**Chloride Damage vs Distance from Ocean:** Below is a graph created by NASA several years ago based on data obtained from testing done at their research center here in Florida. The key take away here is that corrosion rates due the coastal salt environment drop exponentially as you move inward, but the effects can still be significant 10 miles inland. These buildings are about 17,500 feet inland (3.3 Miles), giving you a salt collection rate of about 1.2 milligrams square / Hr. This is substantially less than a building right on the ocean, but salts are still present. The lower rate just means the salts accumulate much slower on the flat decks, delaying the start of corrosion damage until the building are older. We've seen edge damage associated with screened edges as far West as Wellington on similar buildings.

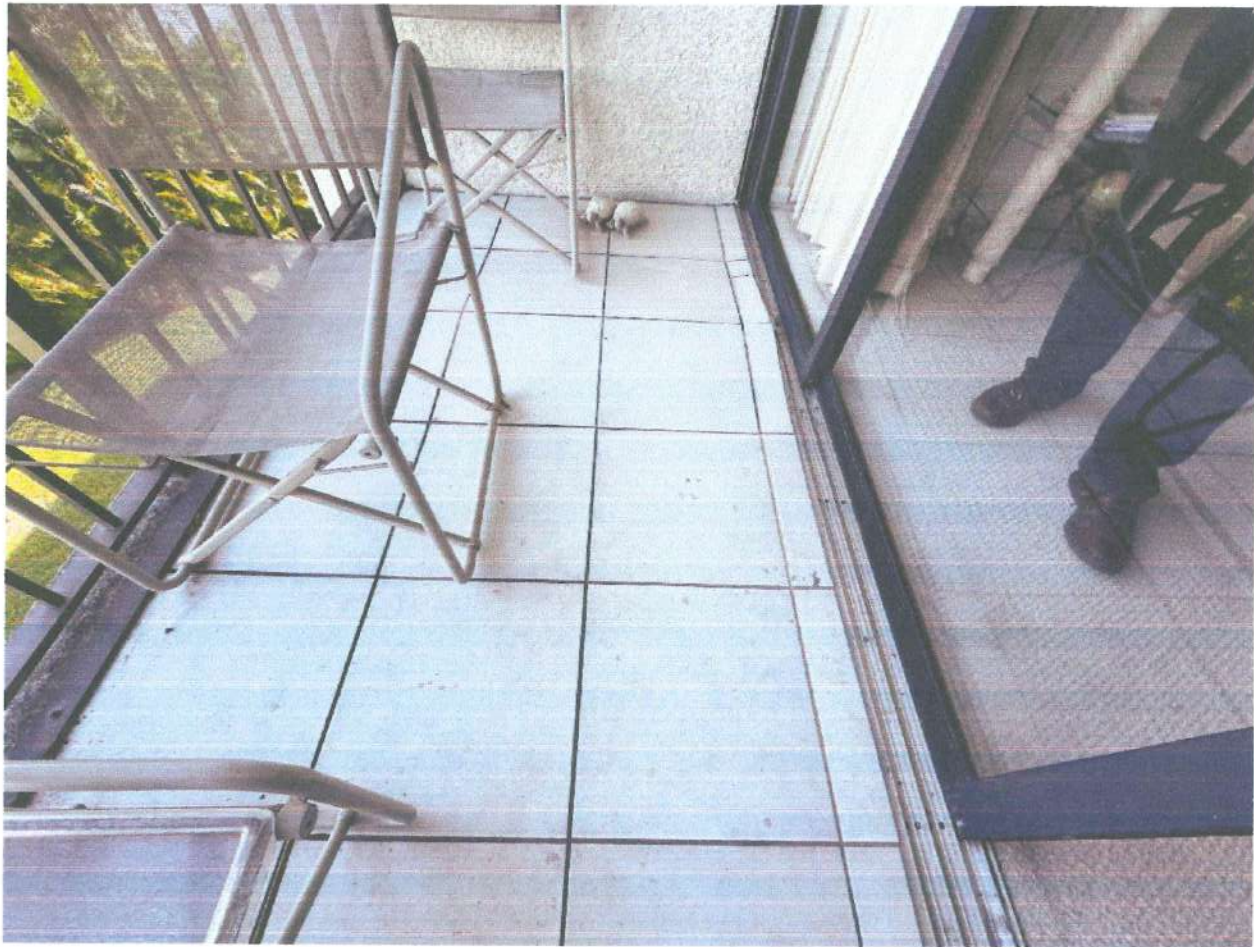
**Screen / Shutter Fasteners:** Typically, the screen enclosure and / or shutters along the edge cause edge problems eventually. The fasteners are typically Tapcons made from hardened steel that may or may not have had a sacrificial coating. Even though the fasteners may have been sealed with caulk when the screen was new, that sealant usually breaks down after 5 to 8 years. As the water starts to seep down past the fastener, the fastener will typically start to rust. As the rust happens, the fastener will first expand because rust is seven times the volume of steel. It will then lose volume and the salt water due to rain will seep down into the hole and out into the edge concrete, eventually causing the horizontal rebar along the edge to corrode. We did not observe much edge damage at this point, but you can expect to find some as time goes on.

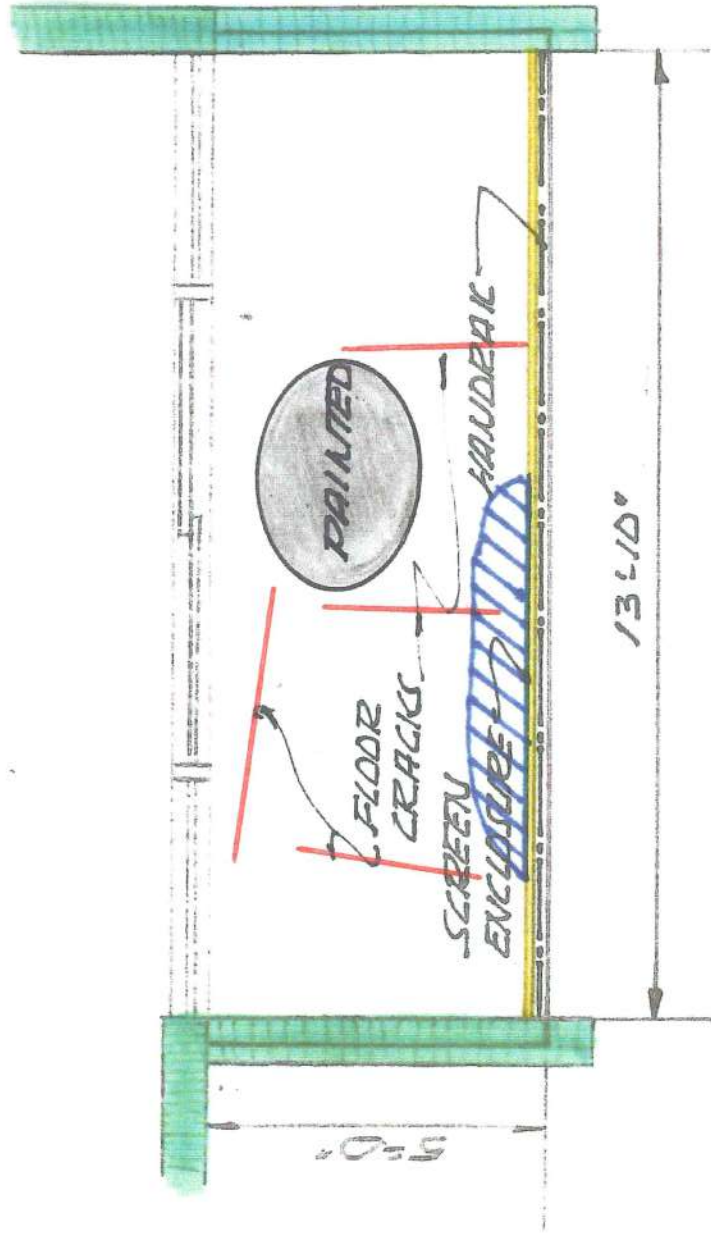
NOTE: STANDING WATER AT  
SCREEN TRACK -  
NO KEEP HOLES IN TRACK

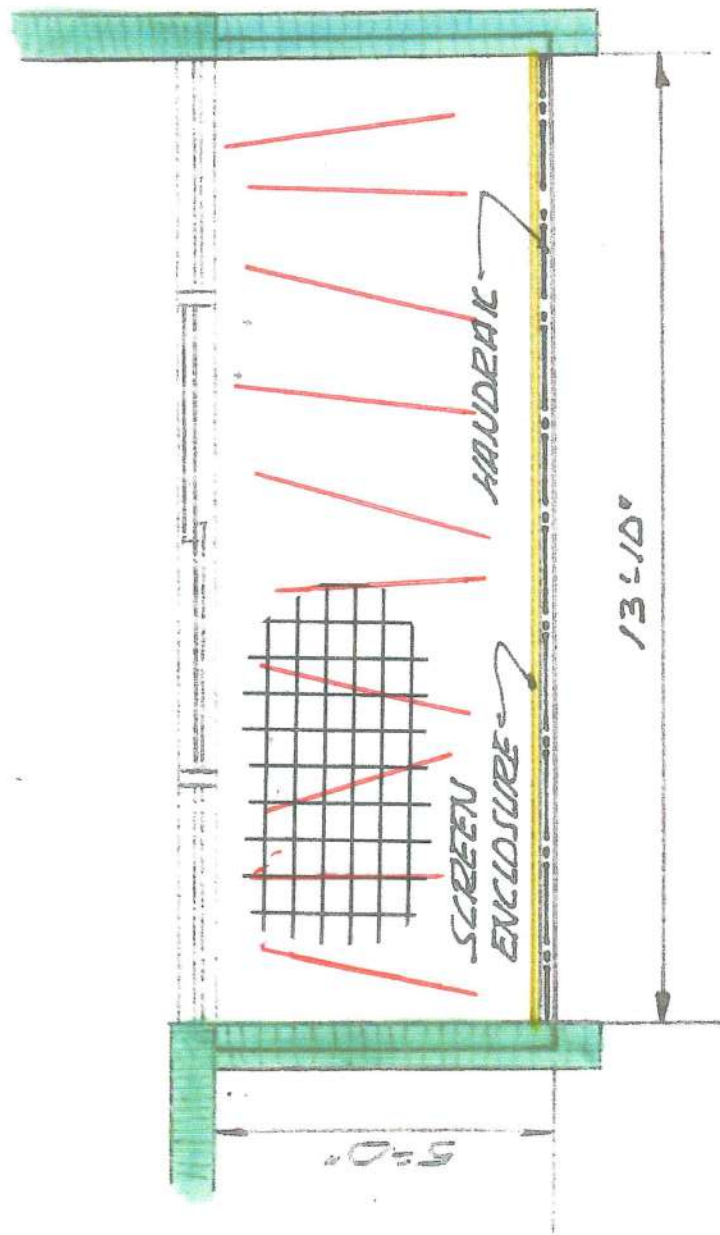
NOTE: CRACKS OVER ENTIRE BALCONY. POTENTIAL SPALLS UNDER TILES. ALL TILES TO BE REMOVED, & BALCONY INSPECTED.

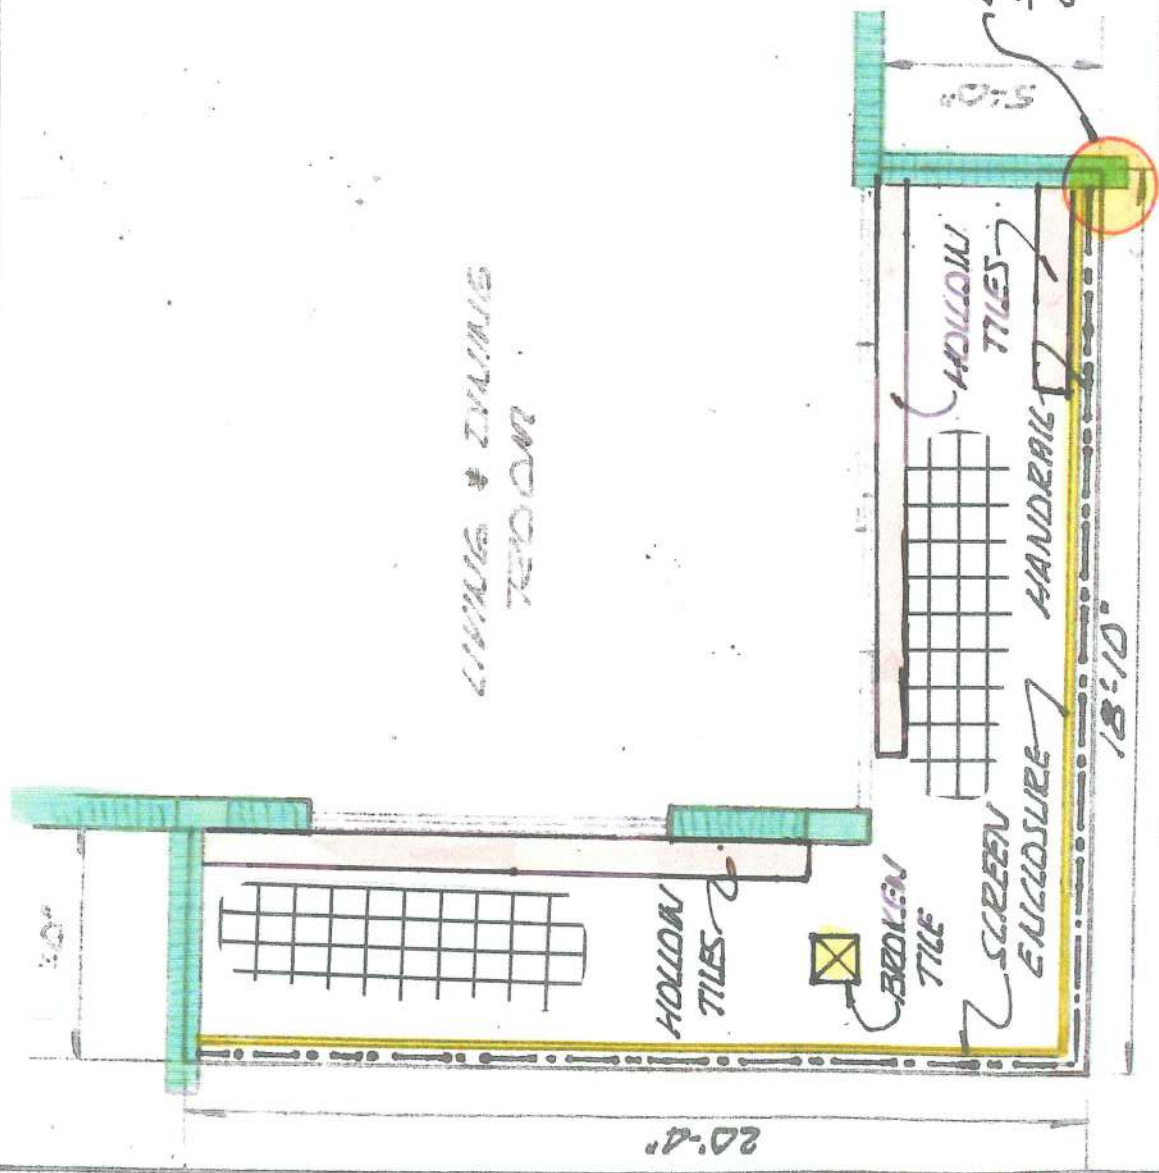
OUTSIDE WALL CRACK,  
9" BELOW CEILING,  
OUTSIDE SCREEN AREA

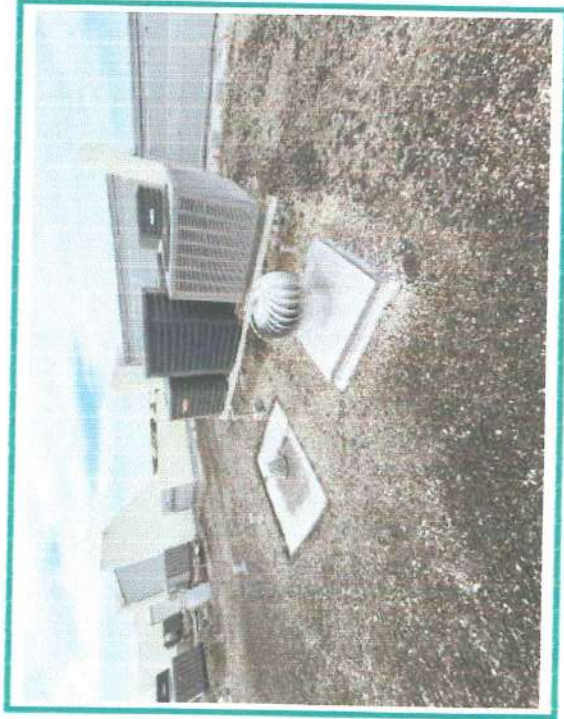
9. View of typical AC stand/vent details, well maintained

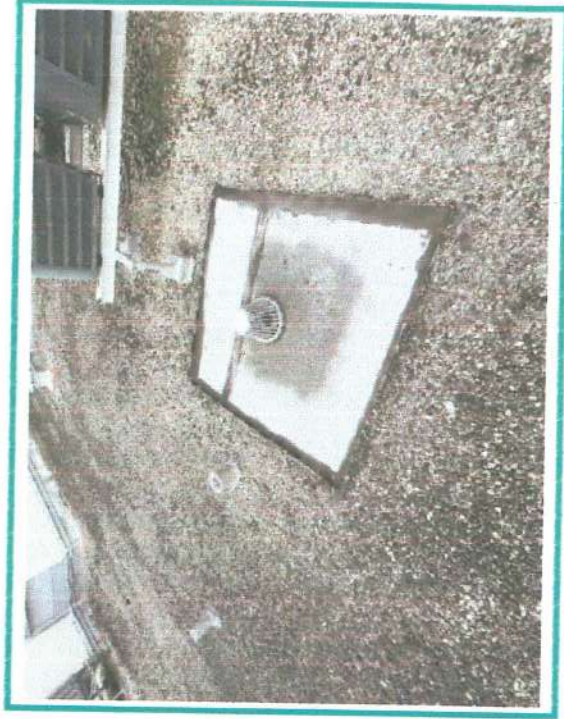
10. View of typical interior drain detail, boarder needs coating

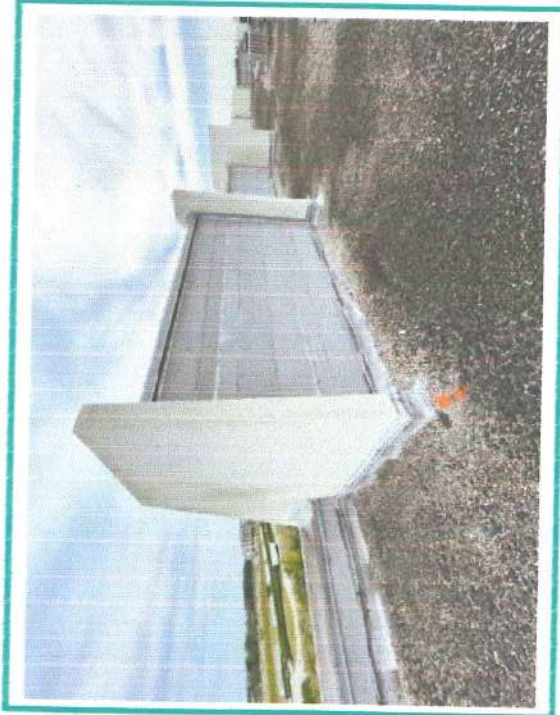
11. View of typical flashed parapet wall detail, well maintained

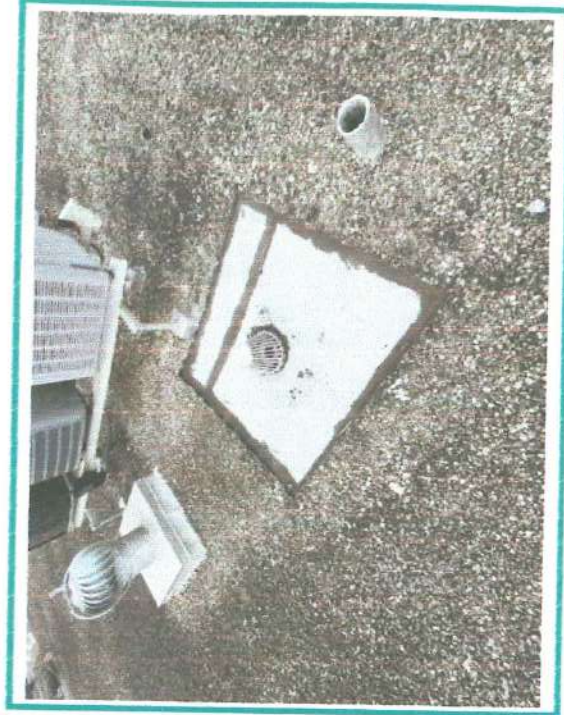
12. View of typical interior drain detail, boarder needs coating

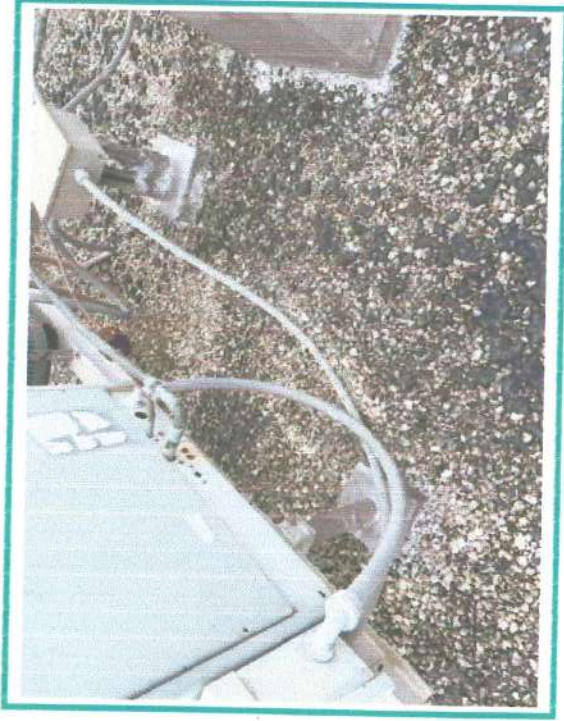
**13** Typical penetration pitch pan detail, properly filled, coated

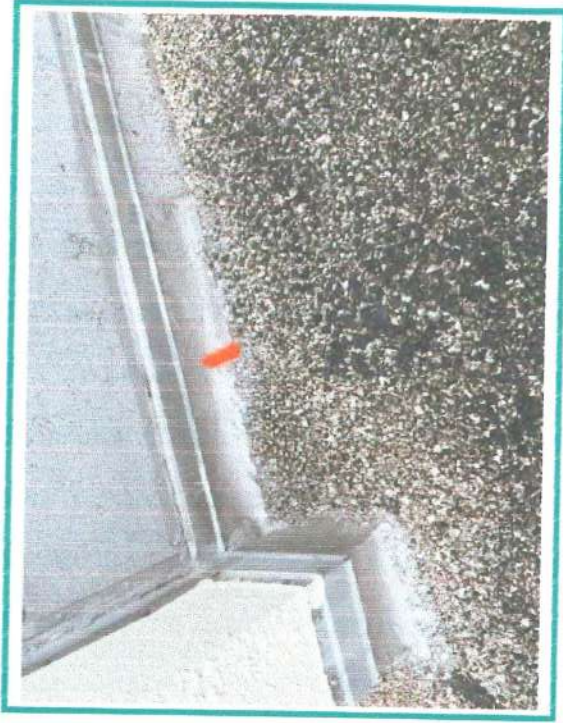
**14** View of typical termination base detail, well maintained
