# UES MILESTONE INSPECTIONS, LLC.

Re: Tropicana Gardens Structural Integrity Reserve Study (SIRS) 4001 S Ocean Blvd South Palm Beach, Florida 33480 UES Project No: 6011.2400077.0000

Tropicana Gardens Condominium – South Palm Beach 4001 S Ocean Boulevard, South Palm Beach, Florida 33480 Palm Beach County, Florida

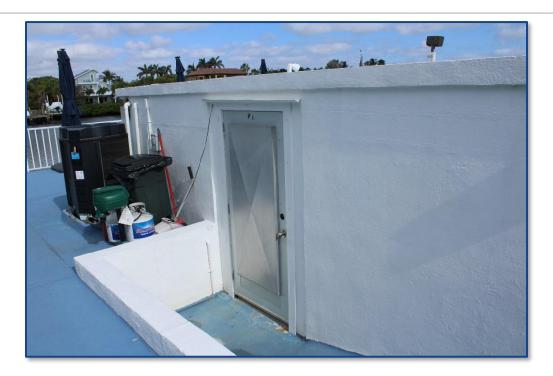
Photograph No. 7: Pool equipment room.

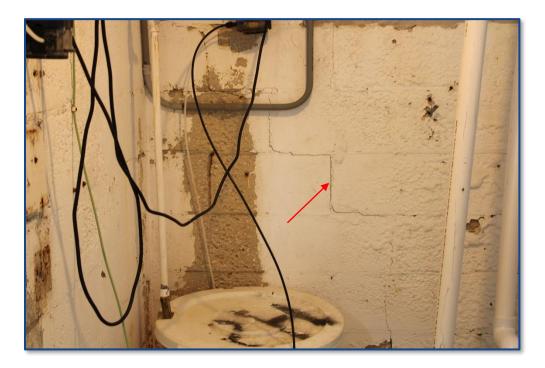
The pool equipment room, which is detached from the main building, shows concrete spalling and heavy rebar corrosion on the ceiling. The ceiling and walls also have cracks. This deficiency is considered a safety concern due to the risk of concrete falling, and immediate action is required. See Appendix B photographs 8, 9 and 10.

Photograph No. 8: Crack in the interior wall of the pool equipment room.

• UES recommends the retention of a licensed structural engineer to investigate the condition of the pool equipment room. After the investigation is completed, a repair strategy is to be prepared as per the engineer's directions with specifications and drawings. Once permits are obtained, a licensed engineer shall be responsible for ensuring that the restoration is performed as per permitted specifications/drawings.

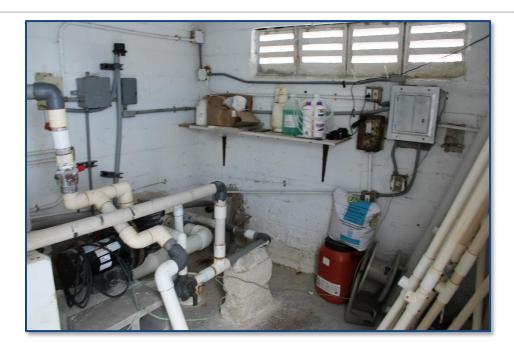
Photograph No. 9: Pool equipment.

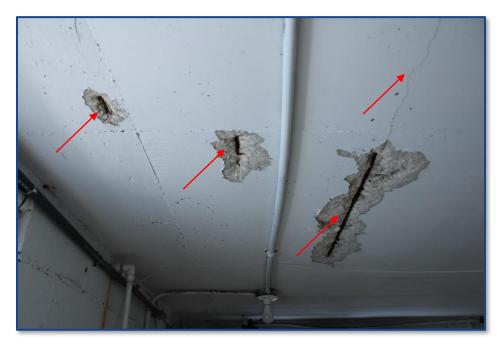
Photograph No. 10: Concrete spalls and cracks at the ceiling of the pool equipment room.

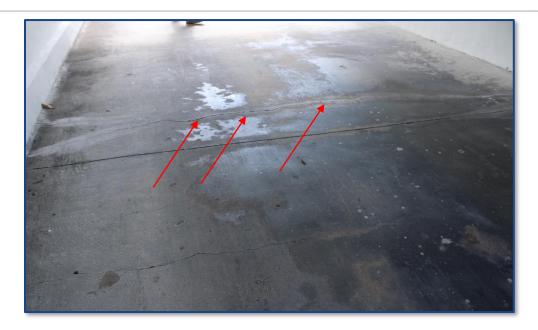
Photograph No. 21: Building driveway crack.

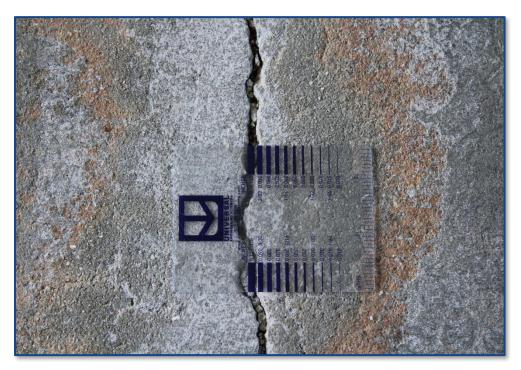
Photograph No. 22: Building driveway crack.

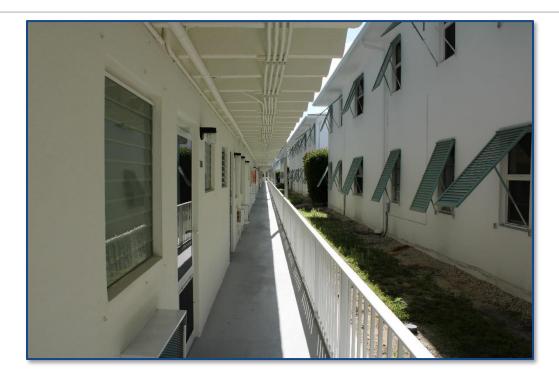
The catwalk decks have a deck waterproofing covering installed at all floors. Based on the site interview no water intrusion issues were reported, nor any issues were observed. The exterior finish of the building consists of painted stucco finishes. Overall, the general condition of the exterior finishes is in good condition with minor cracking/spalling/rusting observed at several areas within the building catwalks, façade, and unit balconies.

Photograph No. 23: Typical catwalk.

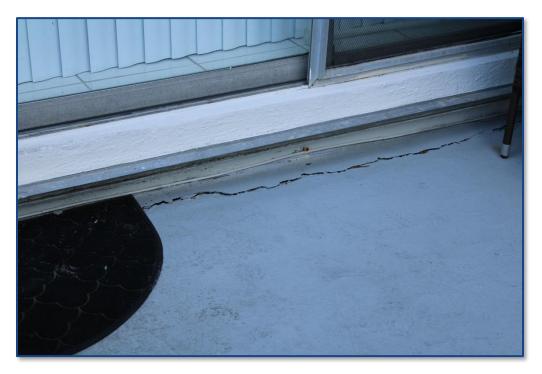
Photograph No. 24: Concrete crack at exterior patios, typical.

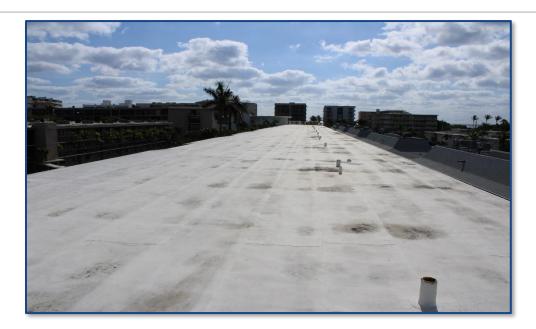
The building's roof is a flat roof consisting of pre-cast (double T's) concrete slabs covered with a seal coat over modified bitumen roofing system. At the time of inspection, the roof is in fair condition with minor ponding and damaged areas observed on the roof. Evidence of previous ponding was observed.

Photograph No. 27: Roof over units.

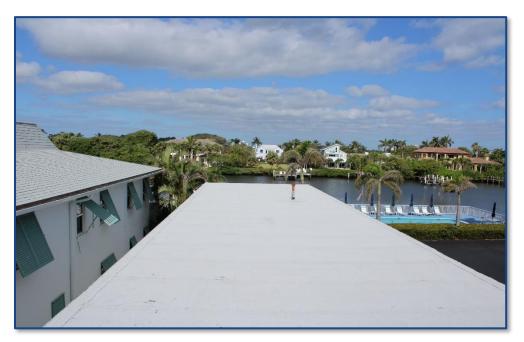
Photograph No. 28: Roof over laundry and storage area.

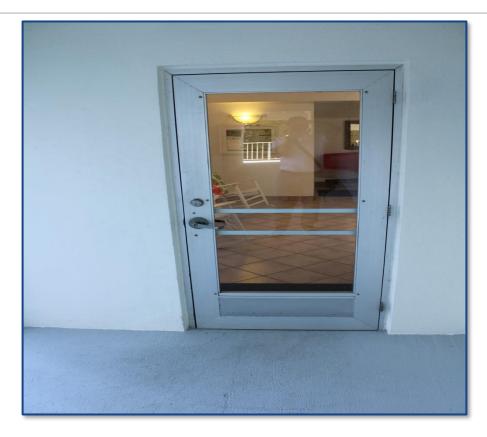
The windows and doors in the common areas were observed to be in fair condition.

Photograph No. 29: Exterior door at common areas, typical.

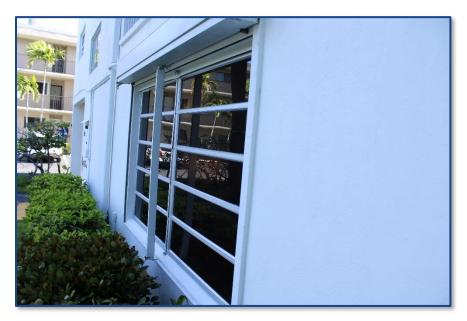
Photograph No. 30: Exterior window at common areas, typical.
