Phase I Structural Assessments

Phase II Structural Forensic Evaluations

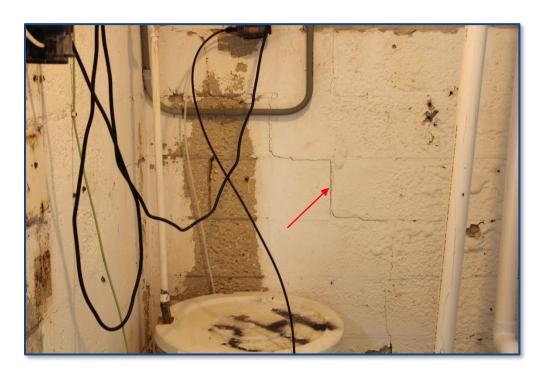
Photograph No. 8: Crack in the interior wall of the pool equipment room.

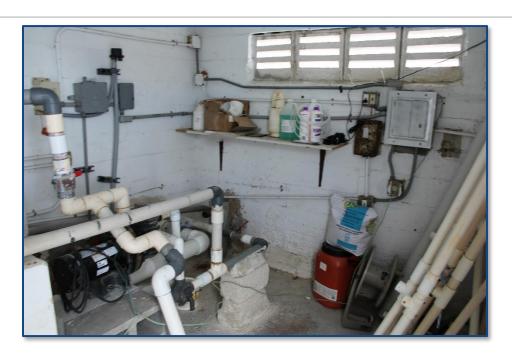
Photograph No. 9: Pool equipment.

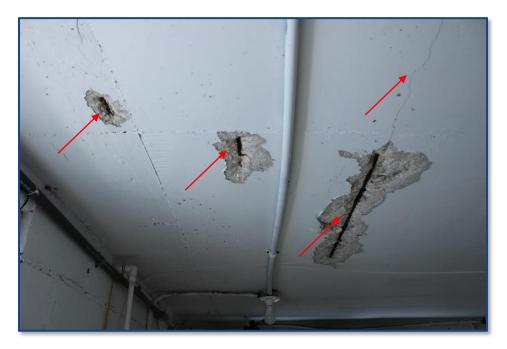
Photograph No. 10: Concrete spalls and cracks at the ceiling of the pool equipment room.

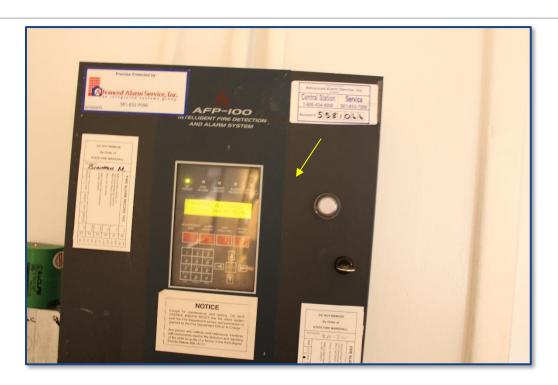
Photograph No. 11: Fire alarm panel

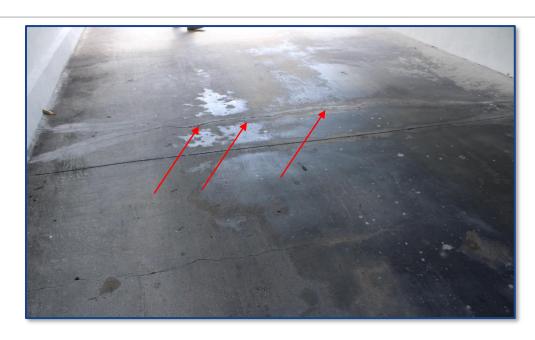
Photograph No. 21: Building driveway crack.

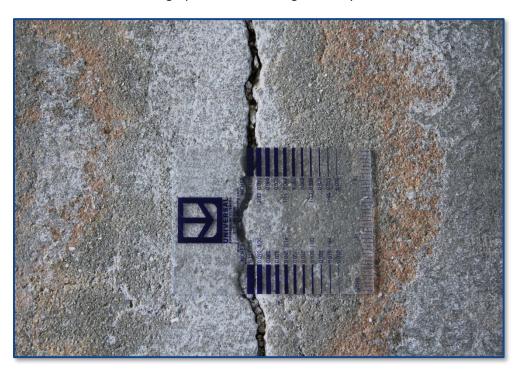
Photograph No. 22: Building driveway crack.

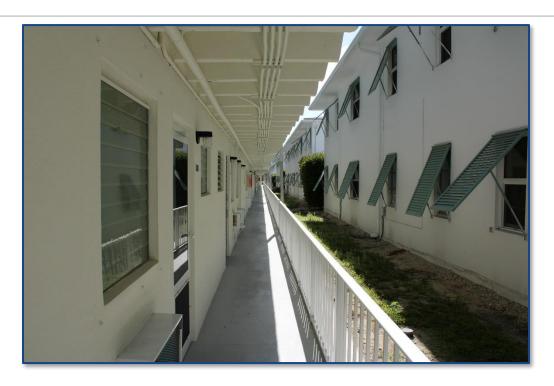
Photograph No. 23: Typical catwalk.

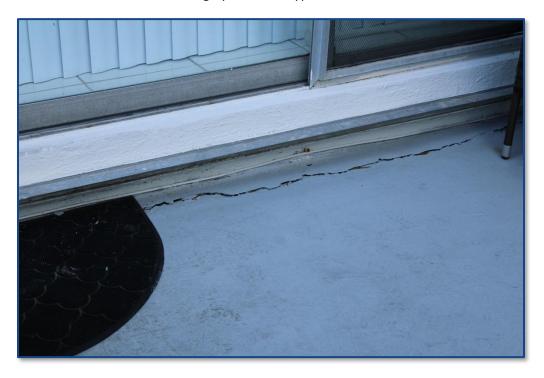
Photograph No. 24: Concrete crack at exterior patios, typical.

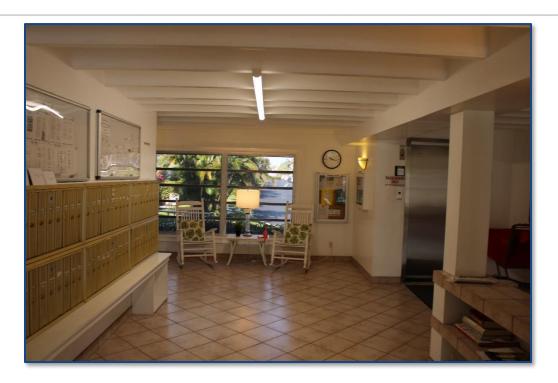
Photograph No. 25: Common area, lobby.
