**Client:** Grand Isles Condominium

**Address:** 4151 Haverhill Rd

# Uniform Mitigation Verification Inspection Form

Inspection Date: 04/04/2024		
<b>Owner Information</b>		
Owner Name: Grand Isles Condominium		Contact Person:
Address: 4151 Haverhill Rd		Home Phone:
City: West Palm Beach	Zip: 33417	Work Phone:
County: Palm Beach		Cell Phone:
Insurance Company:		Policy #:
Year of Home: 2000	# of Stories:	Email:

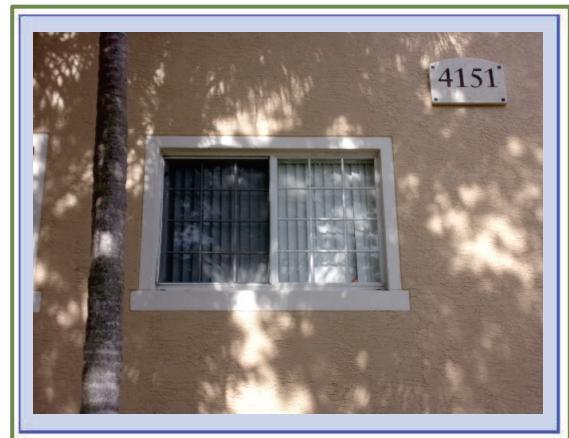
N	Opening Protection products that appear to be A or B but are not verified						
	Other protective coverings that cannot be identified as A, B, or C						
X	No Windborne Debris Protection	X				X	X

Unprotected Opening

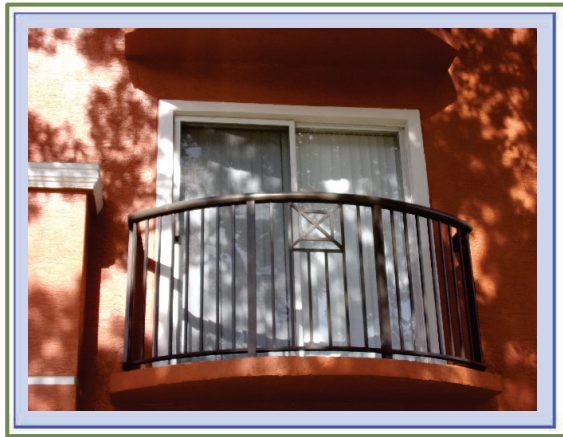
Unprotected Opening

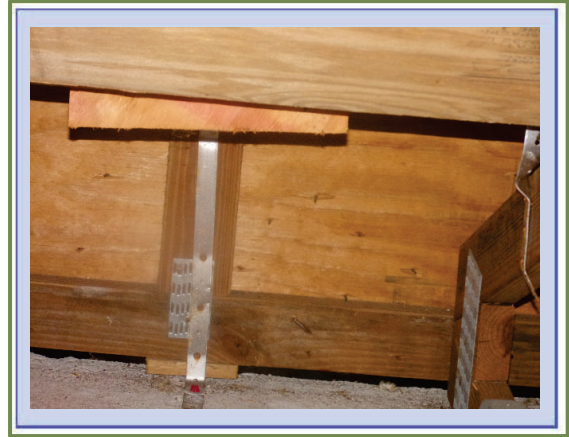
- ☒ Secured to truss/rafter with a minimum of three (3) nails, **and**
- ☒ Attached to the wall top plate of the wall framing, or embedded in the bond beam, with less than a ½" gap from the blocking or truss/rafter **and** blocked no more than 1.5" of the truss/rafter, **and** free of visible severe corrosion.

- ☒ B. Clips
- ☒ Metal connectors that do not wrap over the top of the truss/rafter, **or**
- ☐ Metal connectors with a minimum of 1 strap that wraps over the top of the truss/rafter and does not meet the nail position requirements of C or D, but is secured with a minimum of 3 nails.

Clip

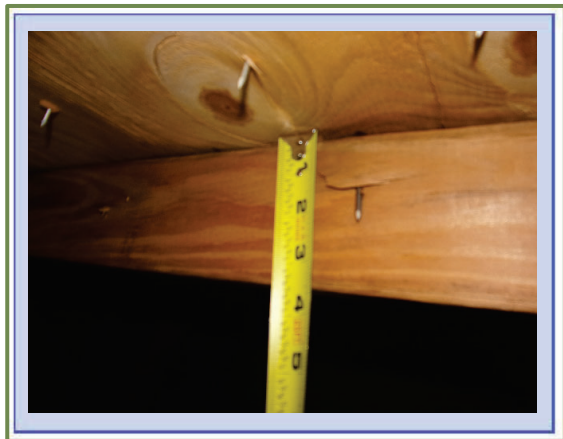
☒ C. Plywood/OSB roof sheathing with a minimum thickness of 7/16" inch attached to the roof truss/rafter (spaced a maximum of 24" inches o.c.) by 8d common nails spaced a maximum of 6" inches in the field. -OR- Dimensional lumber/Tongue & Groove decking with a minimum of 2 nails per board (or 1 nail per board if each board is equal to or less than 6 inches in width). -OR- Any system of screws, nails, adhesives, other deck fastening system or truss/rafter spacing that is shown to have an equivalent

8d nail

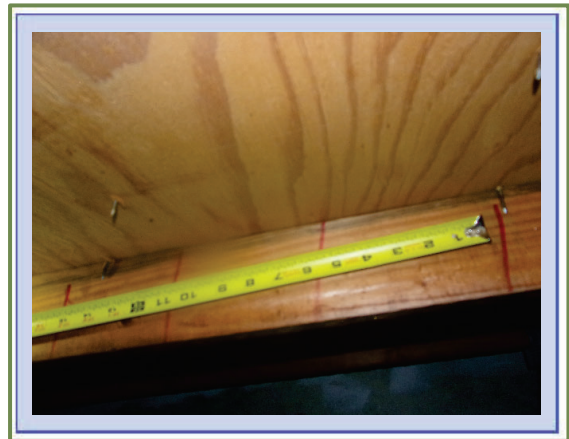
6x6 nail spacing
