Client: Grand Isles Condominium

Address: 4175 Haverhill Rd

Uniform Mitigation Verification Inspection Form

Inspection Date: 04/11/2024		
Owner Information		
Owner Name: Grand Isles Condominium		Contact Person:
Address: 4175 Haverhill Rd		Home Phone:
City: West Palm Beach	Zip: 33417	Work Phone:
County: Palm Beach		Cell Phone:
Insurance Company:		Policy #:
Year of Home: 2000	# of Stories:	Email:

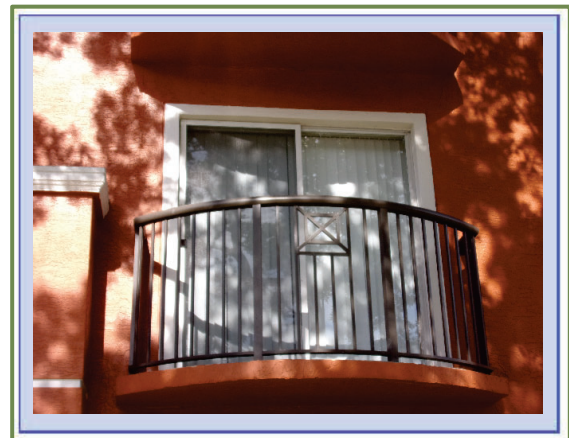
Other protective coverings that cannot be identified as A, B, or C	<input type="checkbox"/>	<input type="checkbox"/>	<input type="checkbox"/>	<input type="checkbox"/>	<input type="checkbox"/>	<input type="checkbox"/>
X	No Windborne Debris Protection	<input checked="" type="checkbox"/>	<input type="checkbox"/>	<input type="checkbox"/>	<input type="checkbox"/>	<input checked="" type="checkbox"/>	<input checked="" type="checkbox"/>

Unprotected Opening

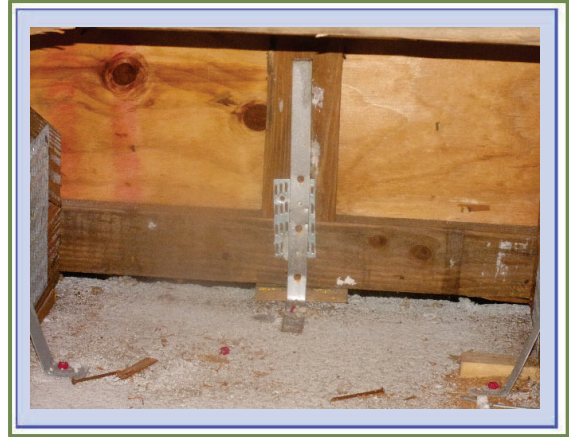
- ☒ Secured to truss/rafter with a minimum of three (3) nails, **and**
- ☒ Attached to the wall top plate of the wall framing, or embedded in the bond beam, with less than a ½" gap from the blocking or truss/rafter **and** blocked no more than 1.5" of the truss/rafter, **and** free of visible severe corrosion.

- ☒ B. Clips
- ☒ Metal connectors that do not wrap over the top of the truss/rafter, **or**
- ☐ Metal connectors with a minimum of 1 strap that wraps over the top of the truss/rafter and does not meet the nail position requirements of C or D, but is secured with a minimum of 3 nails.

Clip
