Uniform Mitigation Verification Inspection Form

Inspection Date: 7/16/2024		
Owner Information		
Owner Name: Atlantic Grove Townhome Association Inc.		Contact Person:
Address: 62-90 NW 3rd Ave.		Home Phone:
City: Delray Beach	Zip: 33444	Work Phone:
County:		Cell Phone:
Insurance Company:		Policy #:
Year of Home: 2003	# of Stories: 3	Email:

Inspectors Initials **DB** Property Address 62-90 NW 3rd Ave., Delray Beach, FL 33444

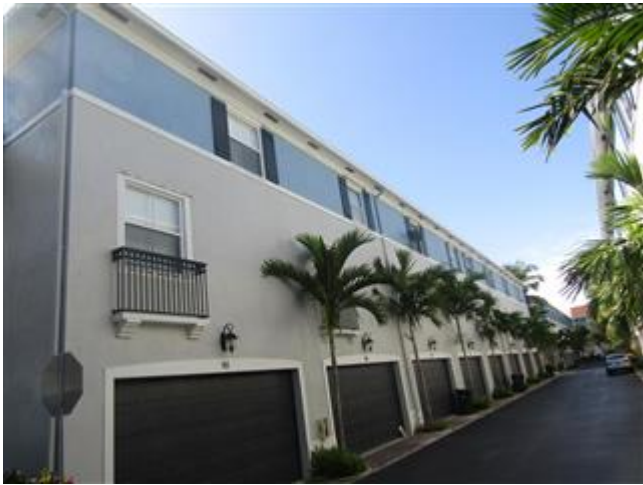
Rear Elevation

- ☒ A. Hip Roof Hip roof with no other roof shapes greater than 10% of the total roof system perimeter.
Total length of non-hip features: _____ feet; Total roof system perimeter: _____ feet
- ☐ B. Flat Roof Roof on a building with 5 or more units where at least 90% of the main roof area has a roof slope of less than 2:12. Roof area with slope less than 2:12 _____ sq ft; Total roof area _____ sq ft
- ☐ C. Other Roof Any roof that does not qualify as either (A) or (B) above.

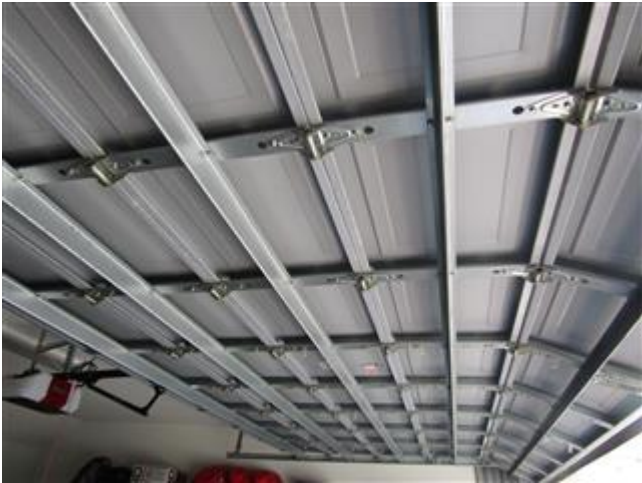
- Southern Standards Technical Document (SSTD) 12
 - For Skylights Only: ASTM E 1886 and ASTM E 1996
 - For Garage Doors Only: ANSI/DASMA 115
- ☒ A.1 All Non-Glazed openings classified as A in the table above, or no Non-Glazed openings exist

Hurricane Impact Garage Door

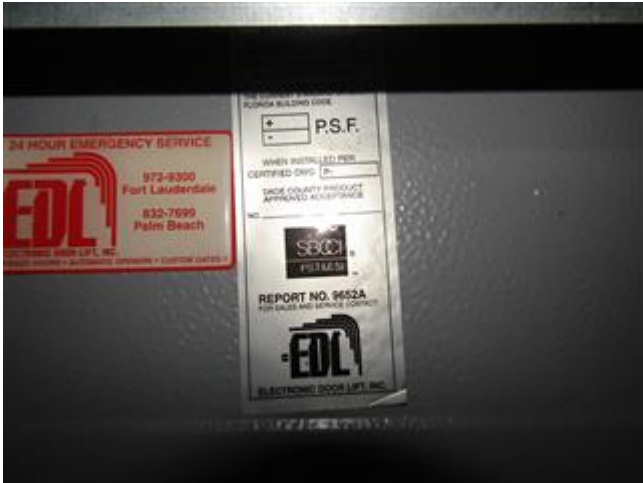
Hurricane Impact Garage Door Verification

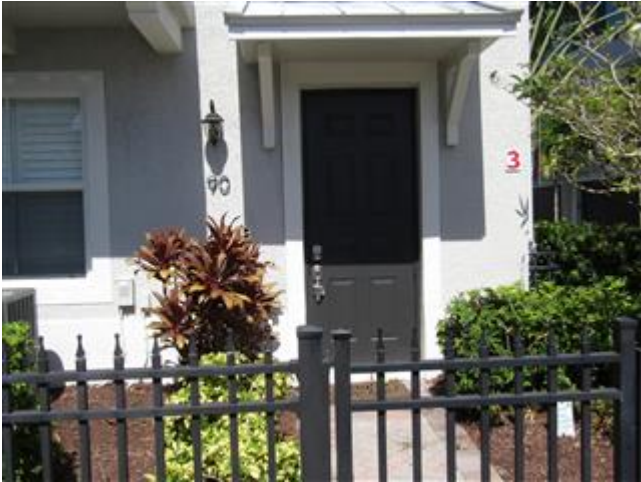
Hurricane Solid Front Door

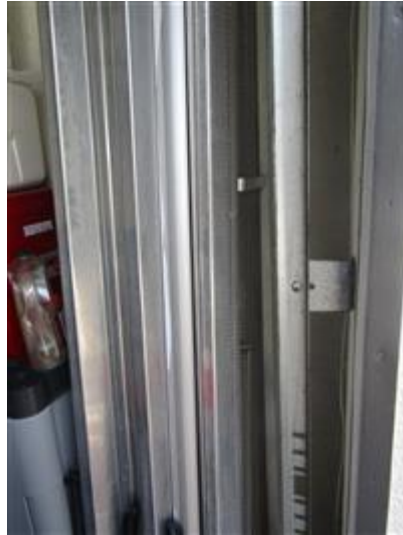
- ☒ **A. Exterior Openings Cyclic Pressure and 9-lb Large Missile (4.5 lb for skylights only)** All Glazed openings are protected at a minimum, with impact resistant coverings or products listed as wind borne debris protection devices in the product approval system of the State of Florida or Miami-Dade County and meet the requirements of one of the following for "Cyclic Pressure and Large Missile Impact" (Level A in the table above).

Hurricane Impact Shutters

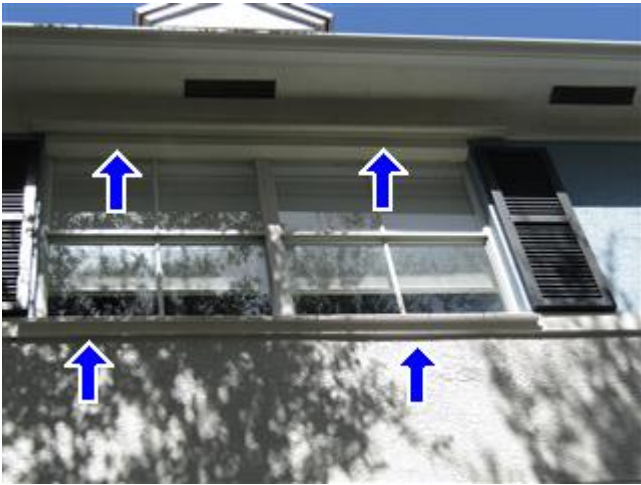
Hurricane Shutter Hardware - Windows

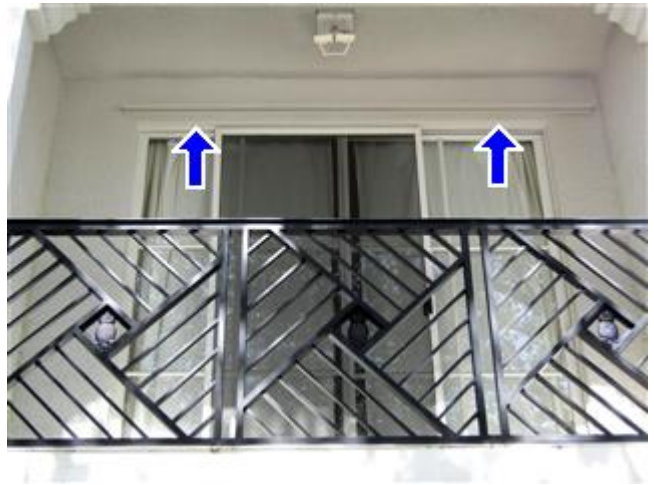
Hurricane Shutter Hardware - Glass Doors

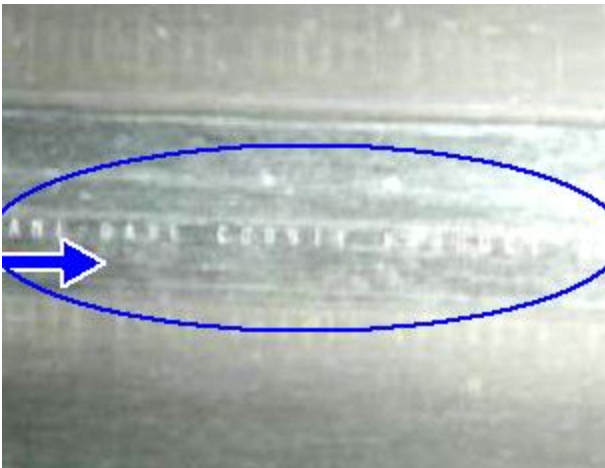
Hurricane Impact Shutters Verification

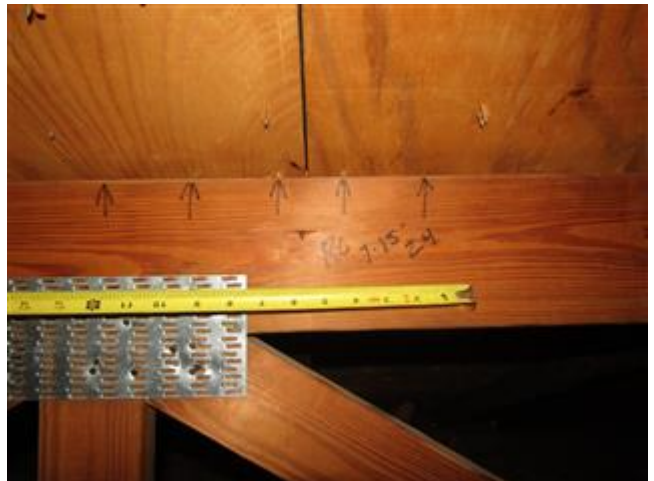
- ☒ C. Plywood/OSB roof sheathing with a minimum thickness of 7/16" inch attached to the roof truss/rafter (spaced a maximum of 24" inches o.c.) by 8d common nails spaced a maximum of 6" inches in the field. -OR- Dimensional lumber/Tongue & Groove decking with a minimum of 2 nails per board (or 1 nail per board if each board is equal to or less than 6 inches in width). -OR- Any system of screws, nails, adhesives, other deck fastening system or truss/rafter spacing that is shown to have an equivalent

Roof to Deck Connection

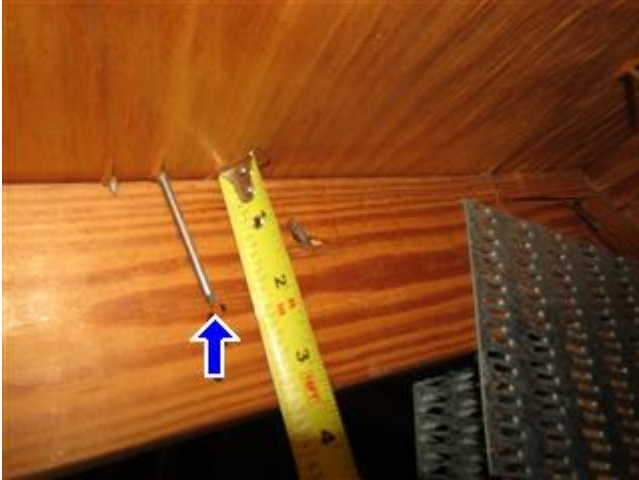
or greater resistance than 8d common nails spaced a maximum of 6 inches in the field or has a mean uplift resistance of at least 182 psf.

Roof to Deck Connection - 8D Nailing

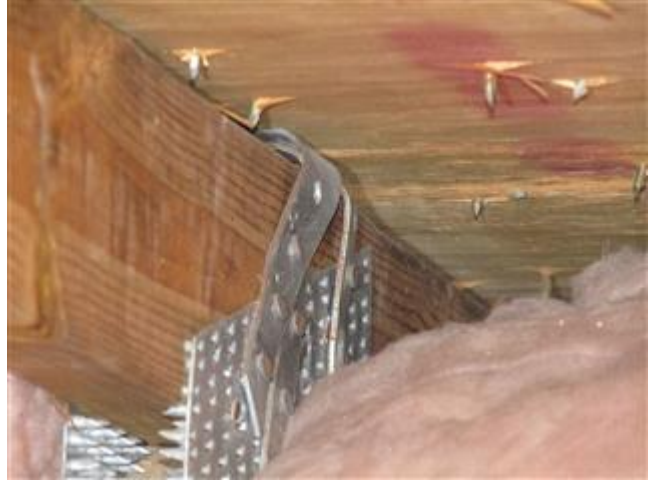
- ☒ Secured to truss/rafter with a minimum of three (3) nails, **and**
- ☒ Attached to the wall top plate of the wall framing, or embedded in the bond beam, with less than a 1/2" gap from the blocking or truss/rafter **and** blocked no more than 1.5" of the truss/rafter, **and** free of visible severe corrosion.
- ☐ B. Clips
 - ☐ Metal connectors that do not wrap over the top of the truss/rafter, **or**
 - ☐ Metal connectors with a minimum of 1 strap that wraps over the top of the truss/rafter and does not meet the nail position requirements of C or D, but is secured with a minimum of 3 nails.
- ☐ C. Single Wraps

- ☒ D. Double Wraps
 - ☒ Metal Connectors consisting of 2 separate straps that are attached to the wall frame, or embedded in the bond beam, on either side of the truss/rafter where each strap wraps over the top of the truss/rafter and is secured with a minimum of 2 nails on the front side, and a minimum of 1 nail on the opposing side, **or**

Roof to Wall Connection - Double Straps
