Uniform Mitigation Verification Inspection

HARBORS AT ABERDEEN
8312 WATERLINE DR BLDG 7
BOYNTON BEACH ,FL 33472

Prepared by: **DAVID GUTIERREZ**

Florida Inspection Center

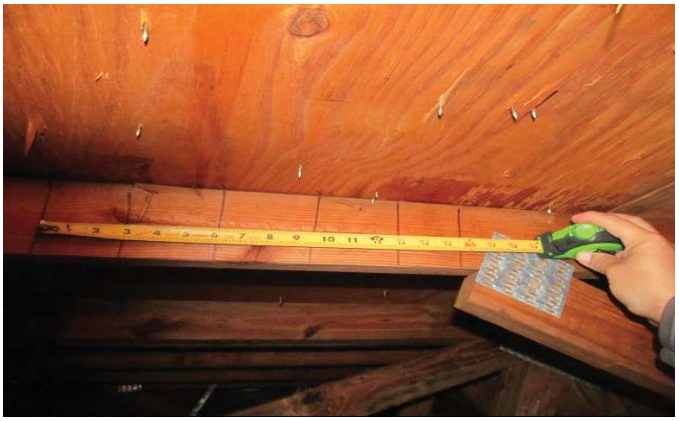
NAILS SPACED 6" ON THE EDGE
