**STRUCTURAL ENGINEERING PROFESSIONALS, INC.**

# **PHASE 1 MILESTONE REPORT**

## **SENATE CONDOMINIUM**

**3000 PRESIDENTIAL WAY**

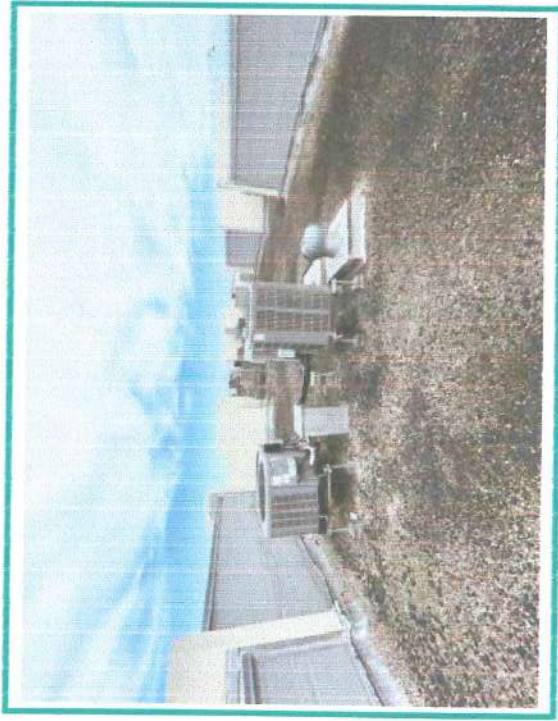
1. Overview of roof (3000 Bldg) looking S. from NE. corner

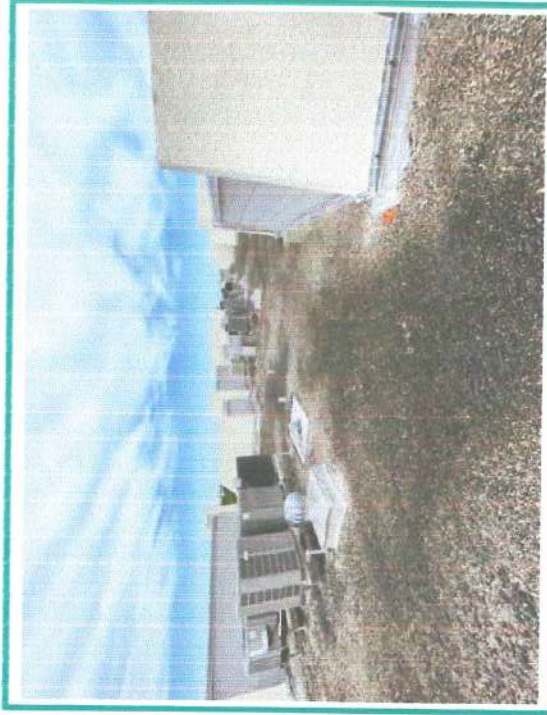
2. Overview of roof (3000 Bldg) looking S. from NW. corner

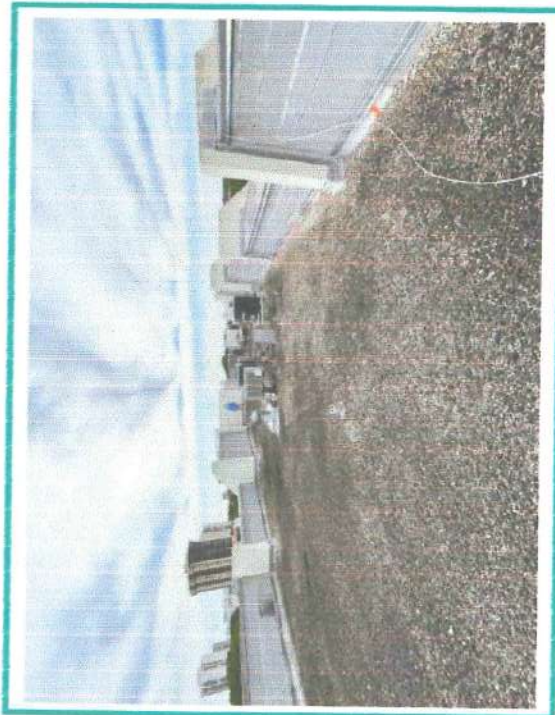
3. Overview of roof (3000 Bldg) looking N. from E. center

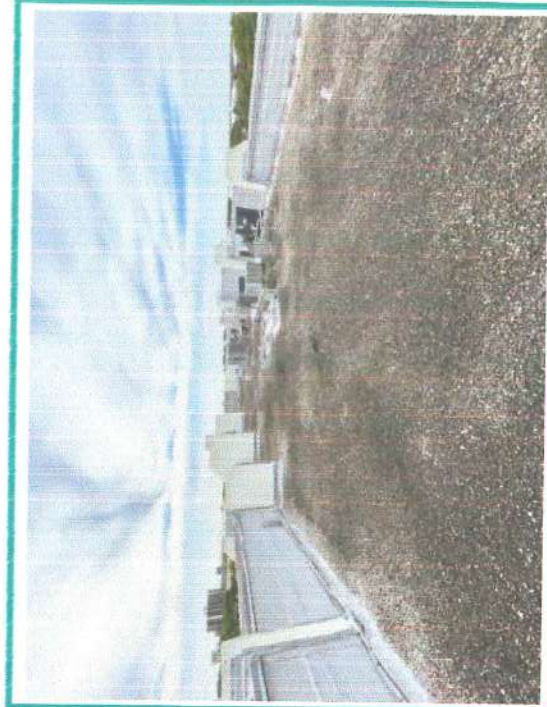
4. Overview of roof (3000 Bldg) looking N. from W. center

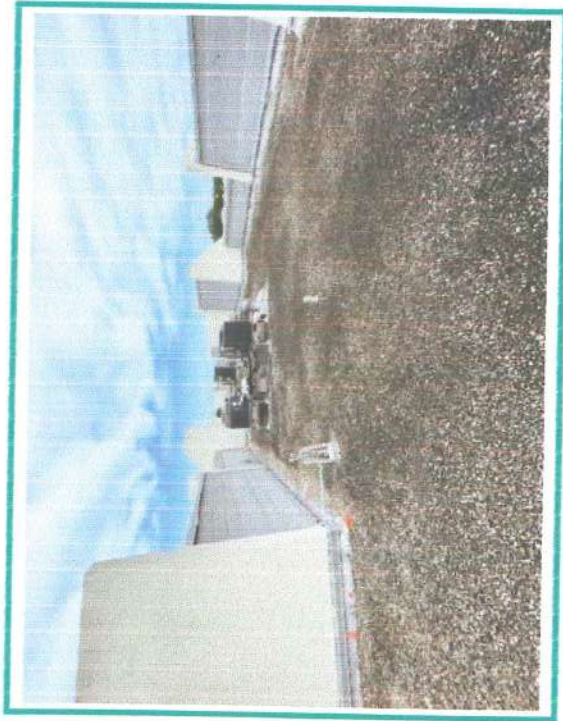
5. Overview of roof (3000 Bldg) looking S. from E. center

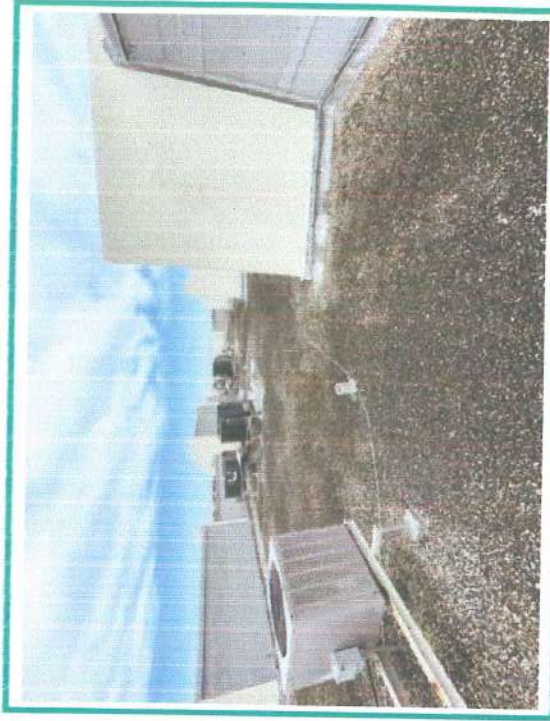
6. Overview of roof (3000 Bldg) looking S. from W. center

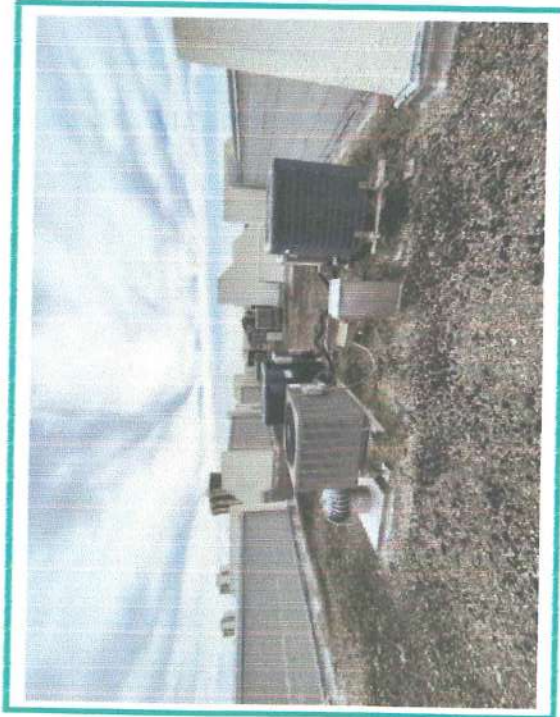
7. Overview of roof (3000 Bldg) looking N. from SE. corner

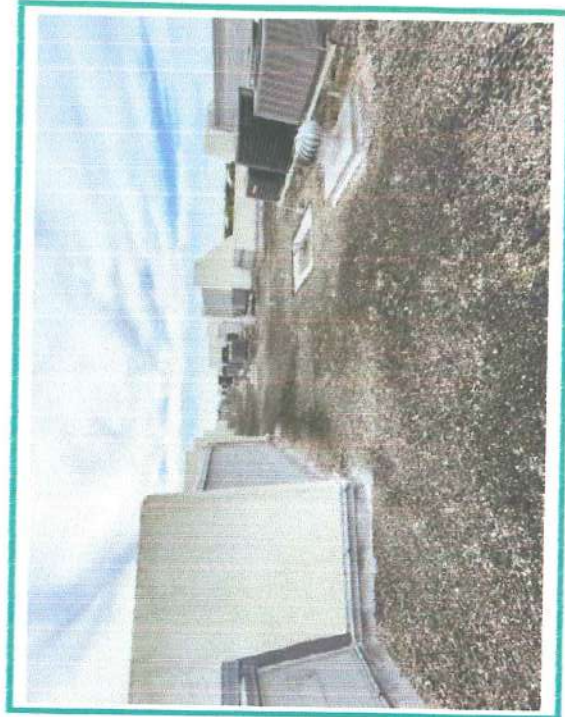
8. Overview of roof (3000 Bldg) looking N. from SW. corner
